LA PEROUSE AND BARE ISLAND HISTORIC SITES, LA PEROUSE.

Conservation Plan.

Historical Archaeology.

For
The Department of Public Works, NSW.

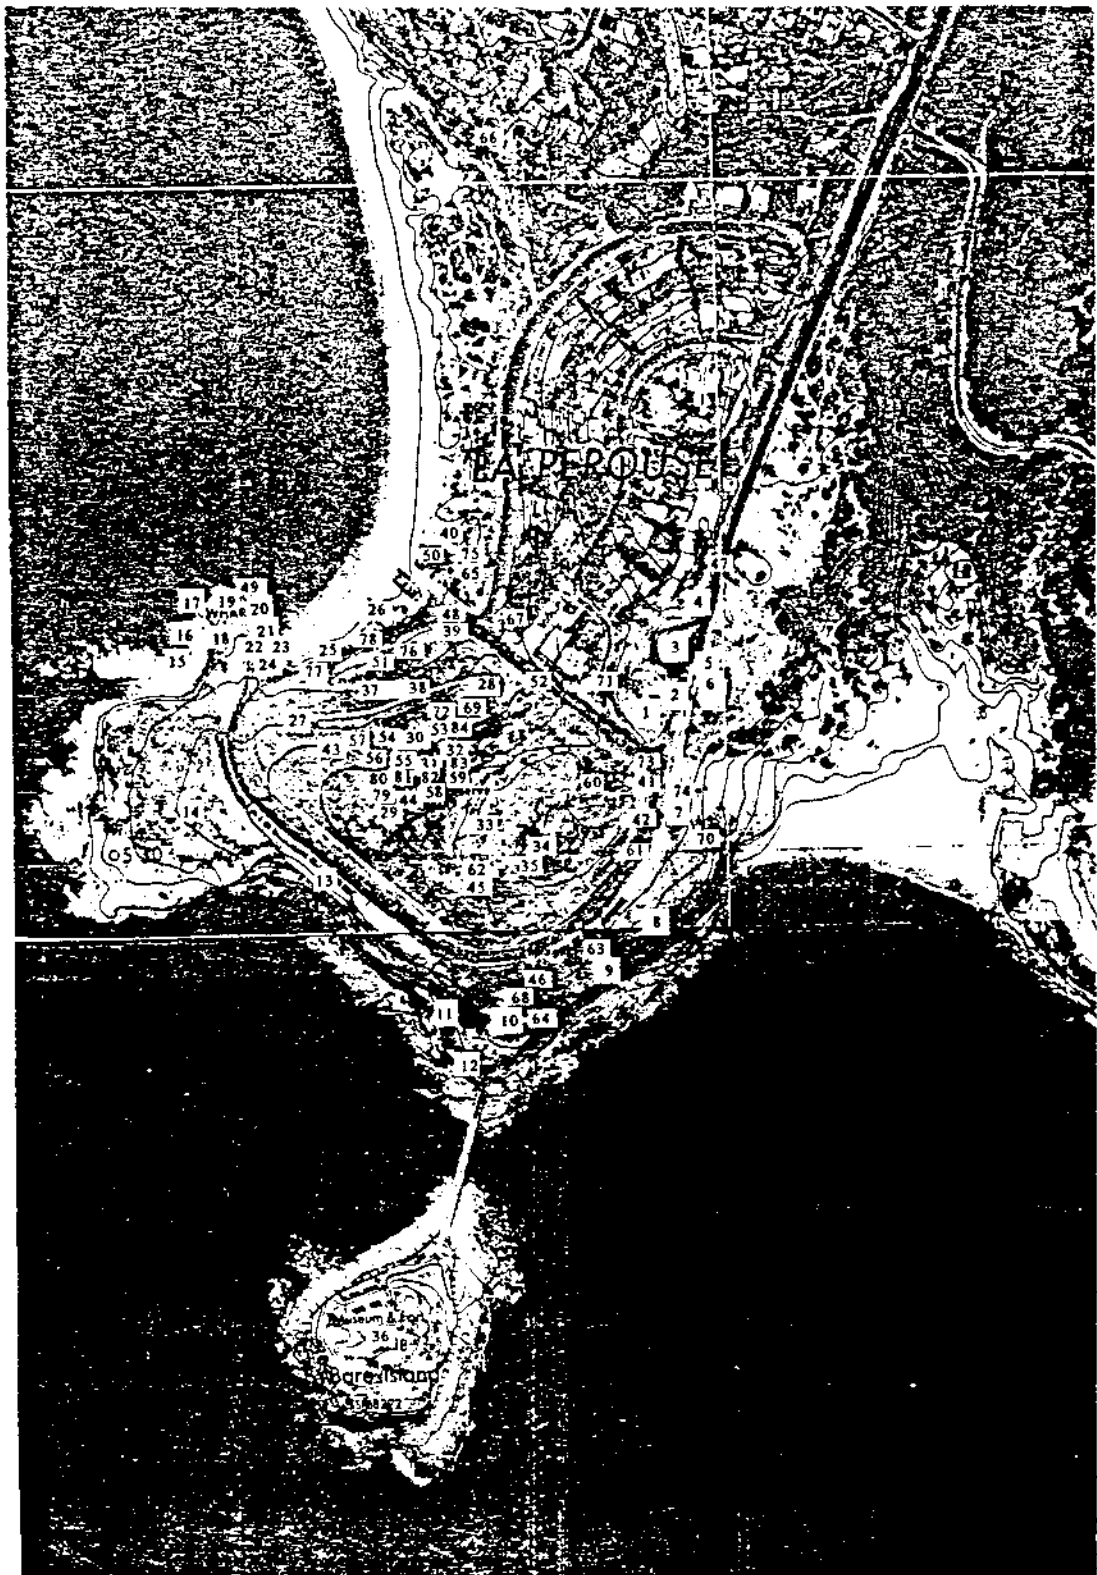
Figure 2.1. Site plan showing the location of all identified archaeological sites, which are listed in appendices 1 and 2.

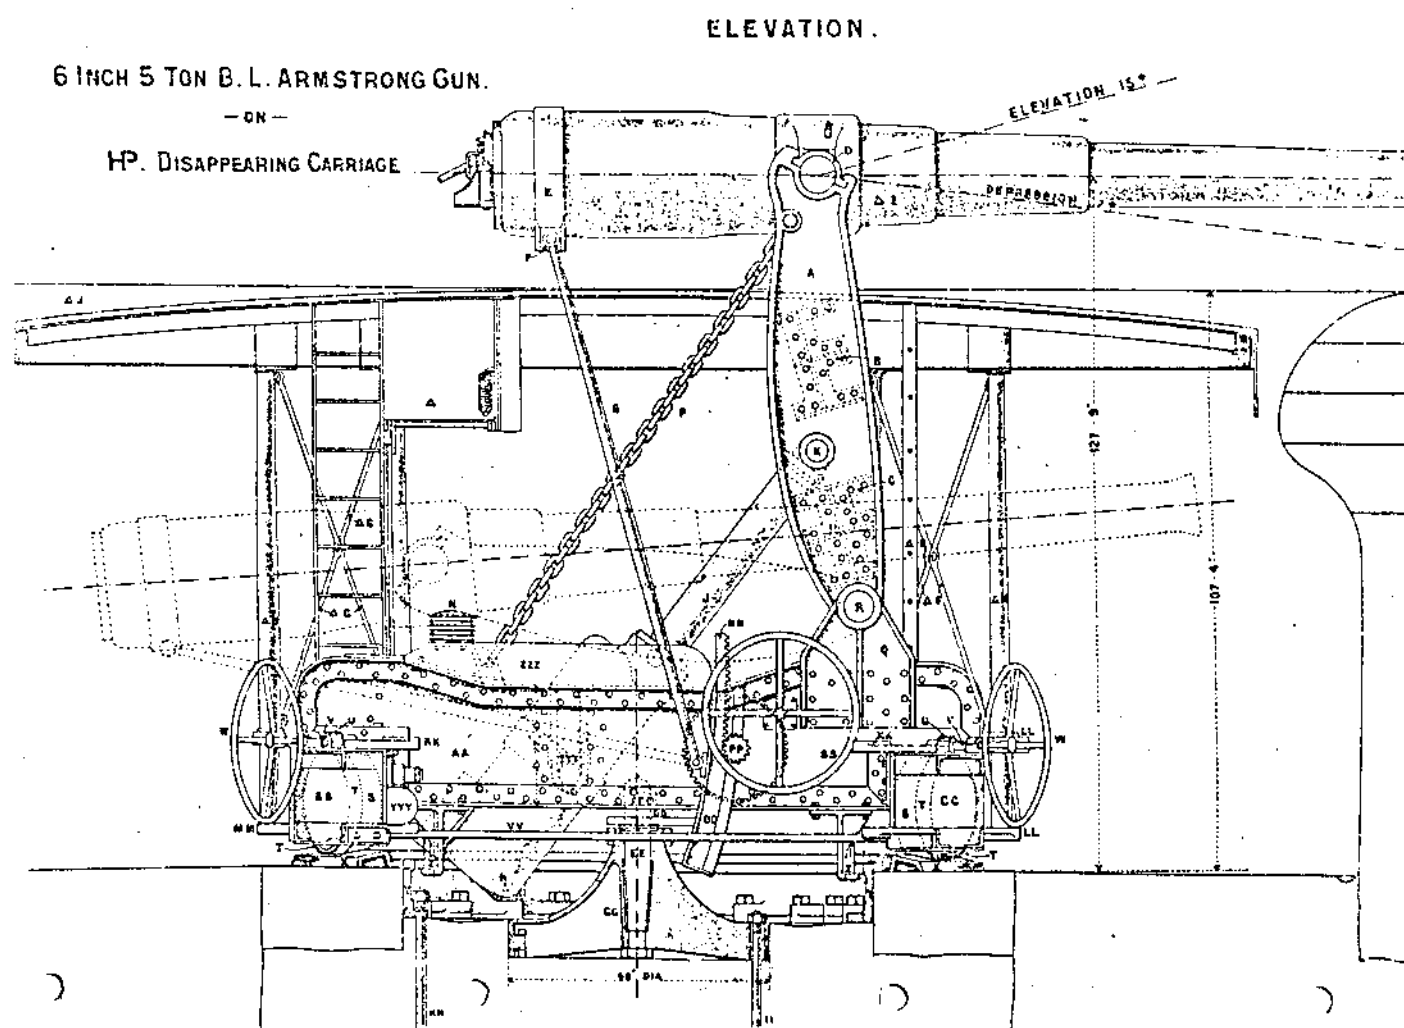
Figure 2.2. Schematic diagram of a hydro-pneumatic carriage for a 6 inch BL gun, as used at Bare Island. (Royal Australian Artillery Historical Society).

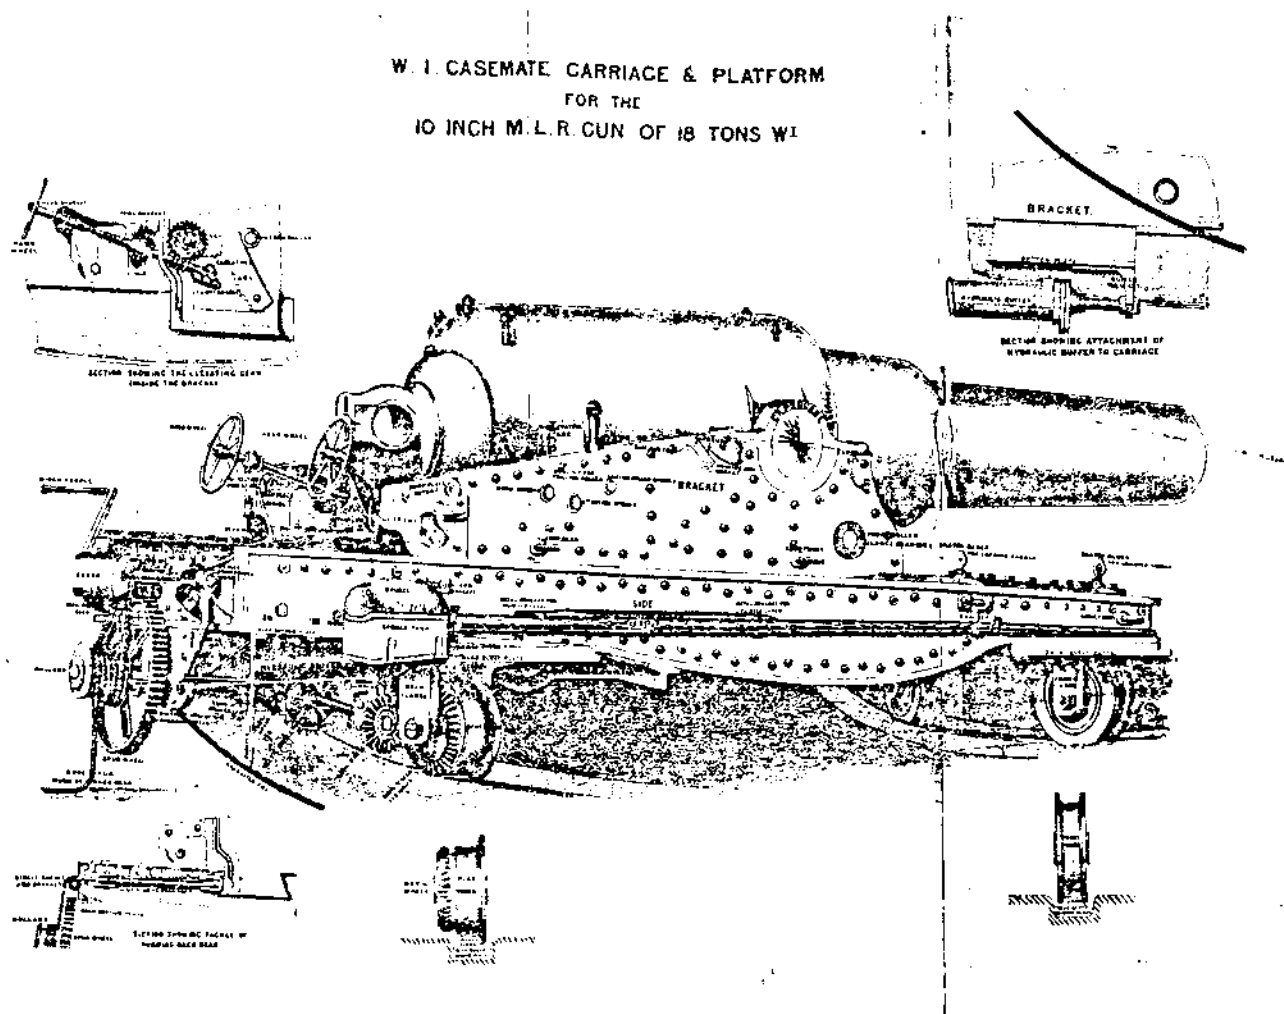
Figure 2.3. Standard casemate carriage for a 10 inch RML gun as used in the casemate at Bare Island. (Royal Australian Artillery Historical Society).
