Point Nepean Forts Conservation Management Plan

POINT NEPEAN FORTS

CONSERVATION MANAGEMENT PLAN

July 2006

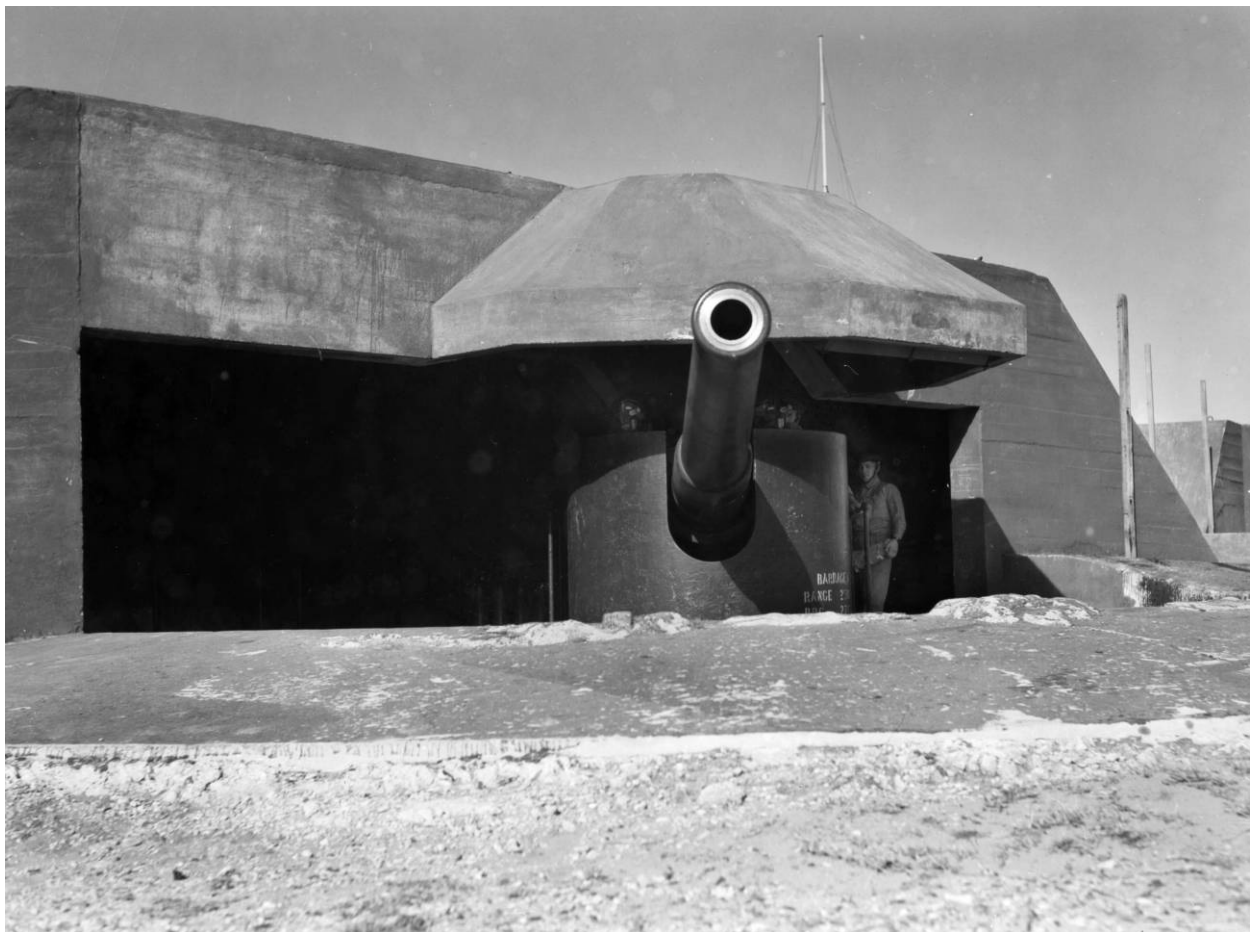
Fig. 5. 6-inch gun, Fort Nepean c. 1943 (Australian War Memorial, Canberra ID 051186)

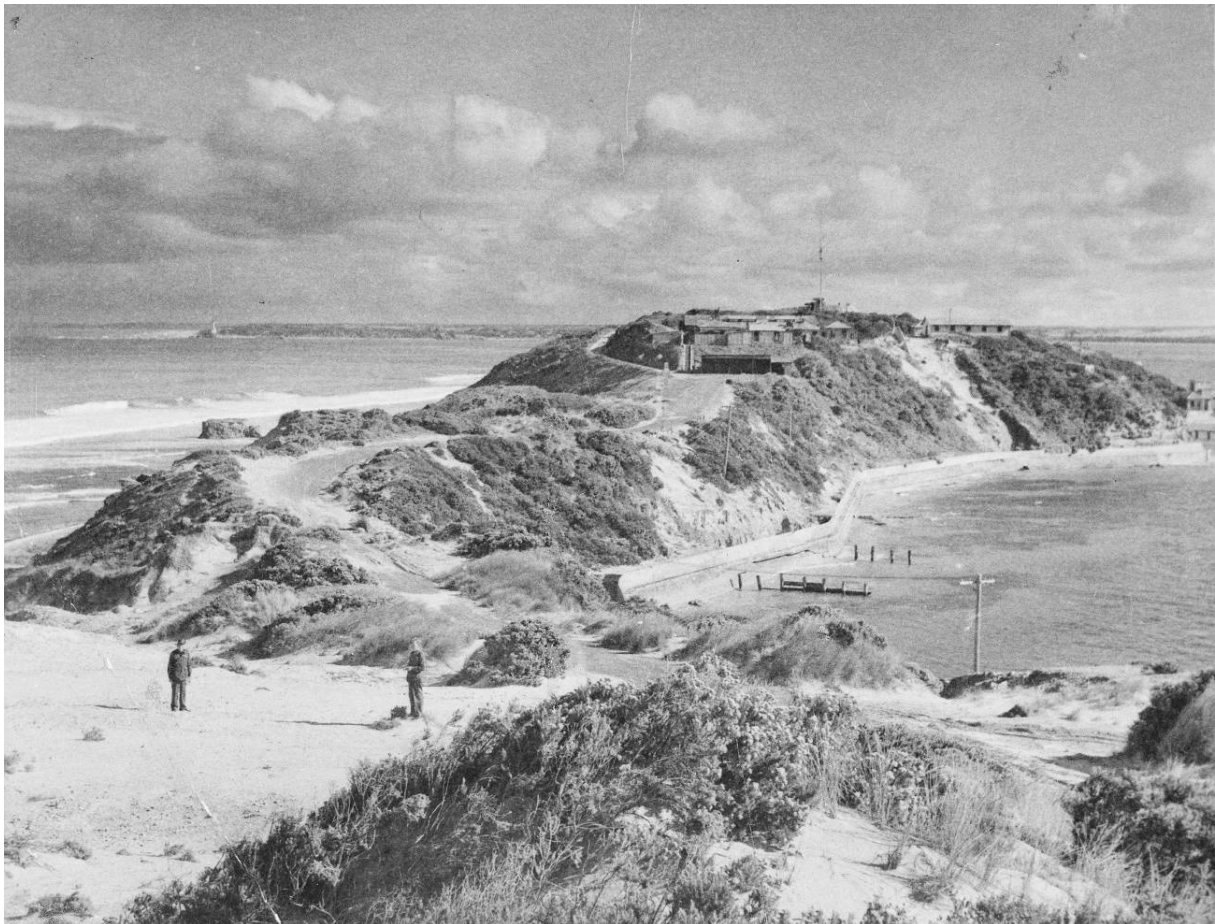
Fig. 6. Looking west to Fort Nepean, c.1946. Barracks blocks and other ancillary timber buildings are visible, now demolished. As well, sea walls constructed to retard erosion of the Point are clearly apparent. (Australian War Memorial, Canberra, ID PO1108.011)

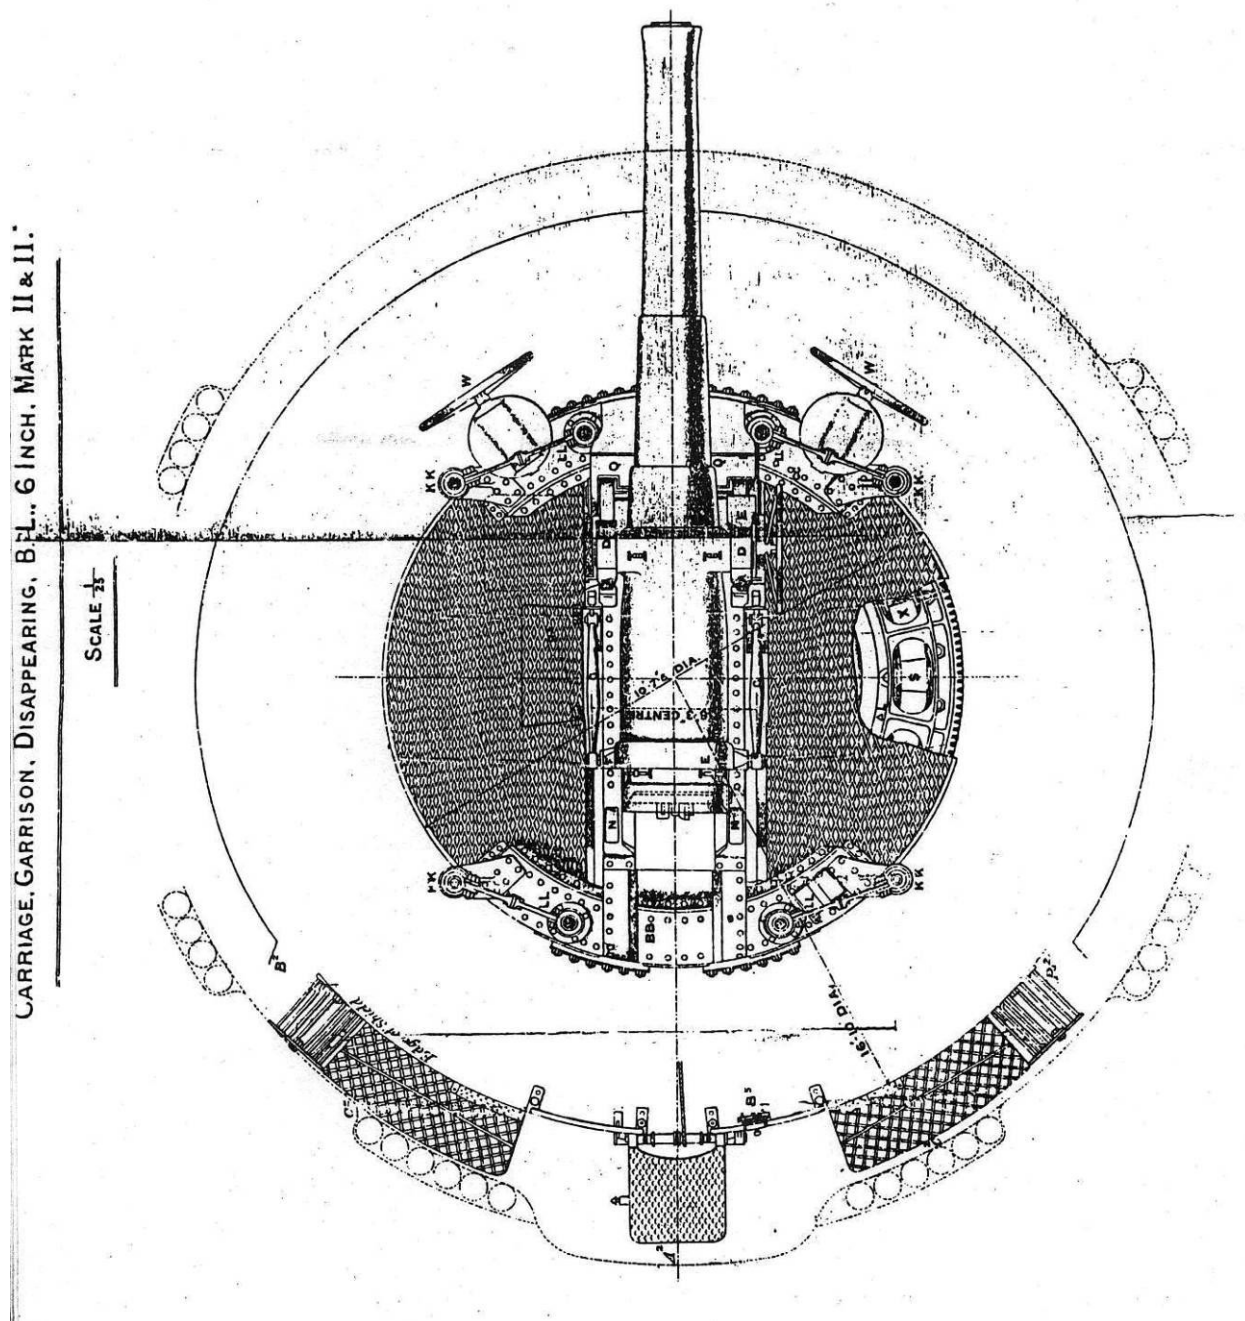
Fig. 12. Plan - 'Carriage, Garrison, Disappearing B.L 6 Inch, Mark II & II'

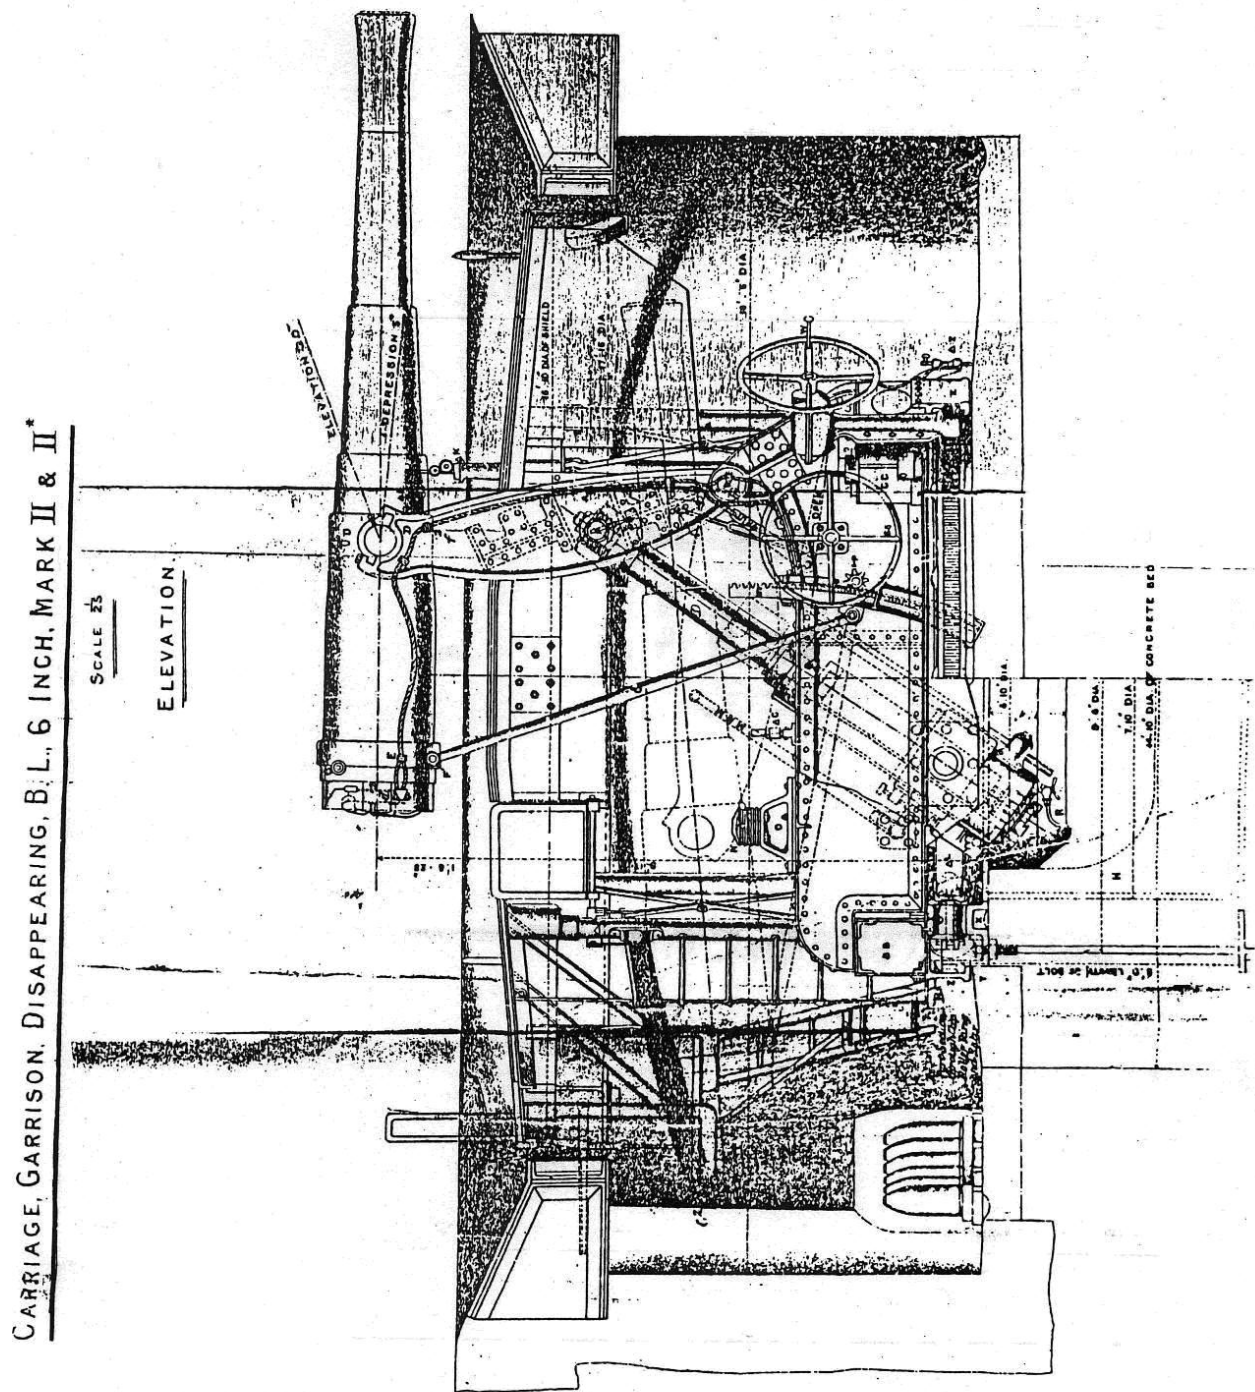
Fig. 13. *Elevation,-'Carriage, Garrison, Disappearing B.L 6 Inch, Mark II & II'*

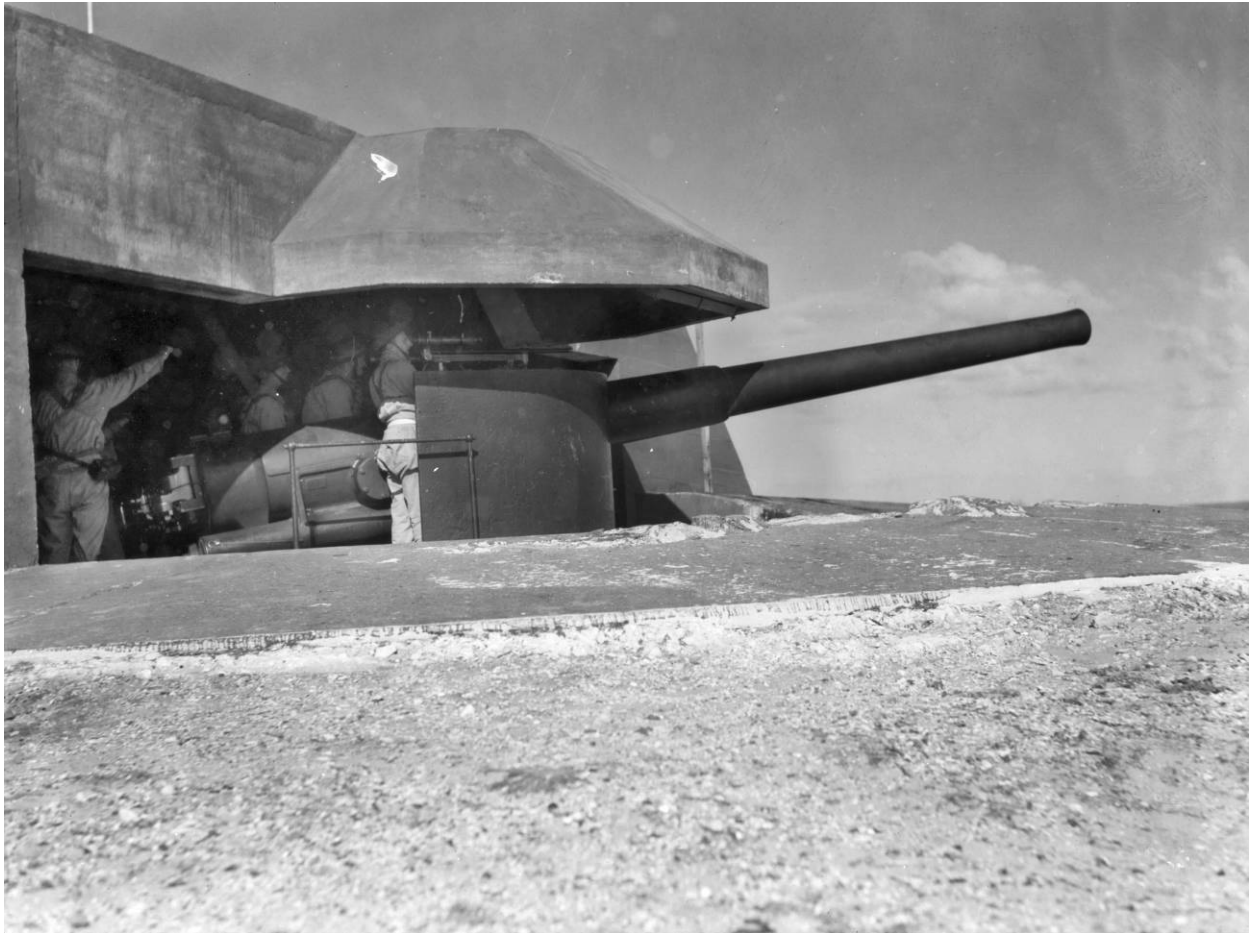
Fig. 15. Gun Emplacement No. 5 (Australian War Memorial, Canberra, ID 051185)

The significance of Gun Emplacement No. 5 lies in its contribution to the understanding of the network of fortifications provided at the entrance to Port Phillip over four changes in gun and fortification technology.

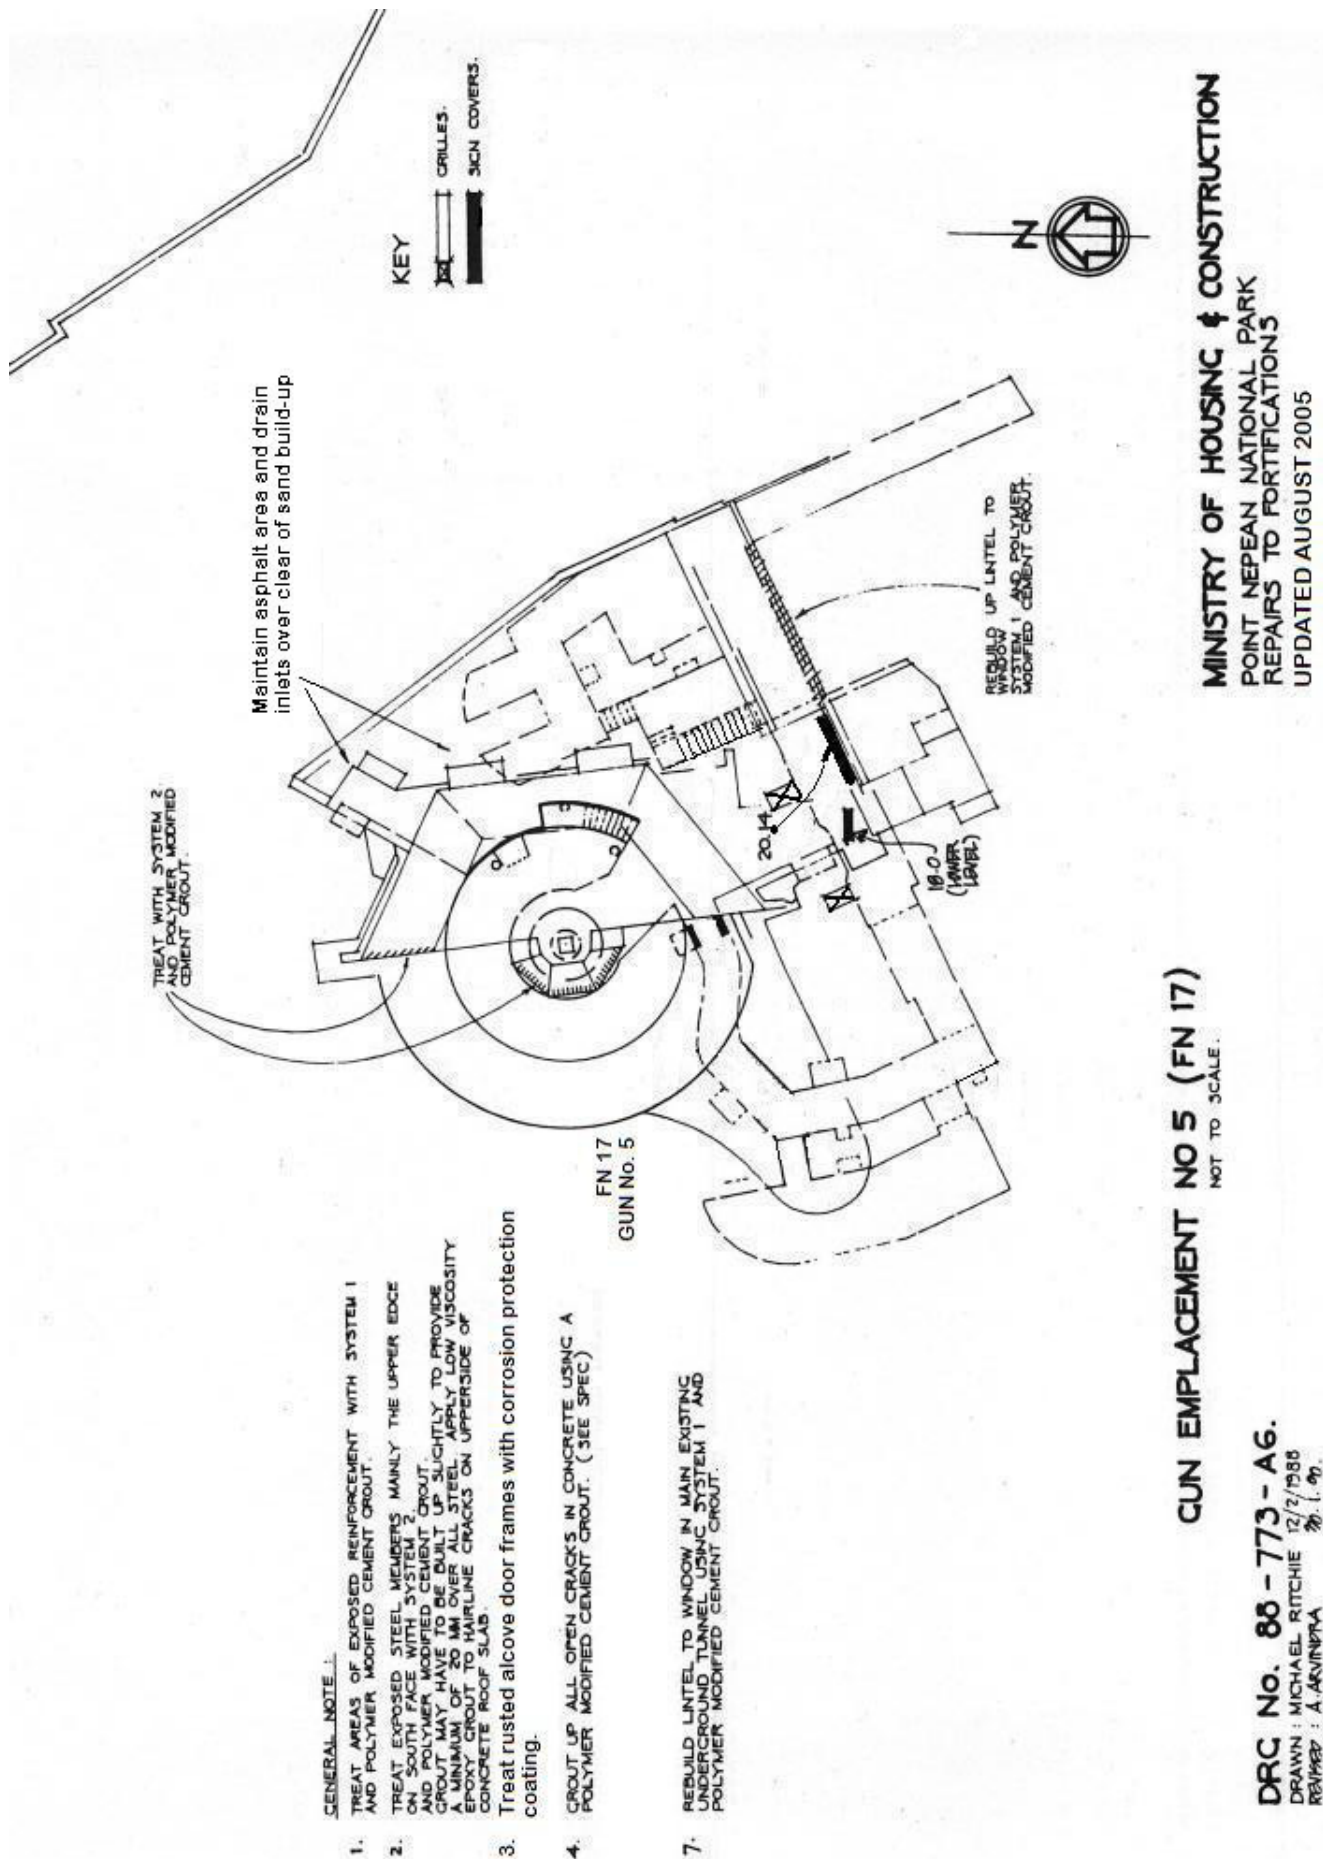
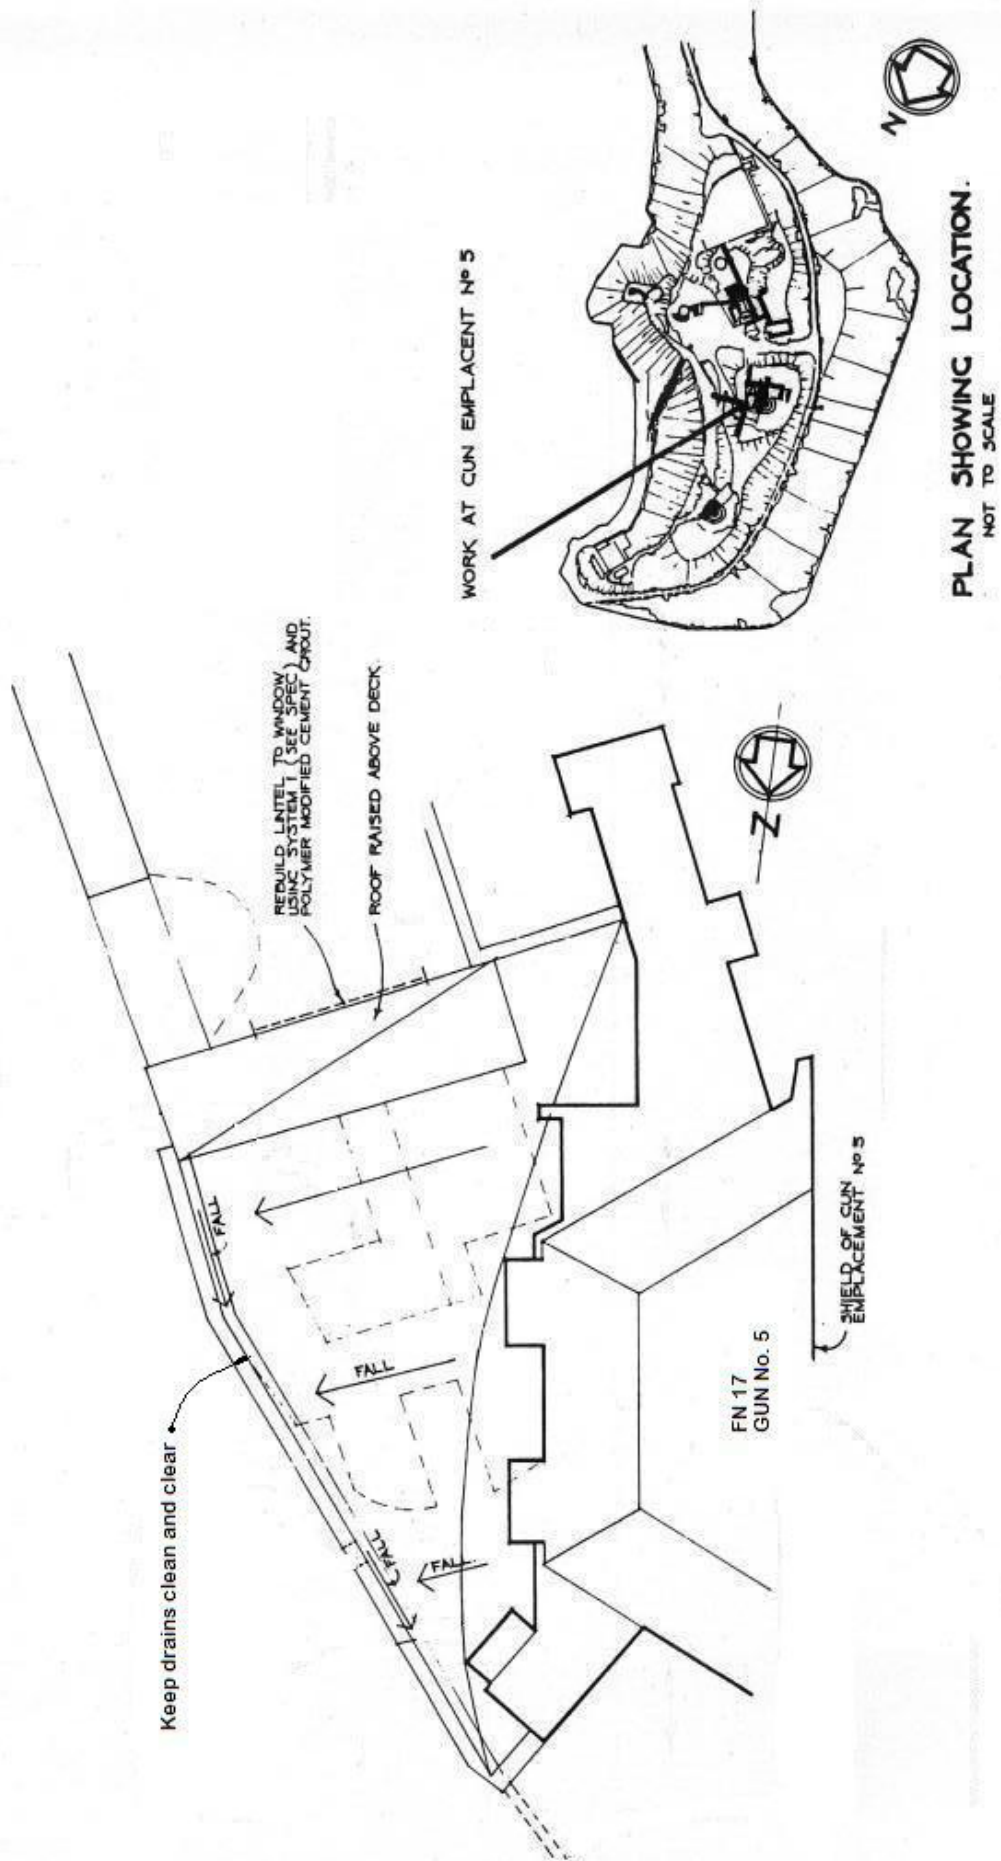
AREA ADJACENT TO
GUN EMPACEMENT NO 5 (FN 17.)
SCALE: 1:100

An extensive range of conservation works have been undertaken on this Emplacement in recent years, chiefly comprising the replacement of the asphalt roof membrane and waterproofing of the roof over the passages, storage areas and magazines, and concrete repairs and metalwork stabilisation works to underside of the the gun canopy.

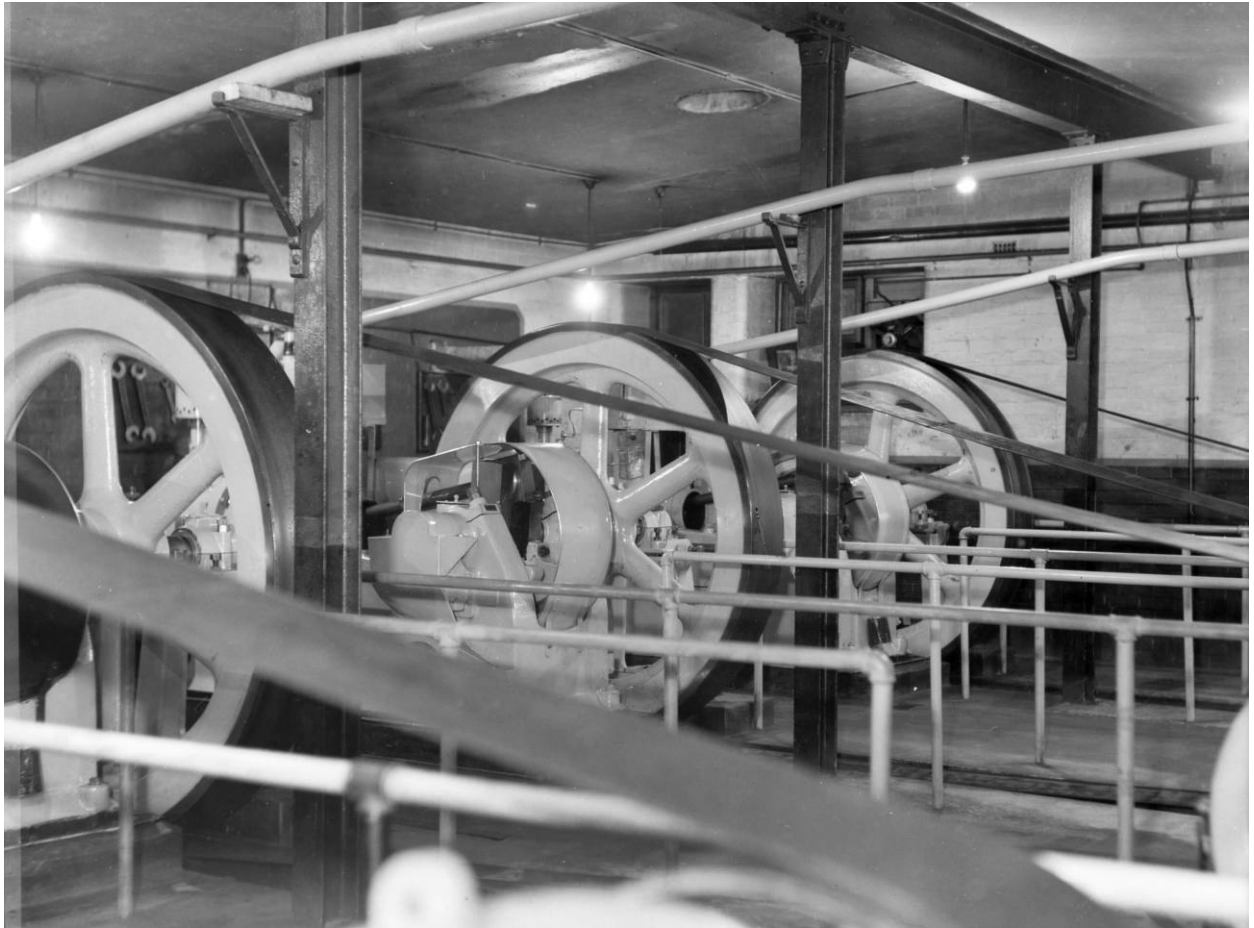
Fig. 15. The engines which generate the power necessary for the working of the powerful searchlight at Point Nepean (Australian War Memorial, Canberra, ID 051178)

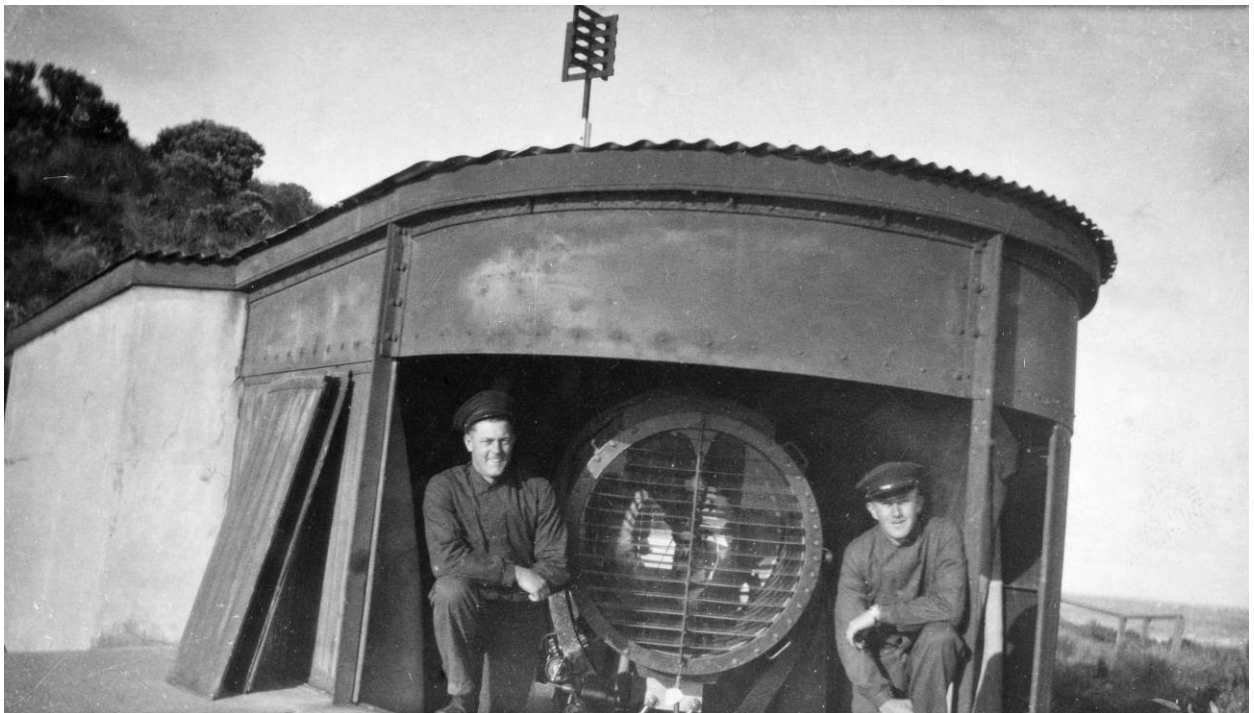
Fig 16 The No. 7 searchlight at Fort Nepean. C.1933 (Australian War Memorial, Canberra, ID PO1449.058)

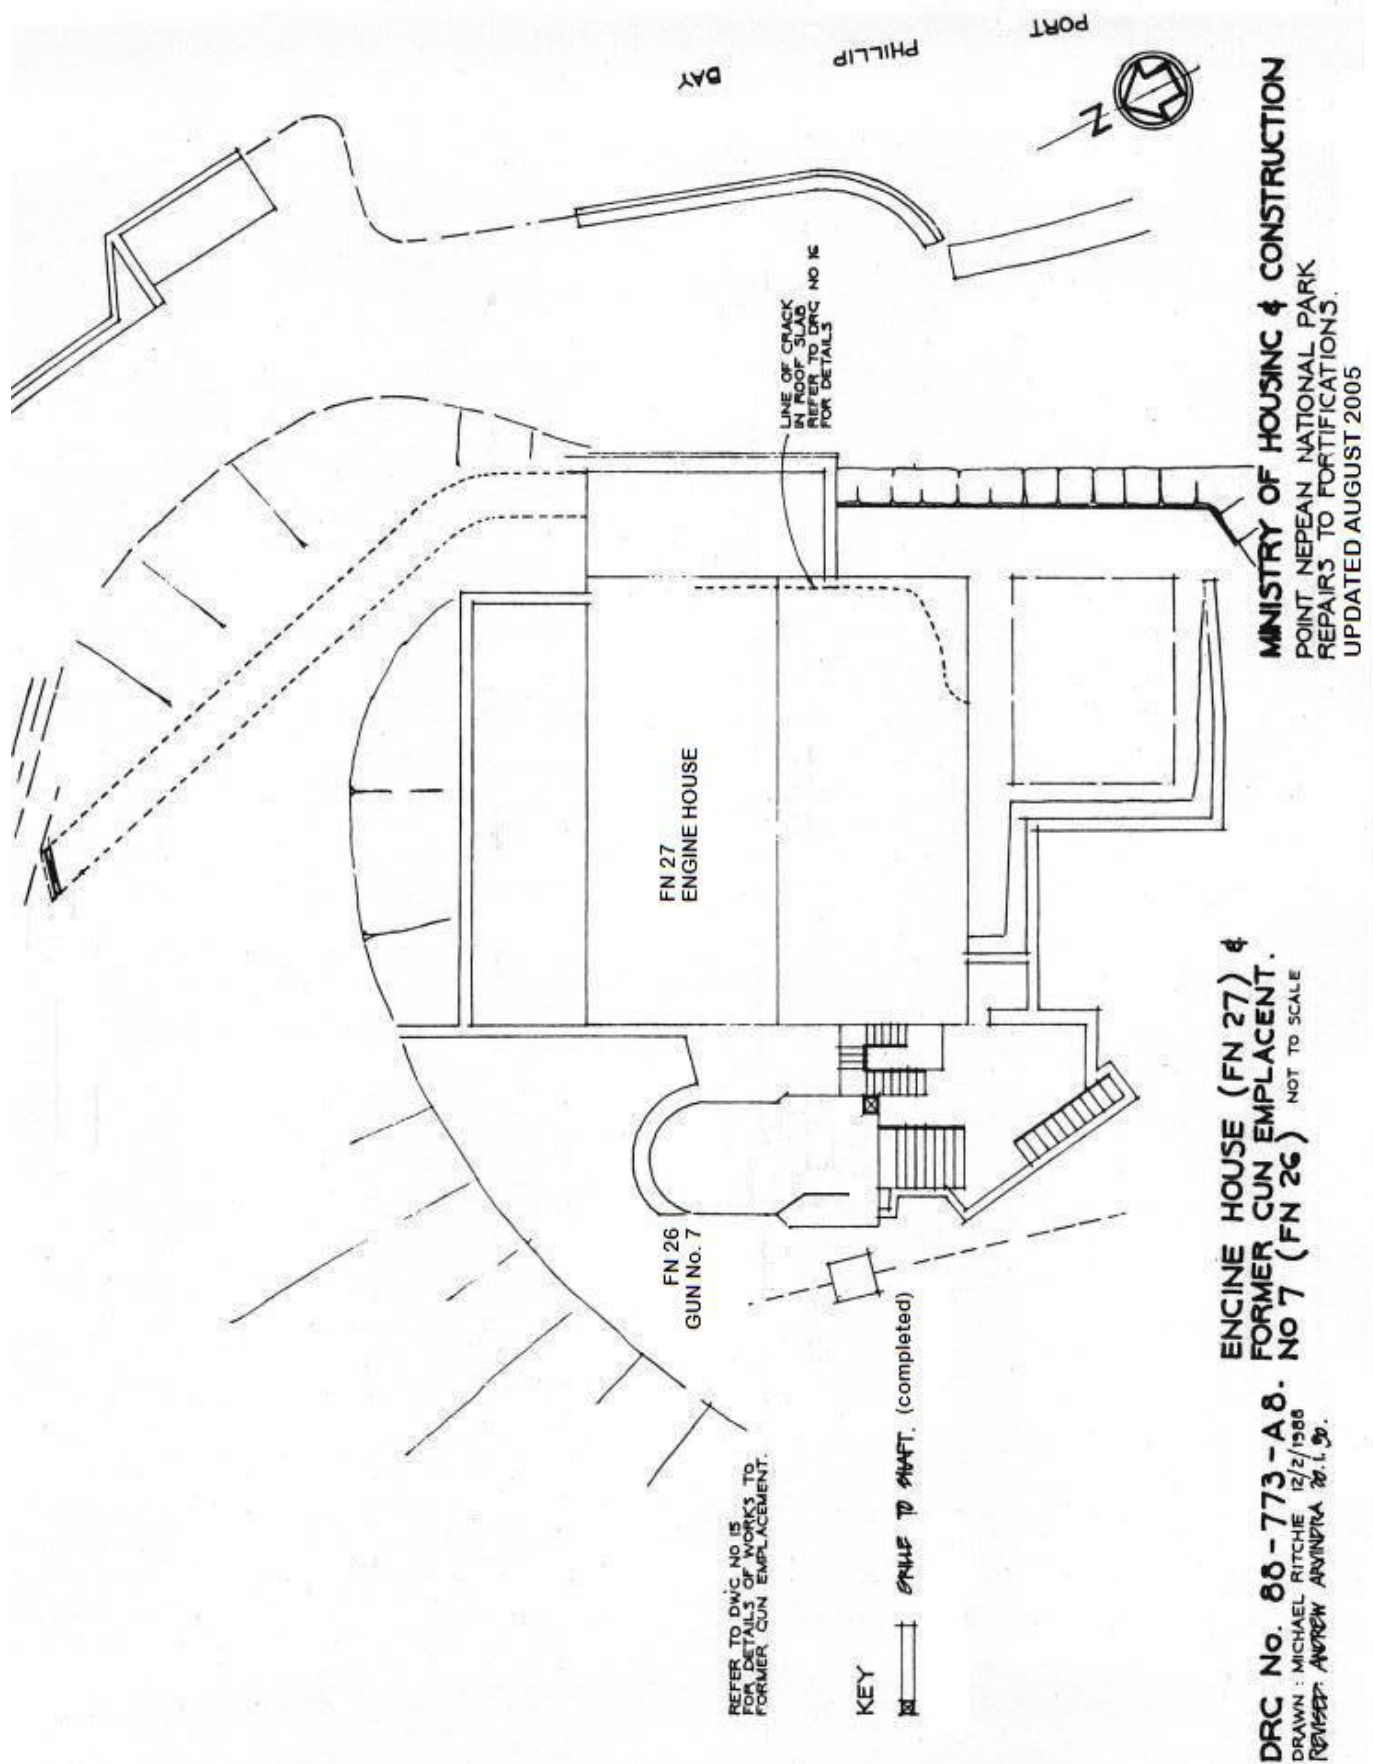
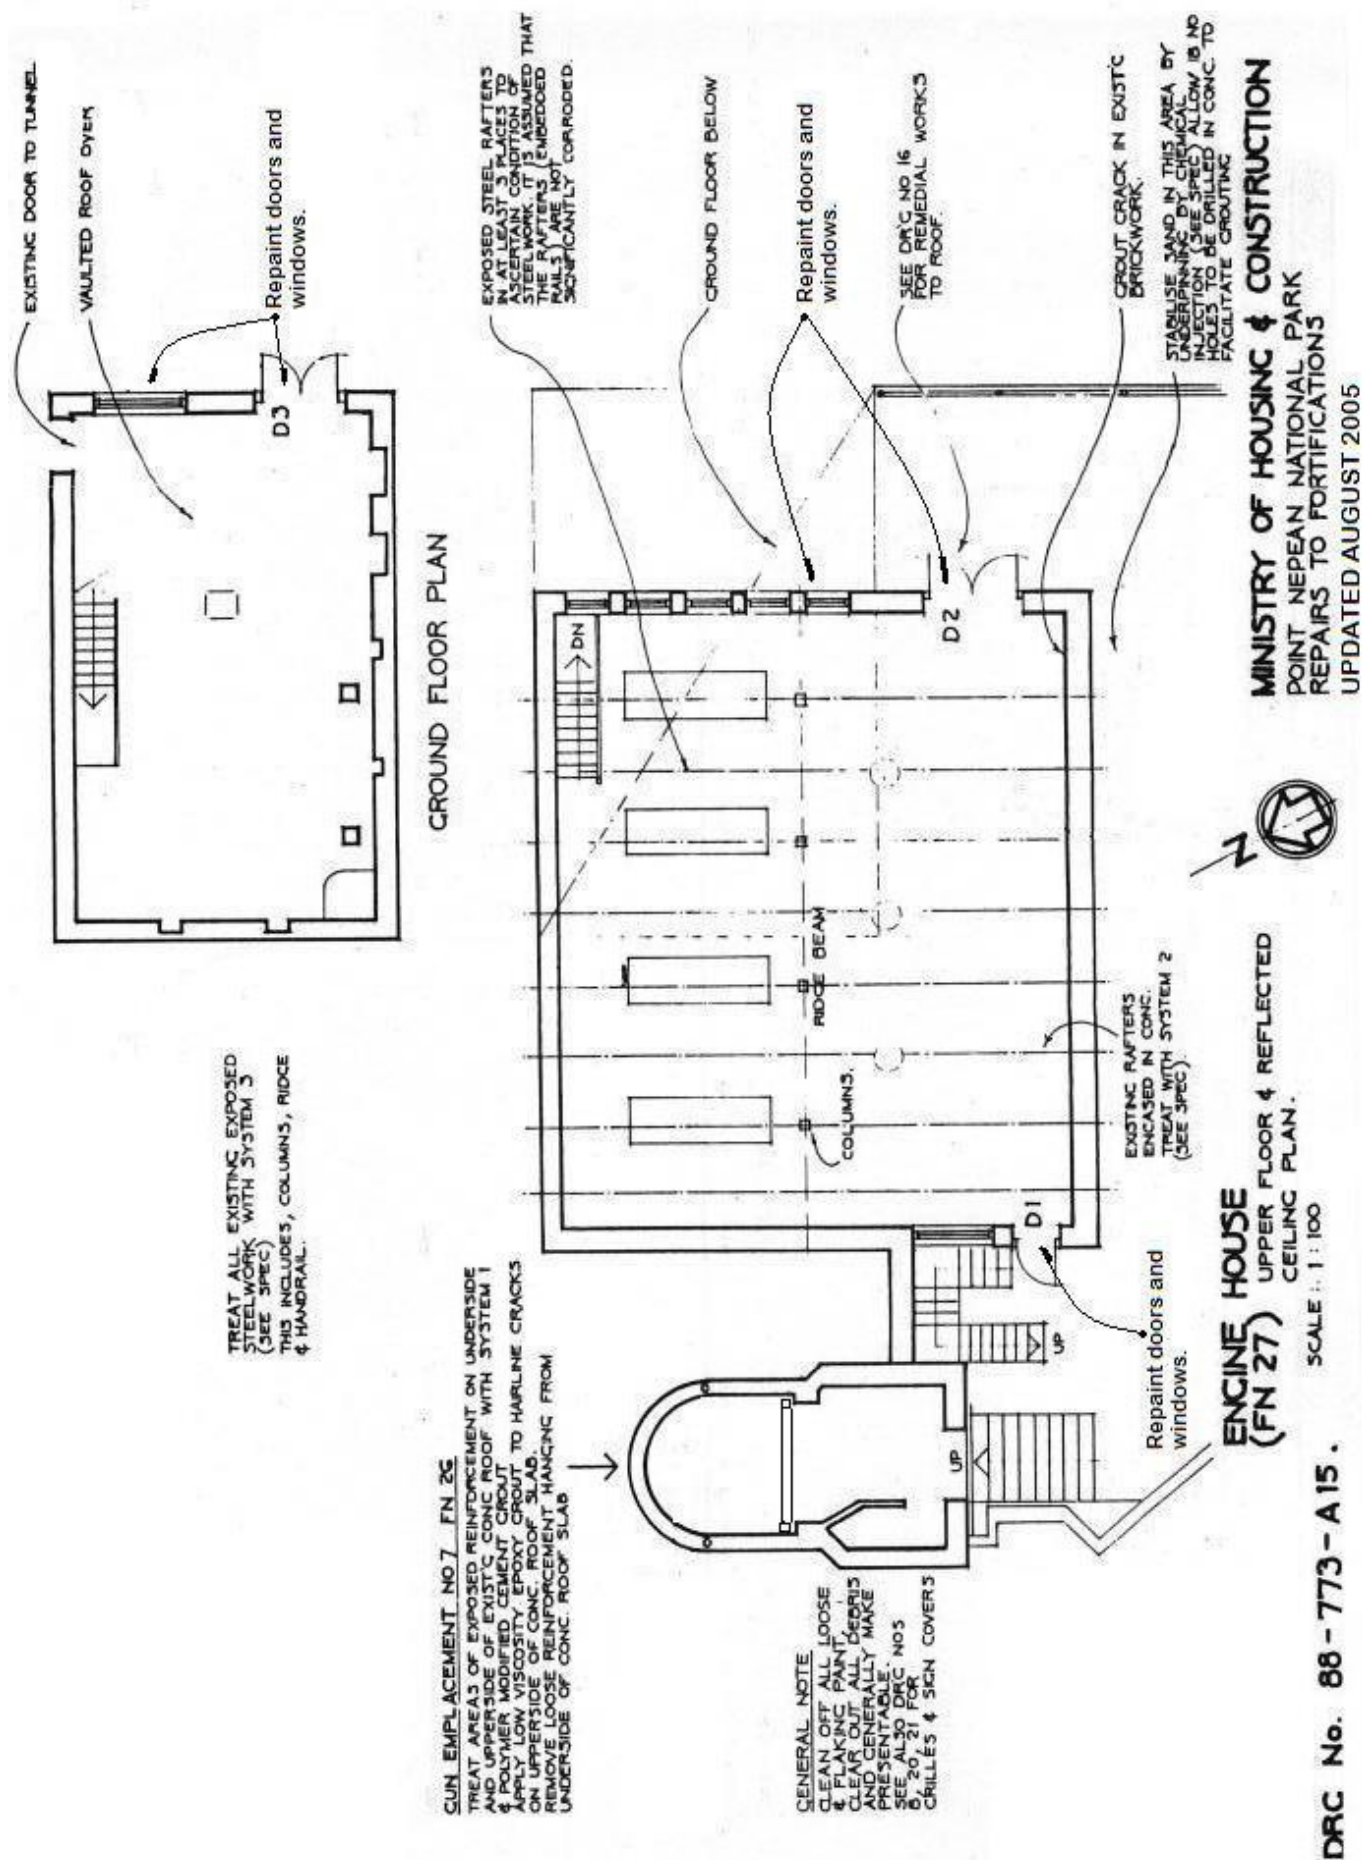
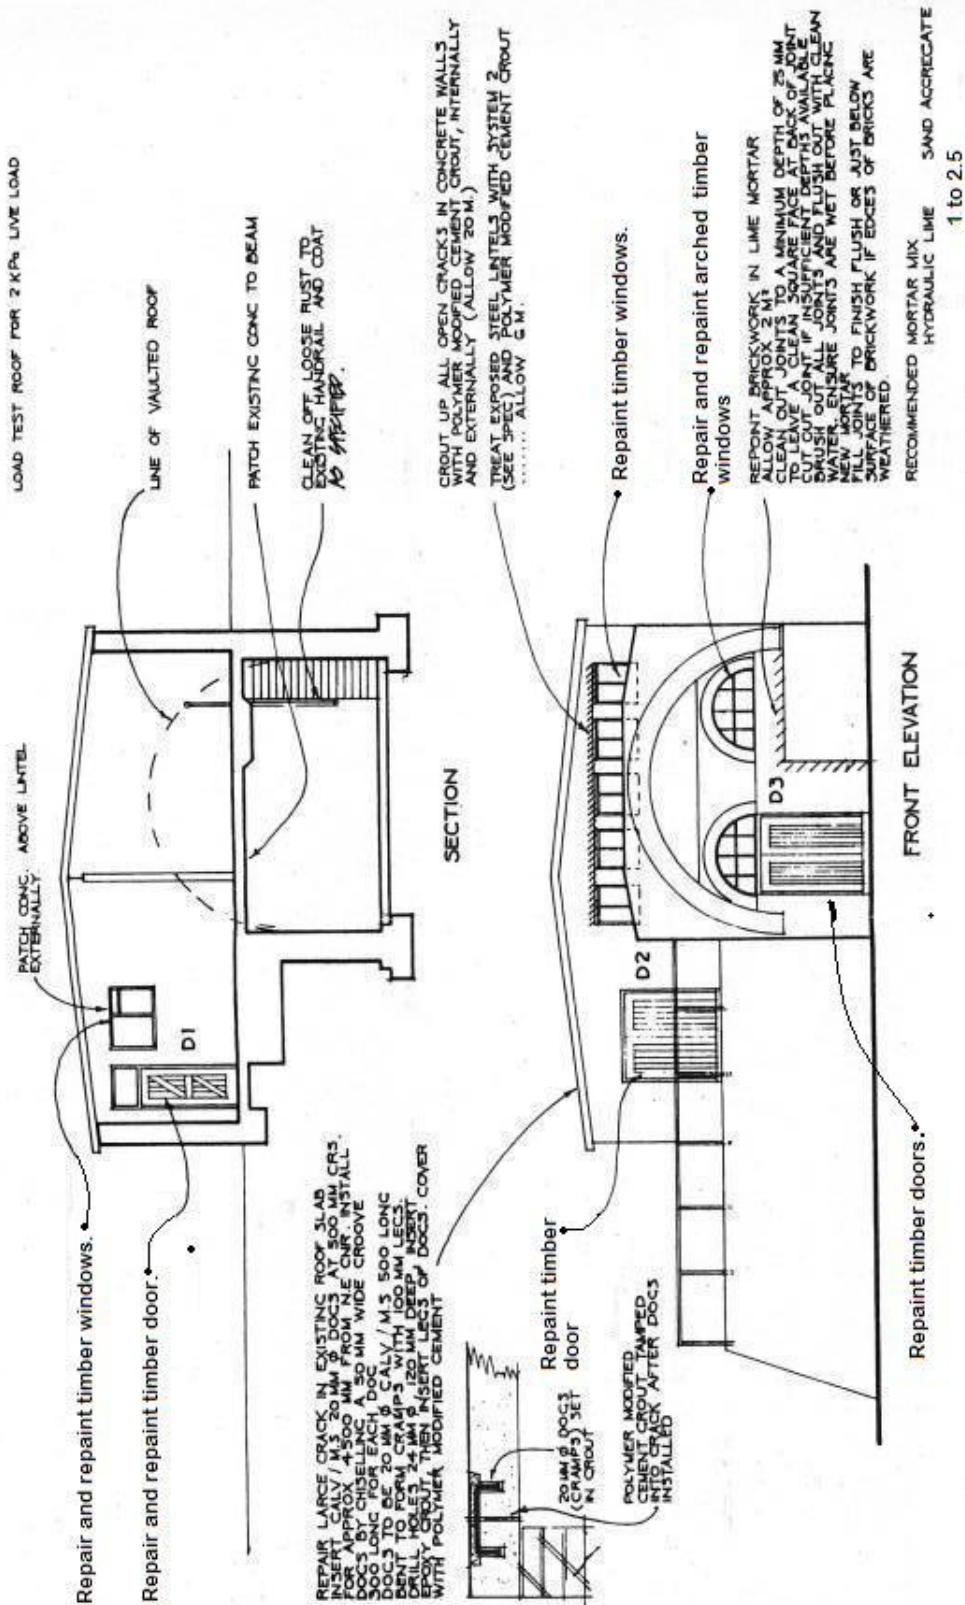
ENGINE HOUSE (FN 27)
SCALE: 1:100

A key area for priority consideration in this regard is the Engine House, where foundation movement has resulted in significant cracking to the brickwork and reinforced concrete in its south east corner. As a major throughpoint on the primary visitor interpretation route, this area is a priority for remedial attention. Formal monitoring and structural assessment will help indicate whether continual movement is occurring and the nature of necessary remedial action.

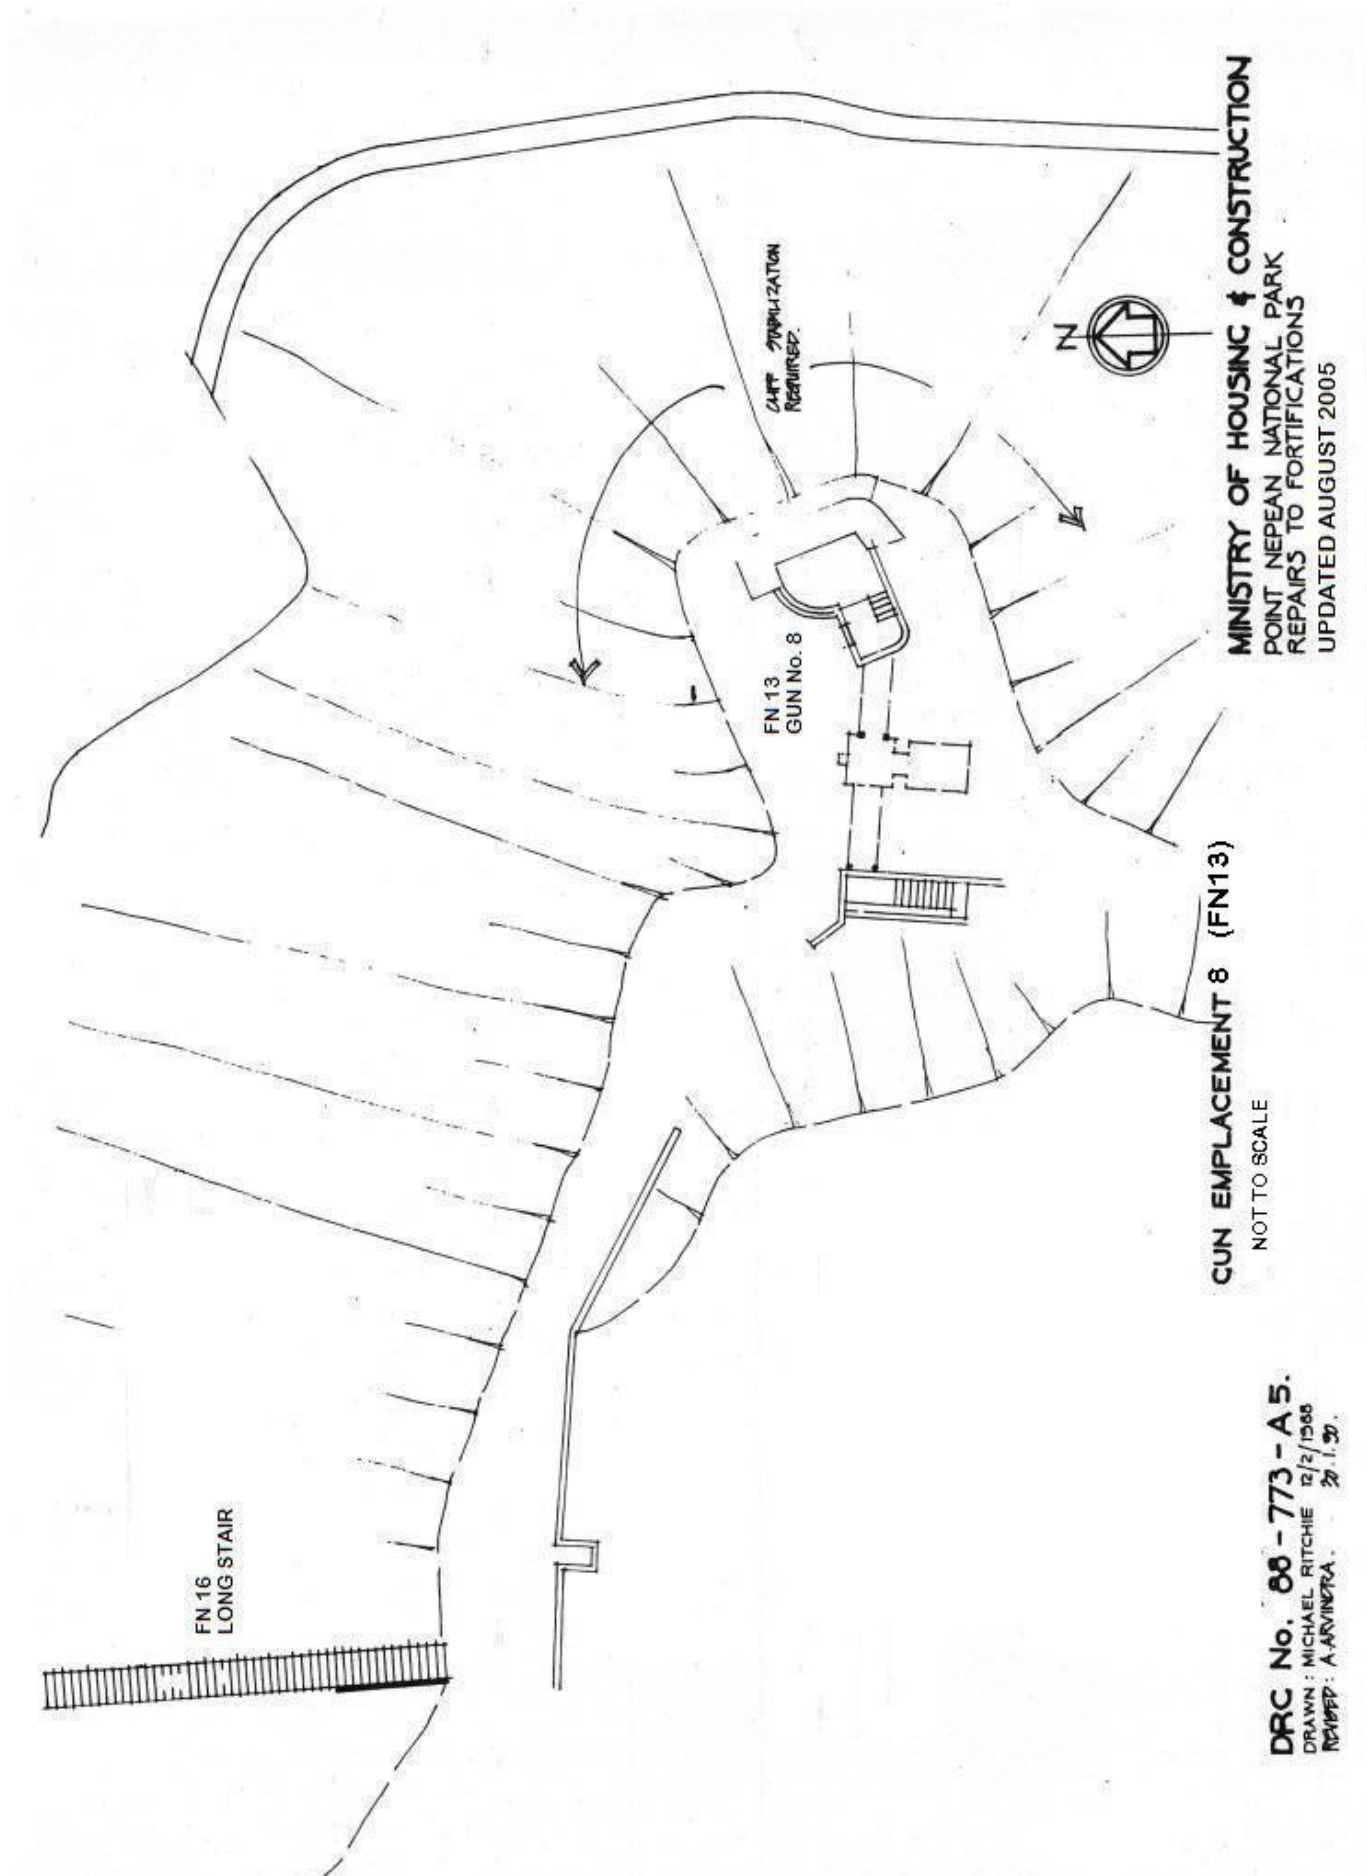
EXISTING STRUCTURAL CONDITION & RECOMMENDED WORKS**1. Tunnel to Gun No. 8 - FN 13 (Phase 3)**

- a) Structurally sound.
