Point Nepean Forts Conservation Management Plan

POINT NEPEAN FORTS

CONSERVATION MANAGEMENT PLAN

July 2006

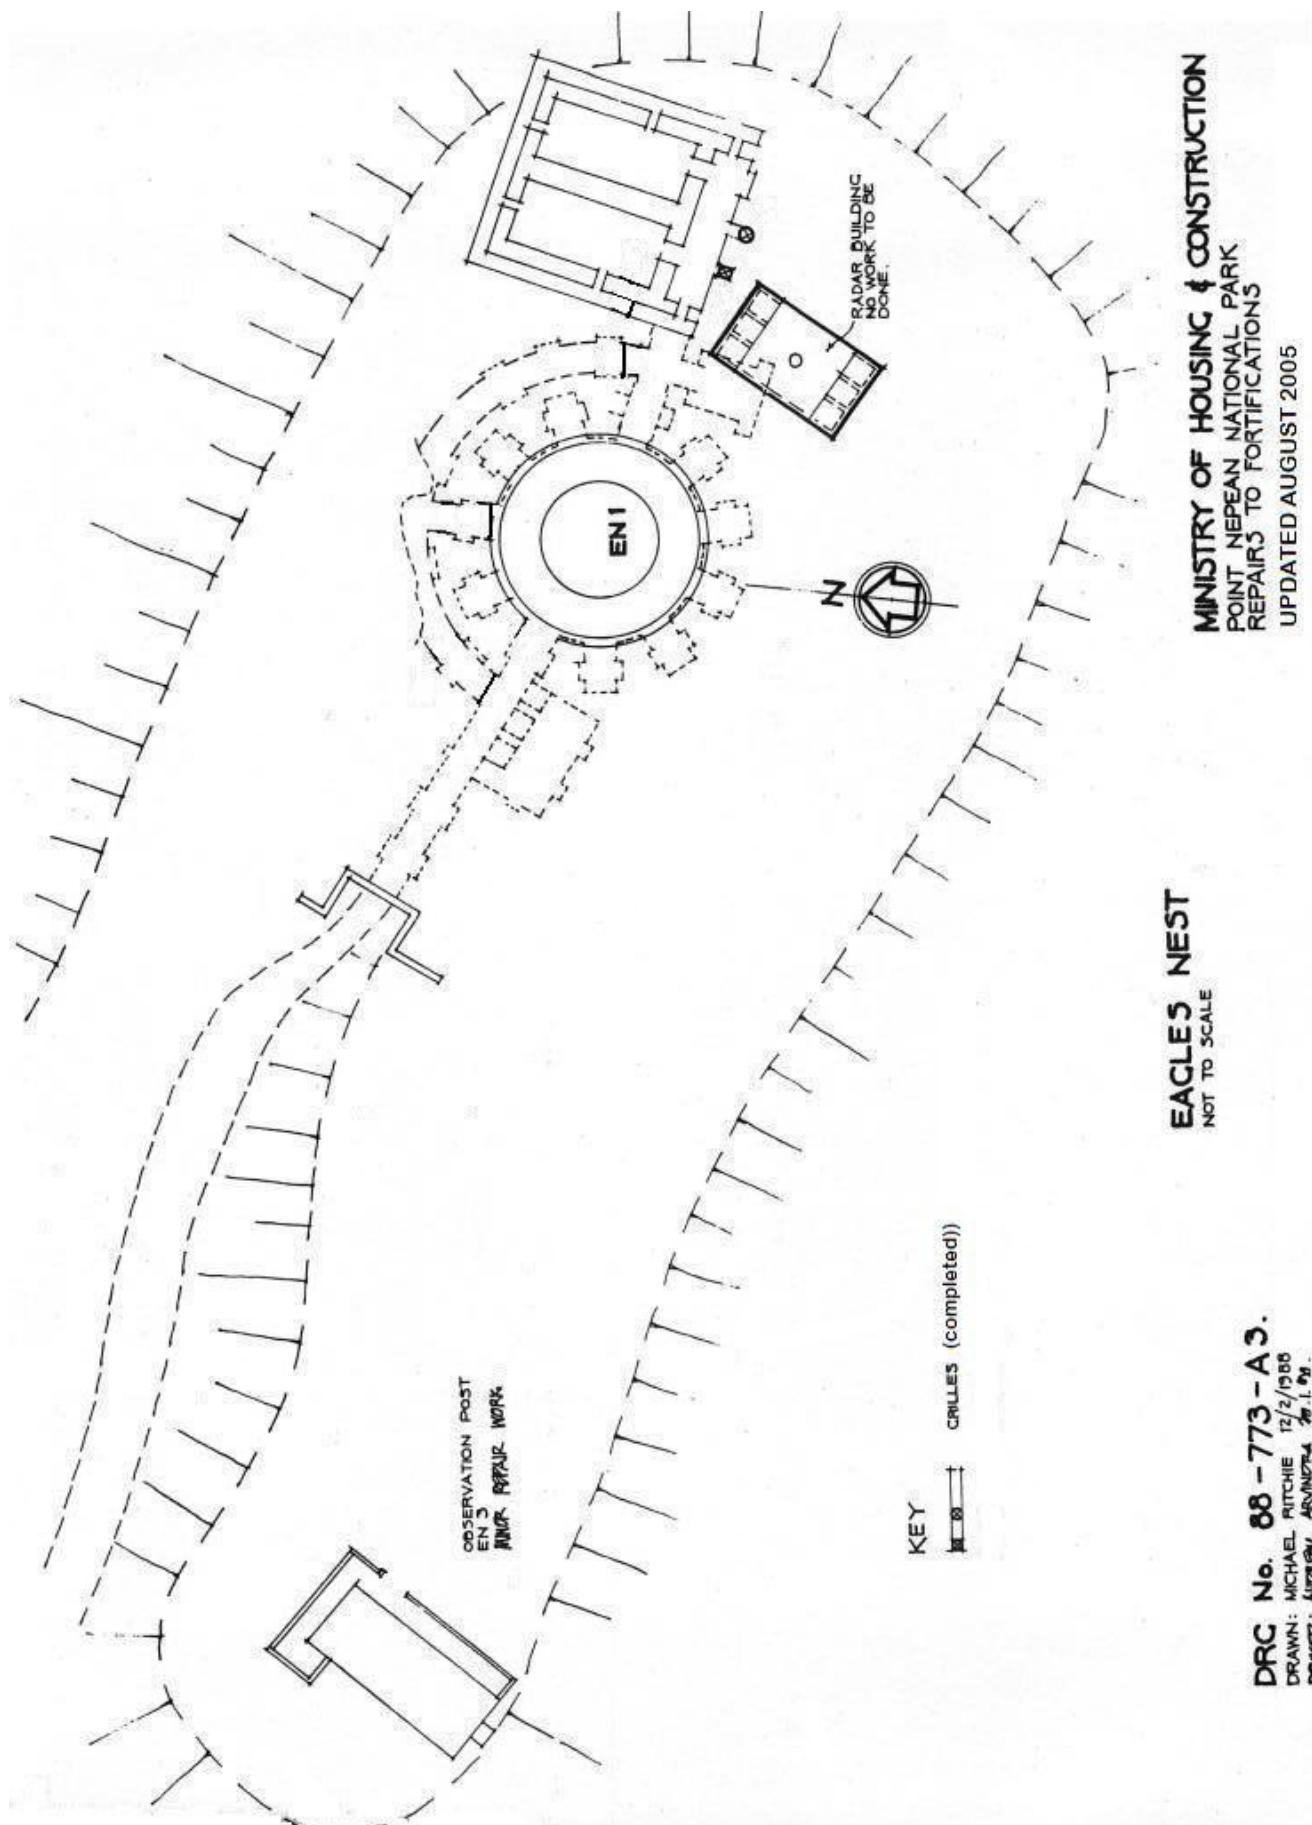
EXISTING STRUCTURAL CONDITION & RECOMMENDED WORKS**GENERALLY**

The mass concrete structure of the Eagles Nest gun Emplacement is severely cracked. The sea wall at the base of the adjacent northern cliff has been undermined causing erosion of the base of the cliff and subsequent landslips.

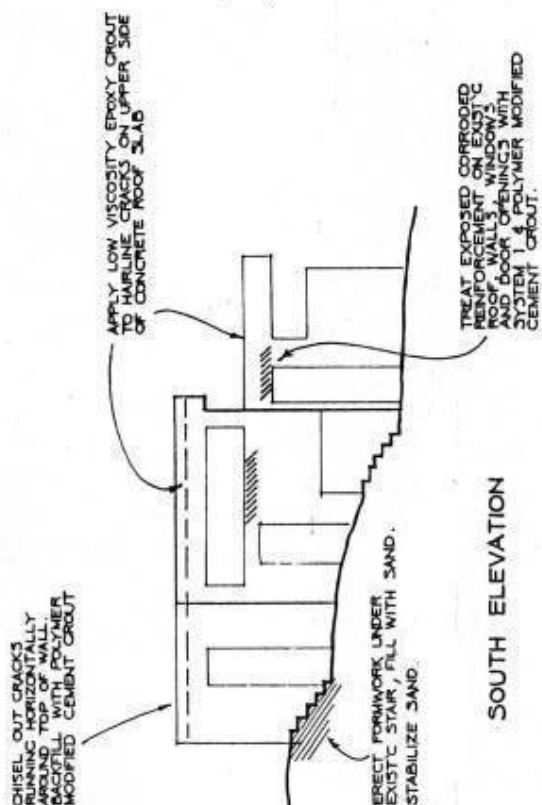
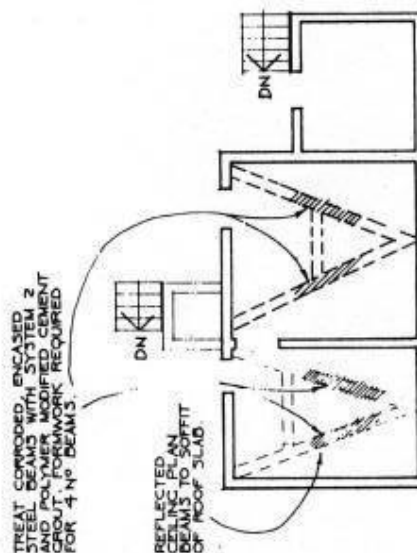
OBSERVATION POST
CHEVIOT HILL CH 3

ROOF SLAB TO BE LOAD TESTED WITH 2 KPa LIVELOAD

Action is required to arrest further spalling and corrosion at the BOP. These works should be achieved conservatively and no attempt made at reconstruction.
