# THE WESTERN HEIGHTS DOVER, KENT

Report No 6: The Entrances to the Fortress:  
19th-century infantry and artillery fortifications

**REPORT NO 6**

**THE ENTRANCES TO THE FORTRESS**

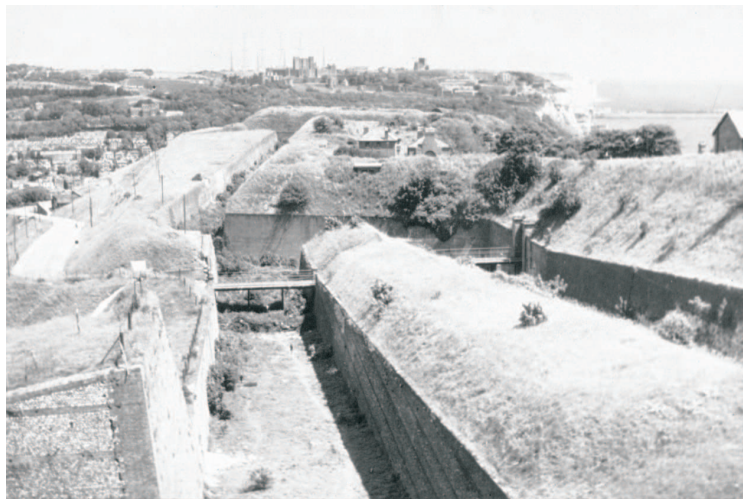
The road across the *tenaille* has been resurfaced but the granite kerbstones are almost certainly part of the original construction and are similar to those used elsewhere in the North Entrance. At the inner end, there are two piers with sandstone anchor blocks for

**Figure 14**  
*The road in its cutting through the tenaille (NMR: AA00/9825)*

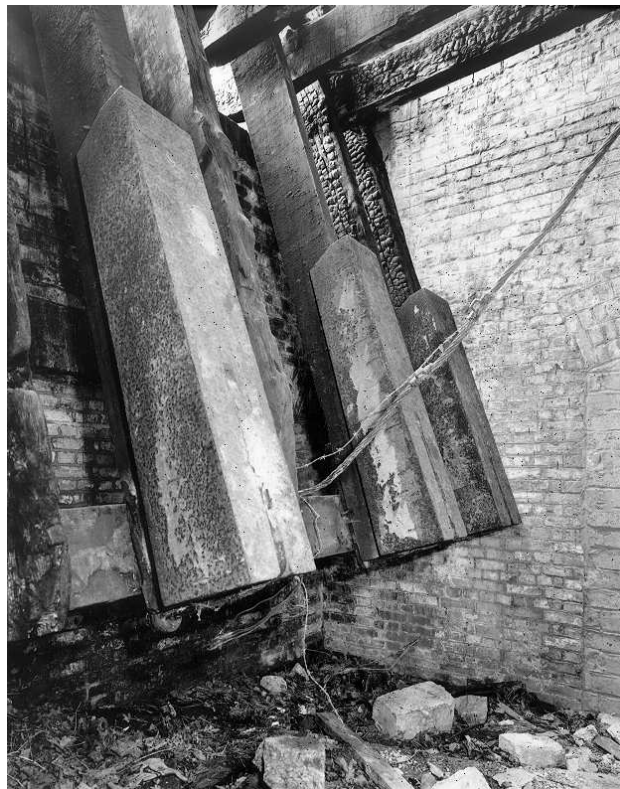
**Figure 17**  
*The counterweight  
recess with the  
bridge counterpoise  
weights in position*  
(NMR:  
AA00/9846)

The drawbridge closed against the curtain wall to form an outer gate, which sealed the entrance chamber. Beneath this chamber is the **counterweight recess** which accommodates the huge cast-iron weights attached to the end of the drawbridge. The recess also contains the surviving mechanism for the drawbridge, comprising a hand-operated winch mounted on the floor in a shallow, segmental-arched apse in the rear wall (Figs 17-18). Steel cable from the winch was connected to the counterweights

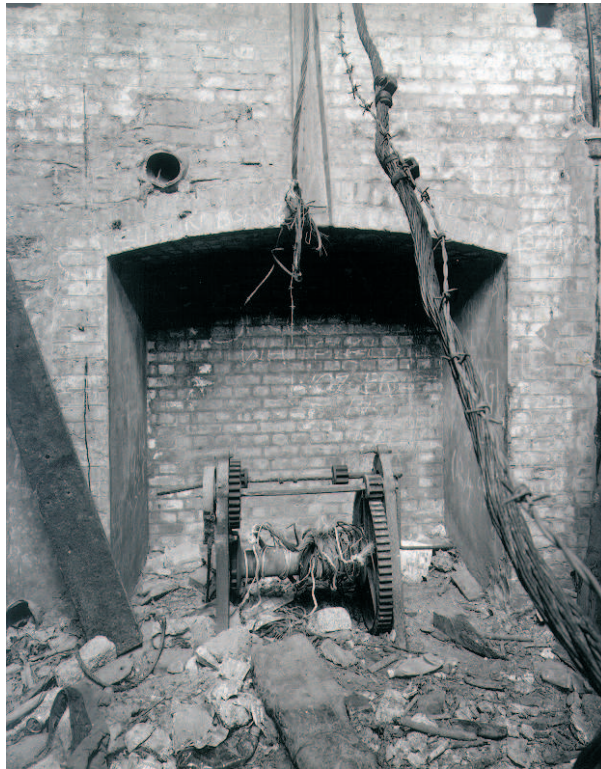
**Figure 18**  
*The winch in the  
counterweight  
recess (NMR:  
AA00/9847)*

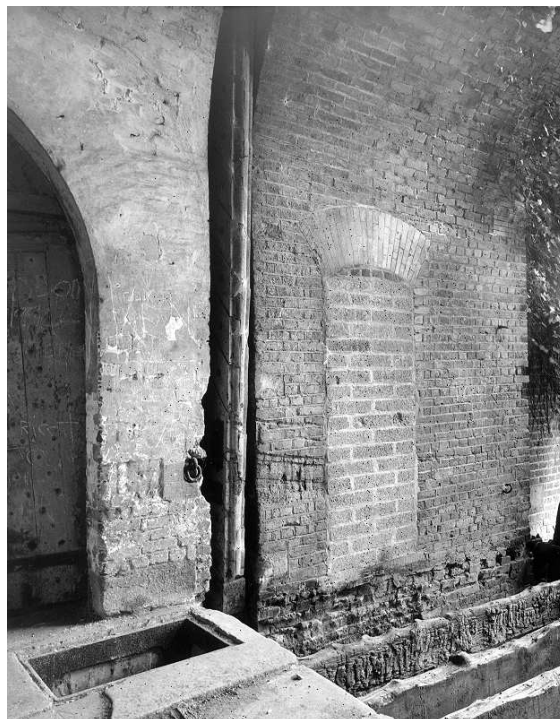
**Figure 20**  
The blocked  
doorway to the  
winch room, with  
the remains of the  
bridge in the  
foreground  
(NMR:  
AA00/9842)

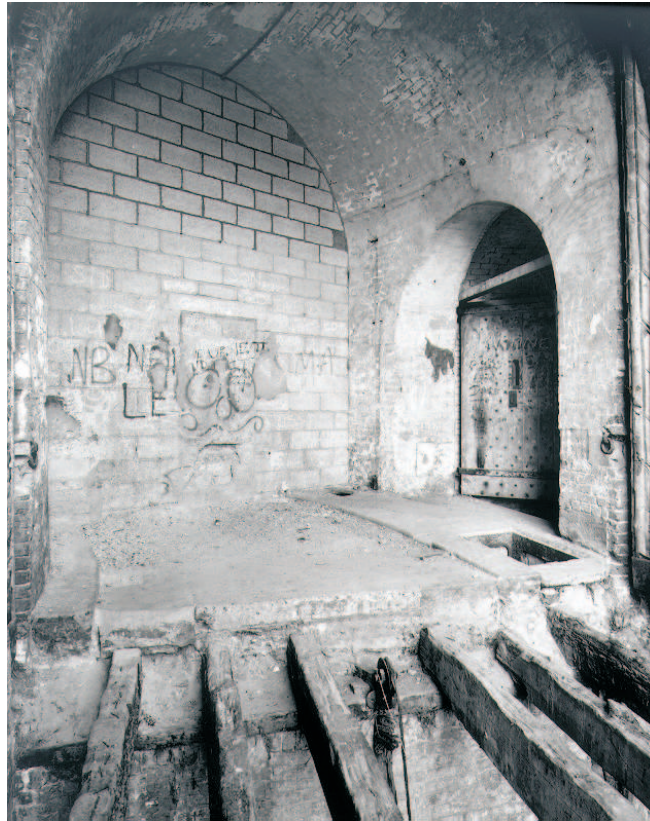
The drawbridge closed against a semicircular arch of two plain orders flanked by projecting piers topped with rounded stone copings. A pair of heavy sliding wooden doors form an inner gate which enabled the entrance chamber and the bridge to be closed off from the **tunnel**. The doors are strongly constructed with raked boarding and rise to the full height of the tunnel entrance with the tops shaped to fit against the vault (Fig 21).

**Figure 21**  
*The blocked road tunnel and doorway to the postern gate, with the remains of the bridge in the foreground (NMR: AA00/9840)*

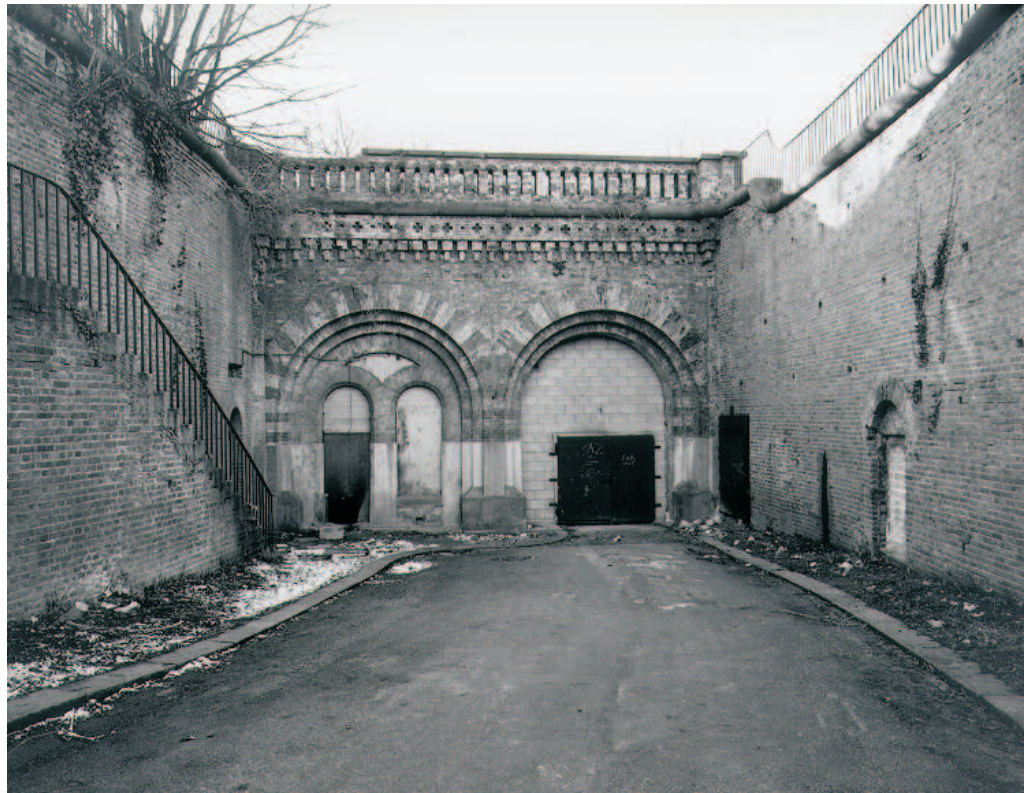
The entrance elevation comprises two semicircular arches of three orders with sandstone plinths and polychrome brickwork in buff, red and cream (Fig 27). The right-hand arch is the entrance to the tunnel, while the left-hand arch contains the guard house. Door and window openings and the outer order of the arches have red-brick jambs and heads, and the entrance is topped by false machicolations in red-brick with cross details in courses placed below a sandstone coping with a roll moulding. The front wall of the guard house is set back in the archway and contains a door and window with arched and chamfered

**Figure 27**  
*The Inner Entrance,  
showing the road  
tunnel and the  
guard room; the  
blocked doorways  
on the right flank  
wall lead to the  
water tanks (NMR:  
AA00/9818)*

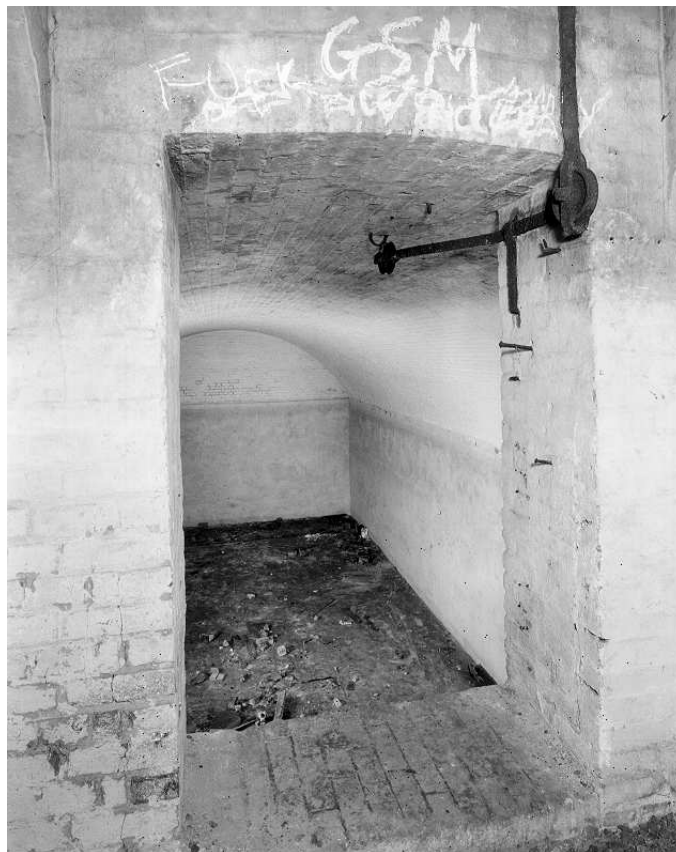
at either end of a steel or iron strap with one pulley wheel suspended over the tank (Fig 29). The small diameter of the pulleys and the thin section of the strap suggests that this is a water level indicator rather than a support for maintenance uses, but there is no other evidence. A narrow-bore pipe emerging beneath the doorway of each tank was probably for overflow rather than the main supply, as pipework of a larger bore running beneath the gallery floor was probably for the main supply, entering the tanks at a lower level.

**Figure 29**  
*No 2 water tank,  
with the pulley in  
the foreground*  
(NMR:  
AA00/9837)

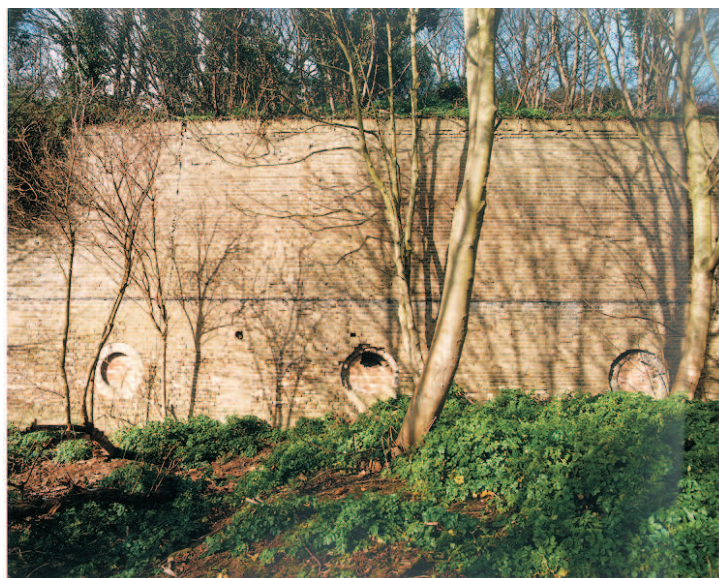
**Figure 33**  
*The scarp  
revetment of South  
Entrance Ditch in  
1999, showing how  
the infilling of  
South Entrance  
Ditch has sealed  
the embrasures and  
loopholes. The  
smoke vents remain  
visible but blocked*  
(NMR:  
AA00/8595)
