# Stokes Bay, Gosport: Five Centuries Of Coastal Defence

Mike Williams and Olaf Bayer

Discovery, Innovation and Science in the Historic Environment

NGR: SZ 597 984

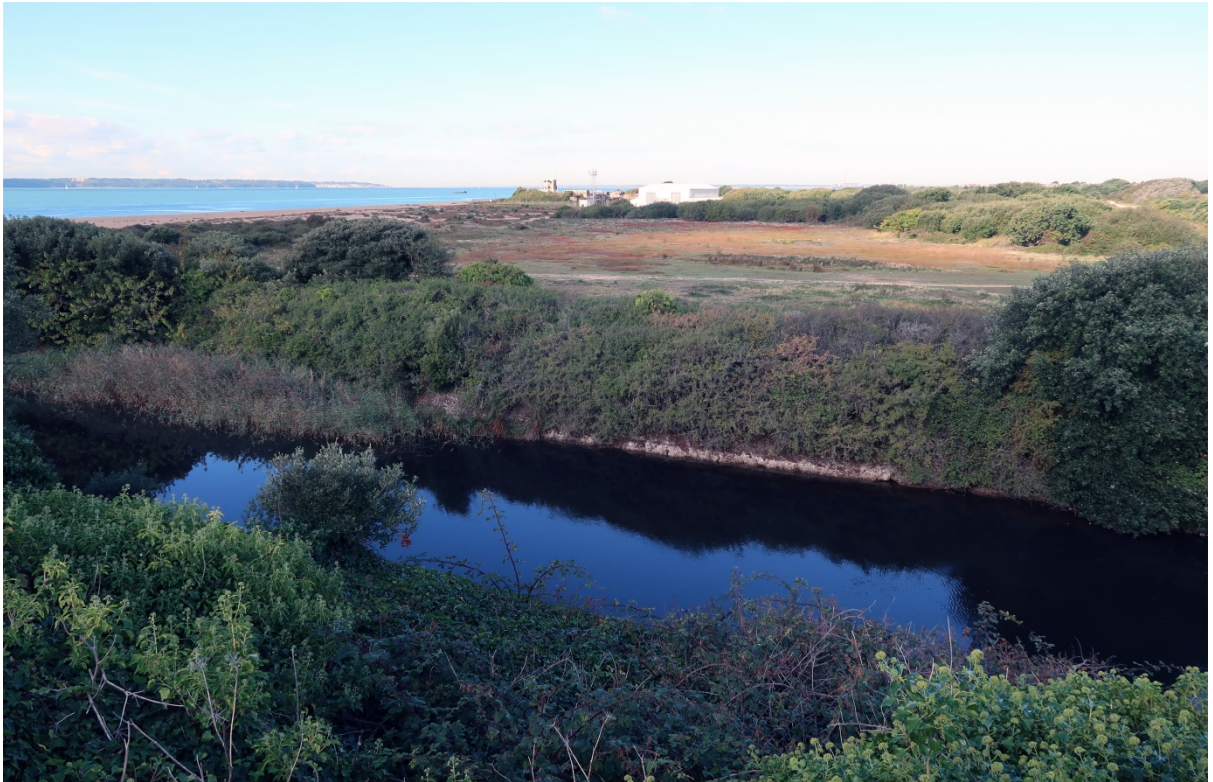
Figure 18. The water-filled and concrete-lined Stokes Bay Lines immediately west of Battery 2 (© Historic England).

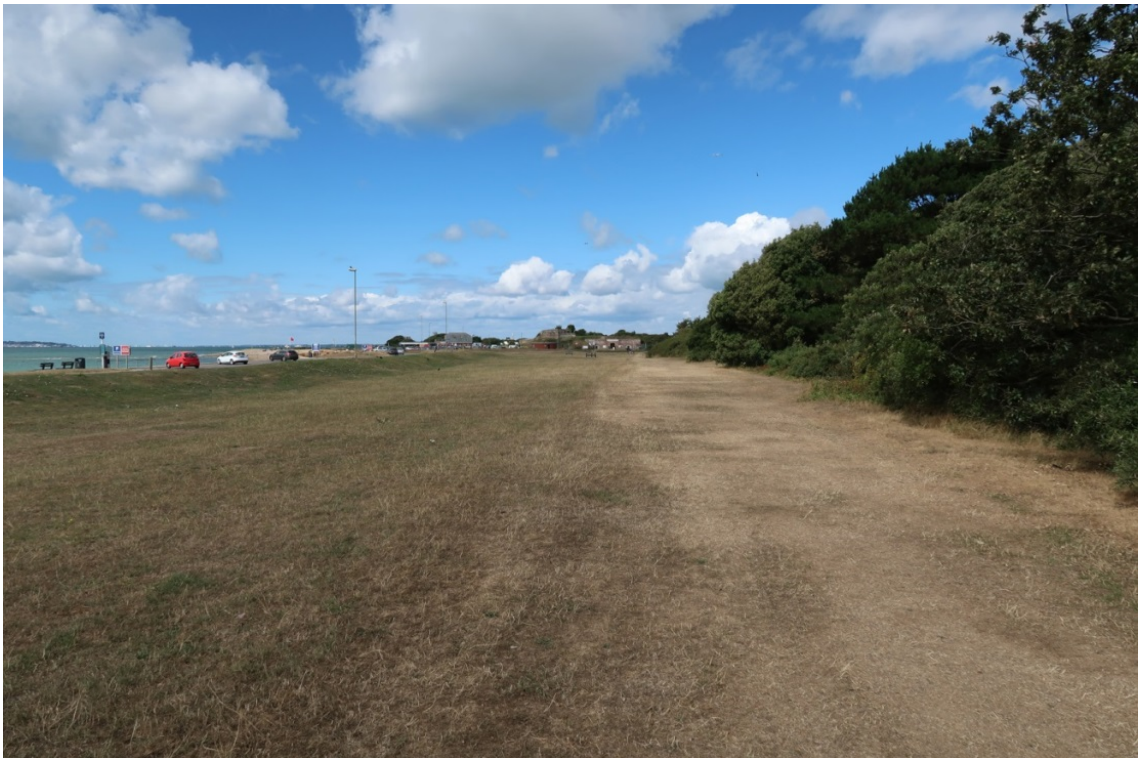
Figure 21. Parch mark showing the northern edge of the Stokes Bay Lines looking west towards Battery 2 (© Historic England).

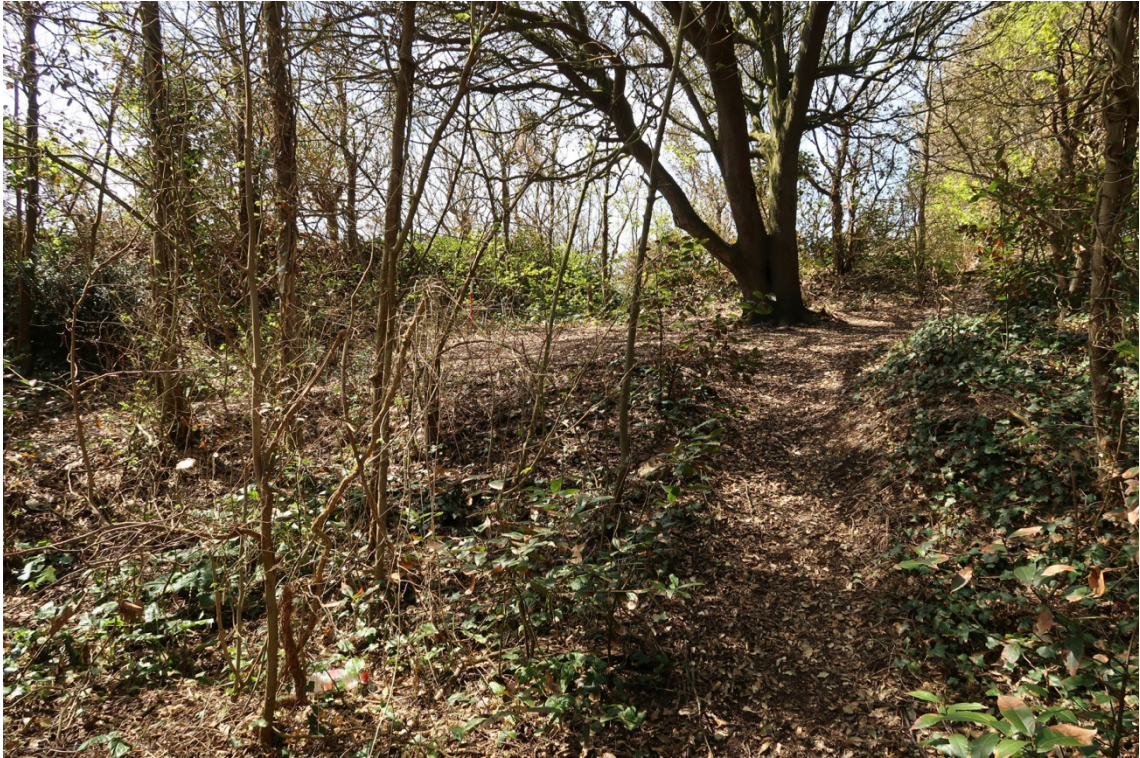
Figure 22. Firing step at the rear of the Stokes Bay Lines, 1m scale (see figure 3 point 1.7). (© Historic England).

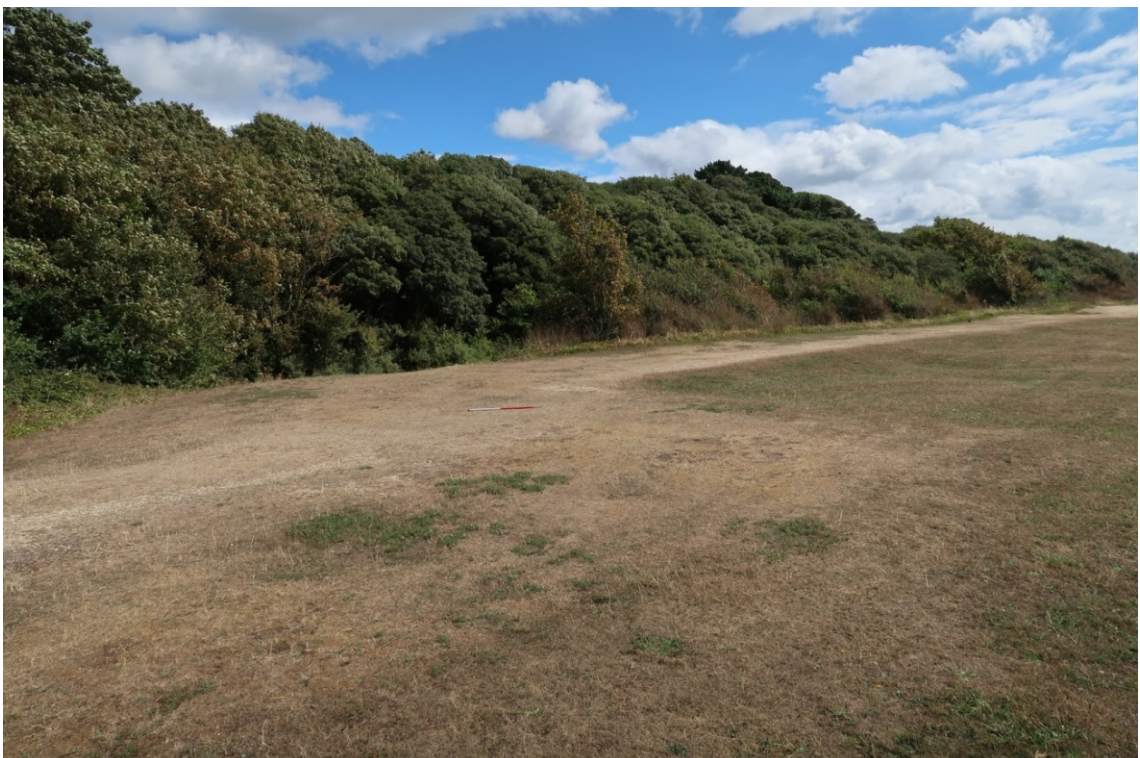
Figure 23. Parch mark showing kink in Stokes Bay Lines to the west of Alverstoke Road, scale 1m (see figure 3 point 1.6), (© Historic England).

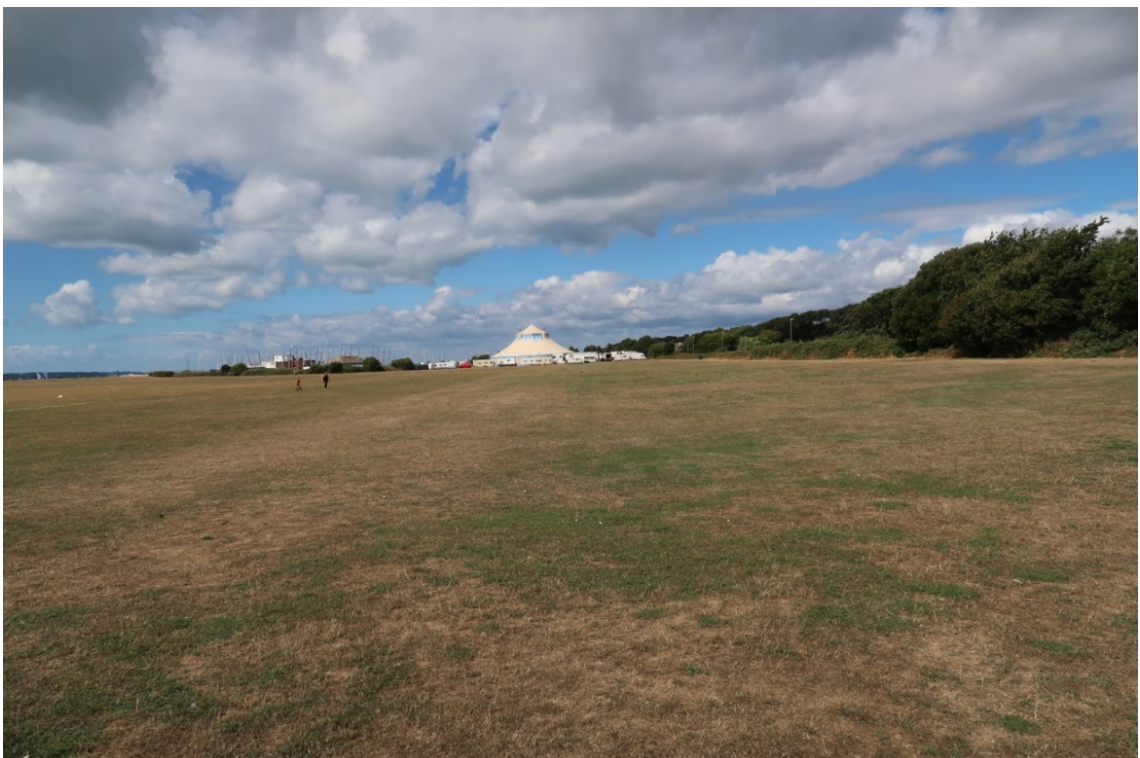
Figure 27. Parch marks and slight earthworks looking west along the Stokes Bay Lines towards Battery 3, south of Stokes Bay Road (© Historic England).

Between Battery 3 and Lifeboat Lane the Stokes Bay Lines survive as a very slight earthwork and show as parch marks in dry weather (Fig 27). The moat is visible as a shallow linear depression between 0.1 and 0.2m deep. The northern edge of the moat was identified between Battery 3 and the causeway leading from Stokes Bay Road to the beach close to embarkation hard G4. Only a short length of its southern edge was identified close to Battery 3. No trace of the southern bank of the lines was observed. It is likely that the approximately 1m drop topped by a c 0.5m high bank (1.11) along the southern edge of Stokes Bay Road is in part formed by the Lines' northern bank (Fig 28). No traces of the Lines were identified between the causeway and Lifeboat Lane.

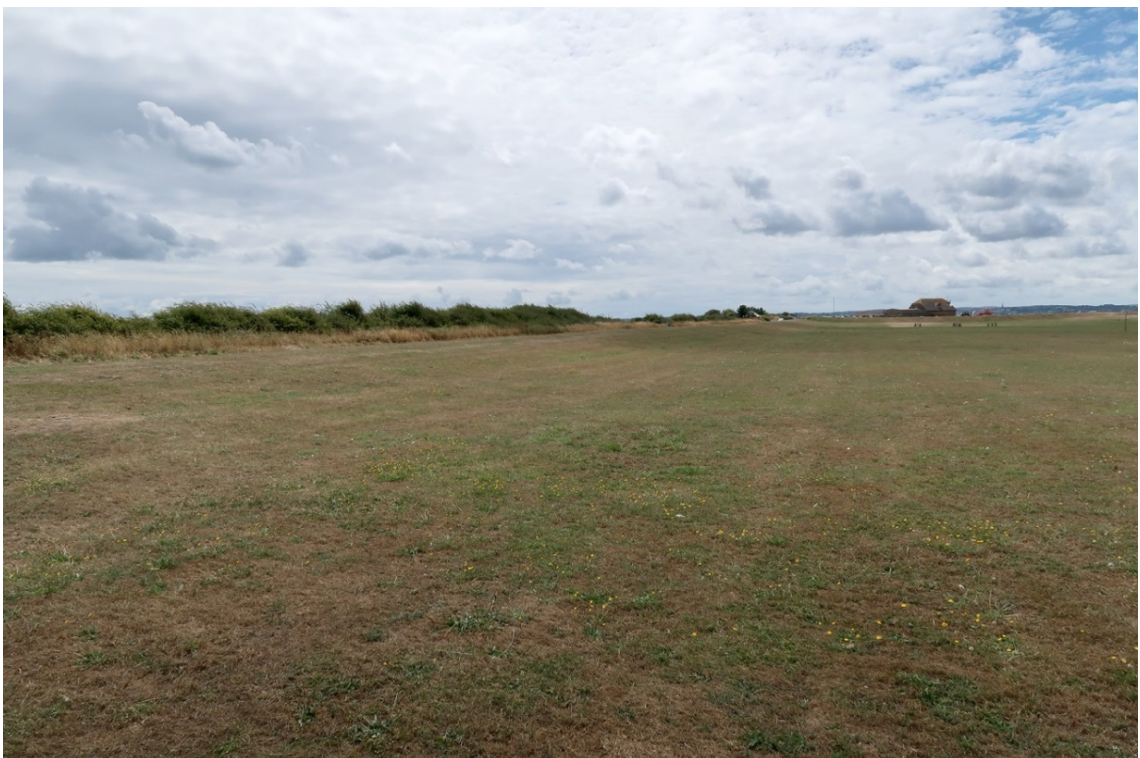
Figure 29. Looking south along Lifeboat Lane. The slight earthwork underlying the lane is the remnant of the eastern bank of the Stokes Bay Lines (© Historic England).

Little surface expression exists of the loop in the Stokes Bay Lines to the south of Battery 4. No surface expression of the moat was recorded on the western part of the loop; however, its inner bank (1.12) survives underlying Lifeboat Lane (Fig 29). An area of very slight and amorphous earthworks coincides with the southern part of the loop (1.13); here the edges of the moat show clearly as parch marks in dry weather. No surface expression of the eastern side of the loop (1.14) was observed.

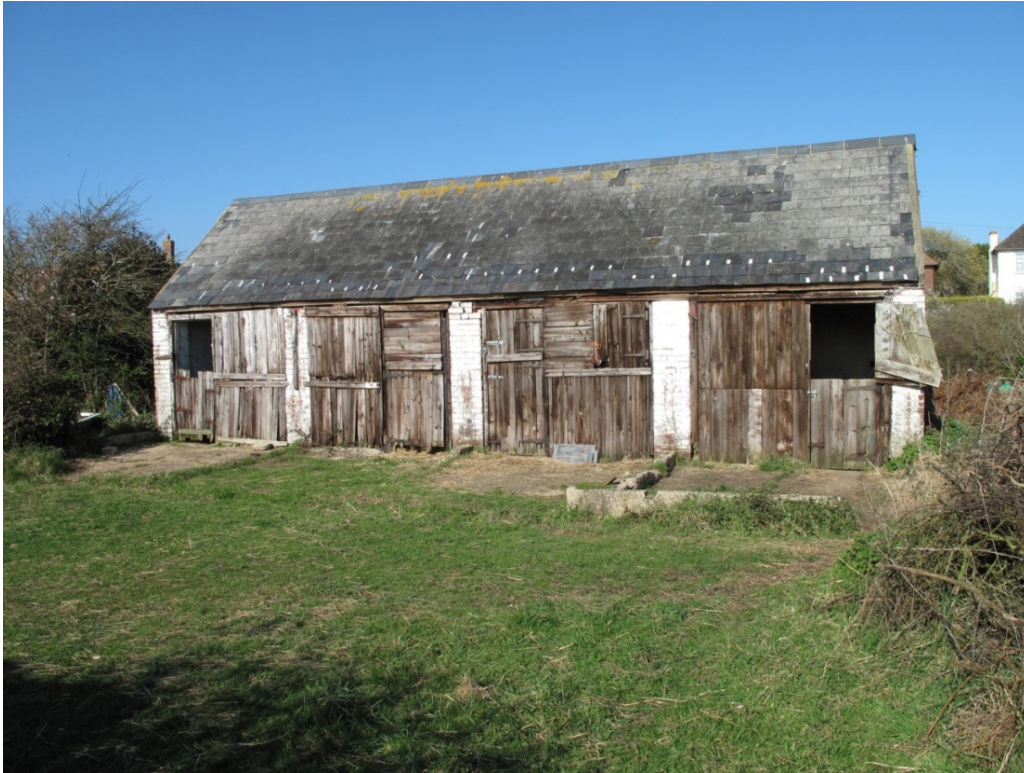
Figure 30. Southern elevation of brick building on the northern edge of Battery 4 (© Historic England).

The area from Lifeboat Lane to west of Battery 5 is partially obscured by vegetation. No surface traces of the Stokes Bay Lines were observed between Lifeboat Lane and Battery 4. Extant elements of the northern edge of Battery 4 were recorded (1.15). This consisted of a single storey, brick built, slate roofed building, measuring approximately 12m by 4m (Fig 30). This building is not shown on 19<sup>th</sup> century mapping and first appears on historic mapping in 1933 (OS 1933). The building sits on top of a low earthen bank approximately 0.5m in height, which appears to form the northern edge of the platform on which Battery 4 was constructed (Fig 31). To the east of Battery 4 elements of both the northern edge of the moat were observed as low earthworks (1.16) approximately 0.25m in height. A short length of the northern edge of the moat's concrete lining is visible.

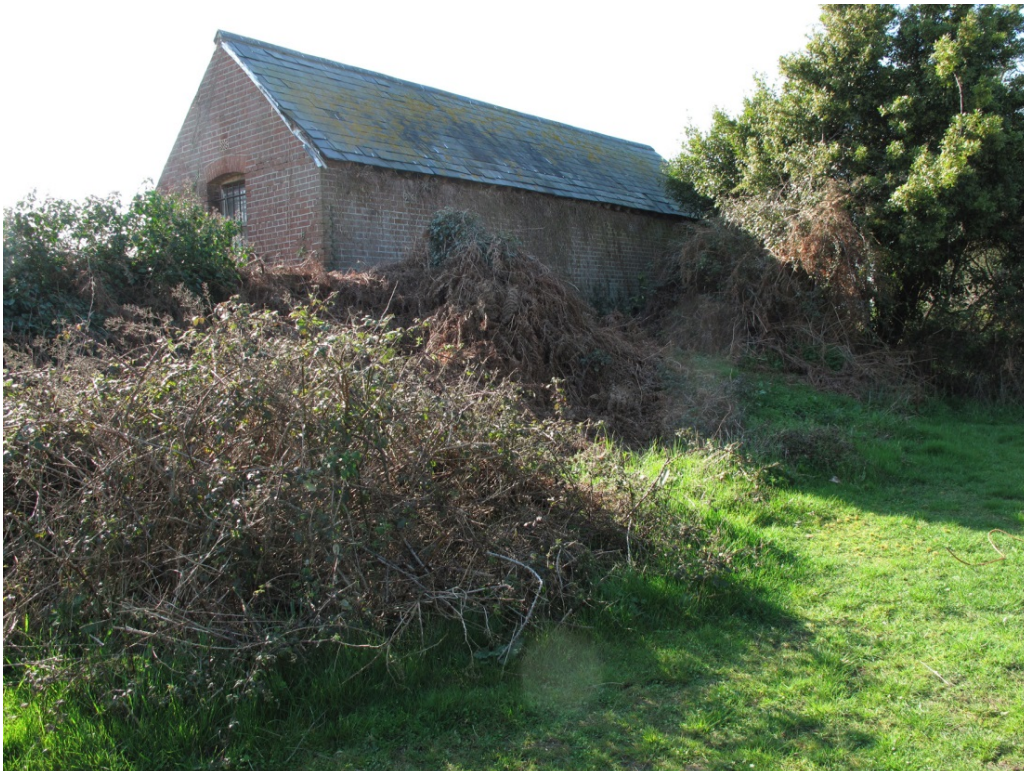
Figure 31. Eastern and northern elevations of brick building on the northern edge of Battery 4, and underlying earthwork, (© Historic England).

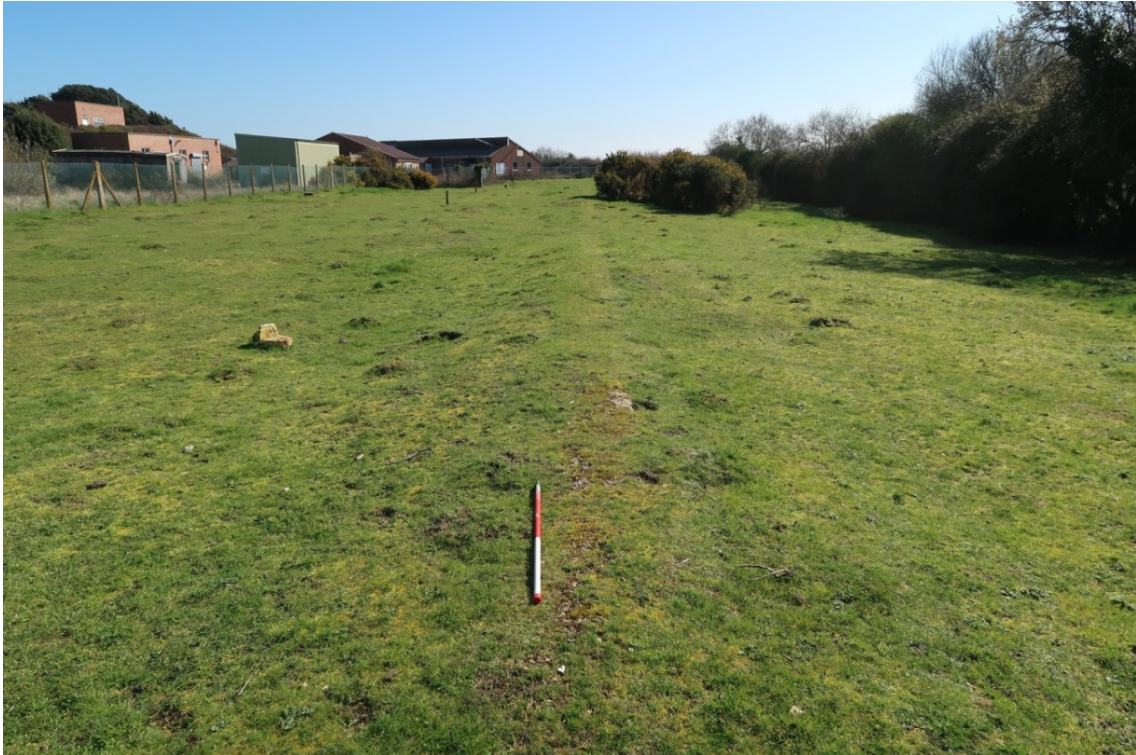
Figure 32. Looking east along the Stokes Bay Lines south of Battery 5. The southern edge of the moat's concrete lining is visible, 1m scale (© Historic England).

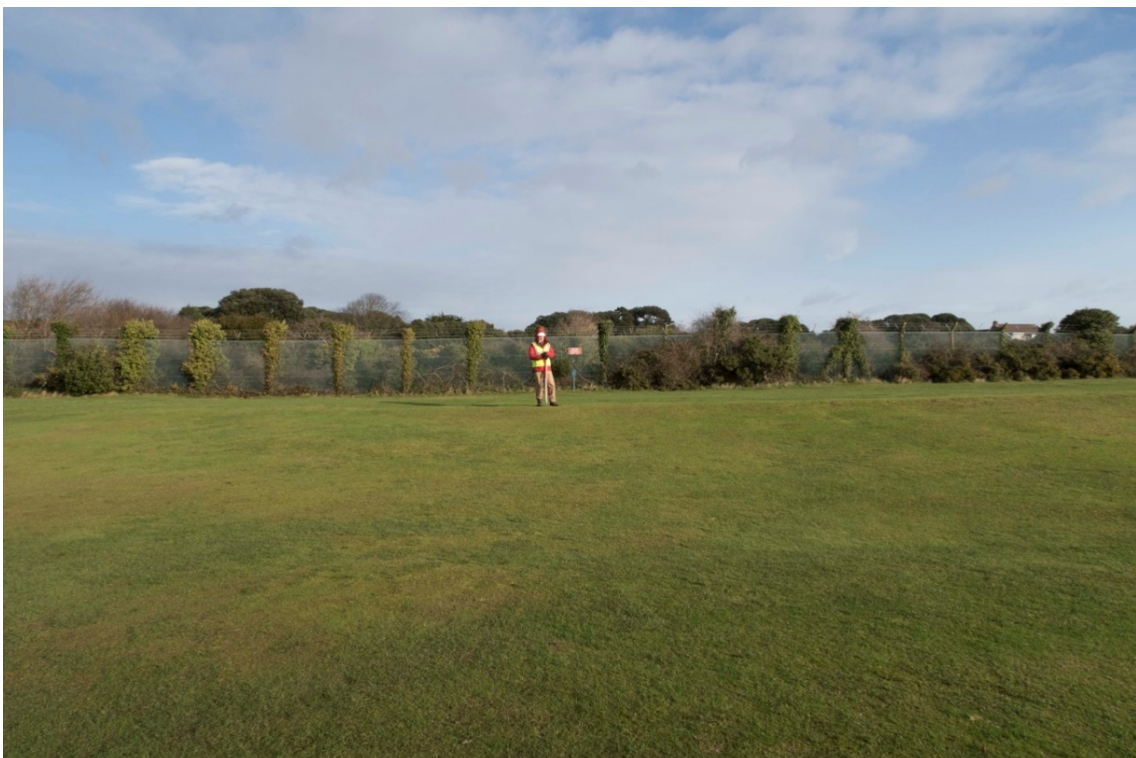
Figure 33. Looking north towards the southern bank of the Stokes Bay Lines east of Battery 5, scale 1m (© Historic England).

- h) Stokes Bay Golf Course (centre SZ 60600 97900)  
Running east across Gosport and Stokes Bay Golf Course from the fenced area surrounding Battery 5 to their eastern end at Gilkicker Lake the Lines have been substantially levelled (Fig 33 and 34). Tree planting along some of their length has also compromised their visibility. In open areas of the golf course the Lines' southern bank (1.19) survives to a height of up to 1m. No traces of the northern bank were observed. Landscaping and golf course features have removed all surface traces of the very eastern end of the Lines.

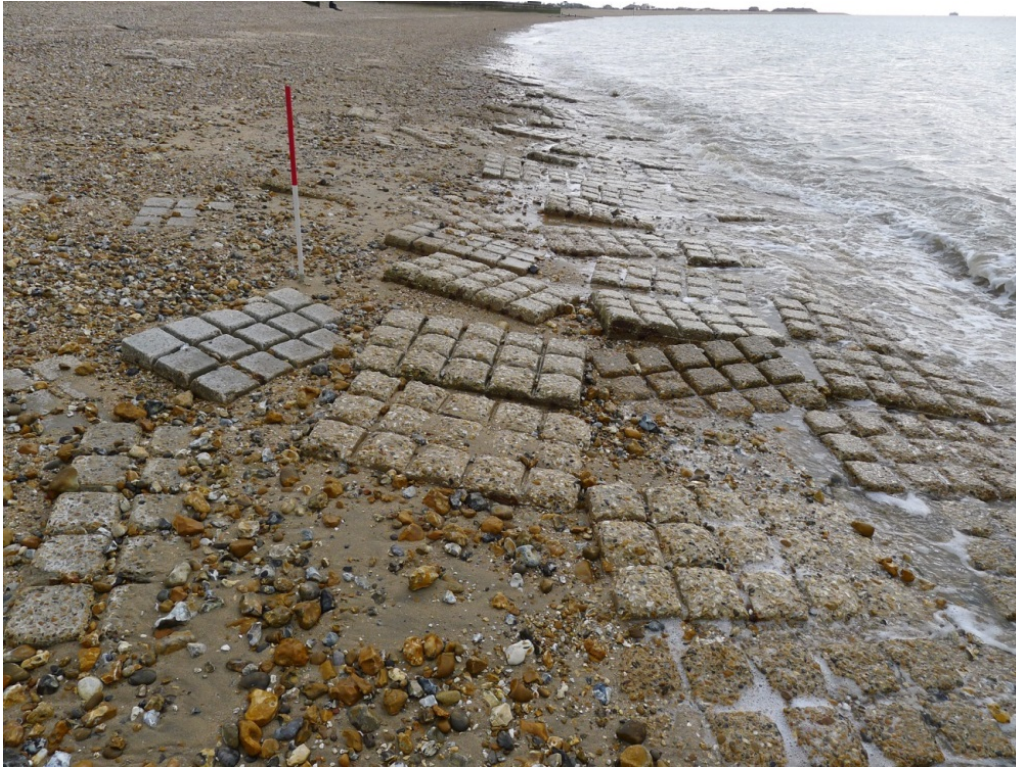
Figure 45. Disturbed areas of 'chocolate block' concrete matting at embarkation hard G1, view to east, scale 1m (© Historic England, photograph by Wayne Cocroft).

At area of 'chocolate block' flexible concrete matting (2.1) measuring 75m wide (east-west) by 13m deep (north-south) was recorded in the area of embarkation hard G1 (Fig 45). Much of this matting appears to have been slightly displaced from its original location. A greater extent of surviving concrete matting is likely to survive in this area buried by beach deposits. Several iron posts (2.2), probably the foundations for a mooring dolphin, were identified at SZ 58893 98759 (Fig 47). The concrete apron is shown on post-war historic mapping (OS 1965) and on RAF vertical aerial photography from 1946 (Historic England Archive: RAF 1946d *RAF/3G/TUD/UK/163 V 5109 20-APR-46*). It is now covered by a Gosport Borough Council car park (Fig 46) on the southern edge of Stokes Bay Road (2.3). A 2.5m long (east-west) alignment of 4 timbers (2.4, Fig 48) was recorded approximately 50m to the east of G1 at SZ 58979 98739. The original purpose of these timbers and their relationship with landing hard G1 is unclear.

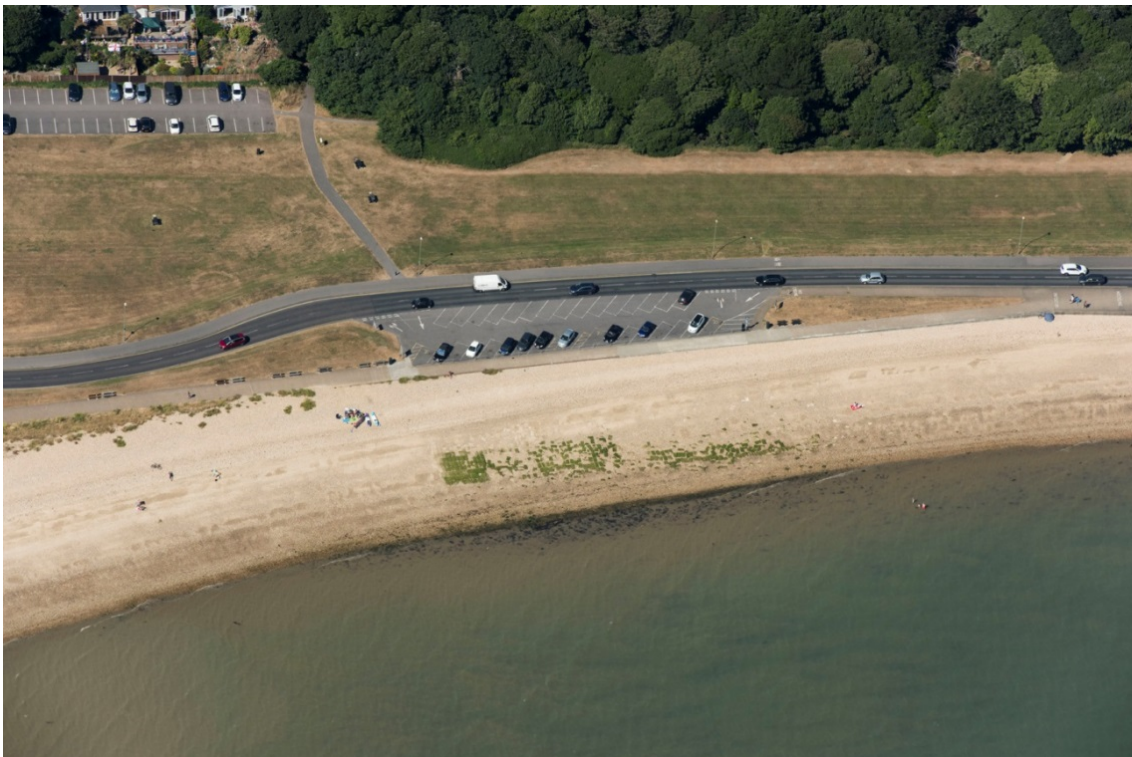
Figure 46. Looking north towards the concrete apron (under car park) and concrete matting (under sea weed on the foreshore) at embarkation hard G1. The circular patch in the centre left of the image is from a storage tank associated with the amphibious tank facility. (33560\_018 26/06/2018 ©Historic England Archive).

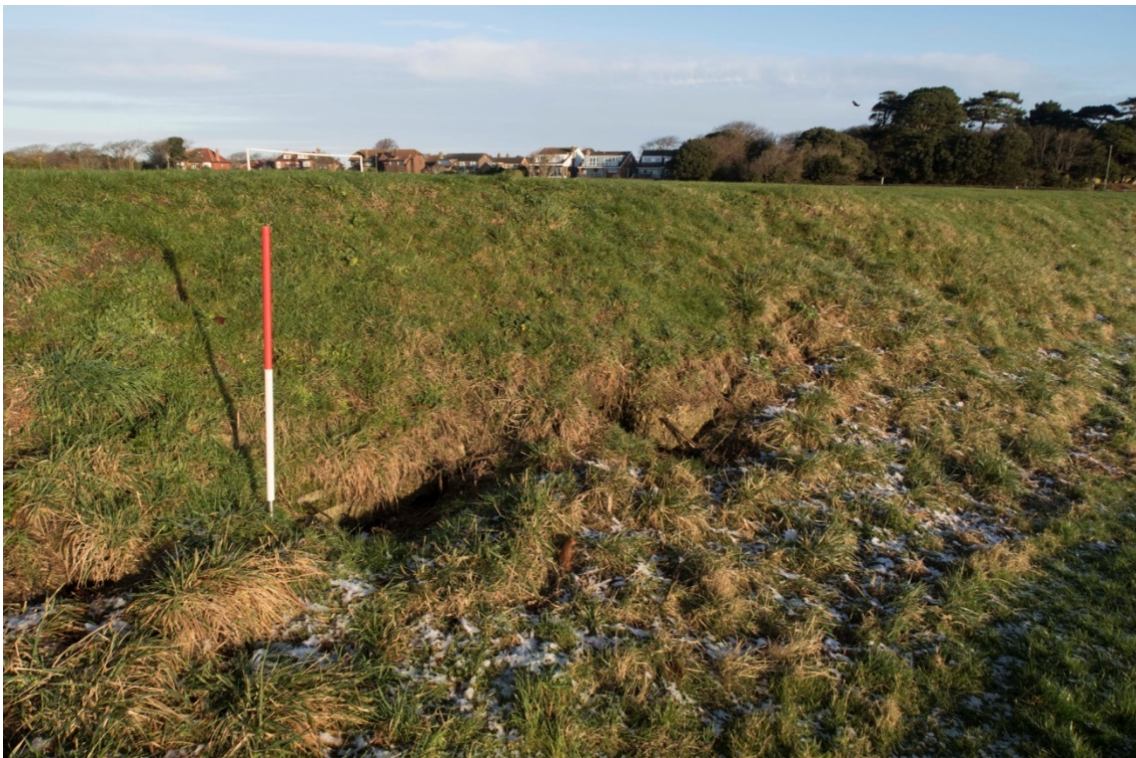
Figure 59. 1950s causeway made from reinforced concrete fragments derived from clearing Phoenix caisson construction sites. Concrete is visible in the face of the embankment, scale 1m (© Historic England).

- f) *Causeway (SZ 59985 98285)*  
 A c1.5m high causeway carrying a tarmac road (2.12) runs south-west from the junction of Stokes Bay Road and Anglesey Road towards embarkation hard G4. The body of this feature is constructed from reinforced concrete slabs cleared from Phoenix caisson construction site 1 (Fig 59). It is shown under construction on oblique aerial photography from 1950 (Historic England Archive: RAF/SFFO/540/317 O 0054 22-APR-50).

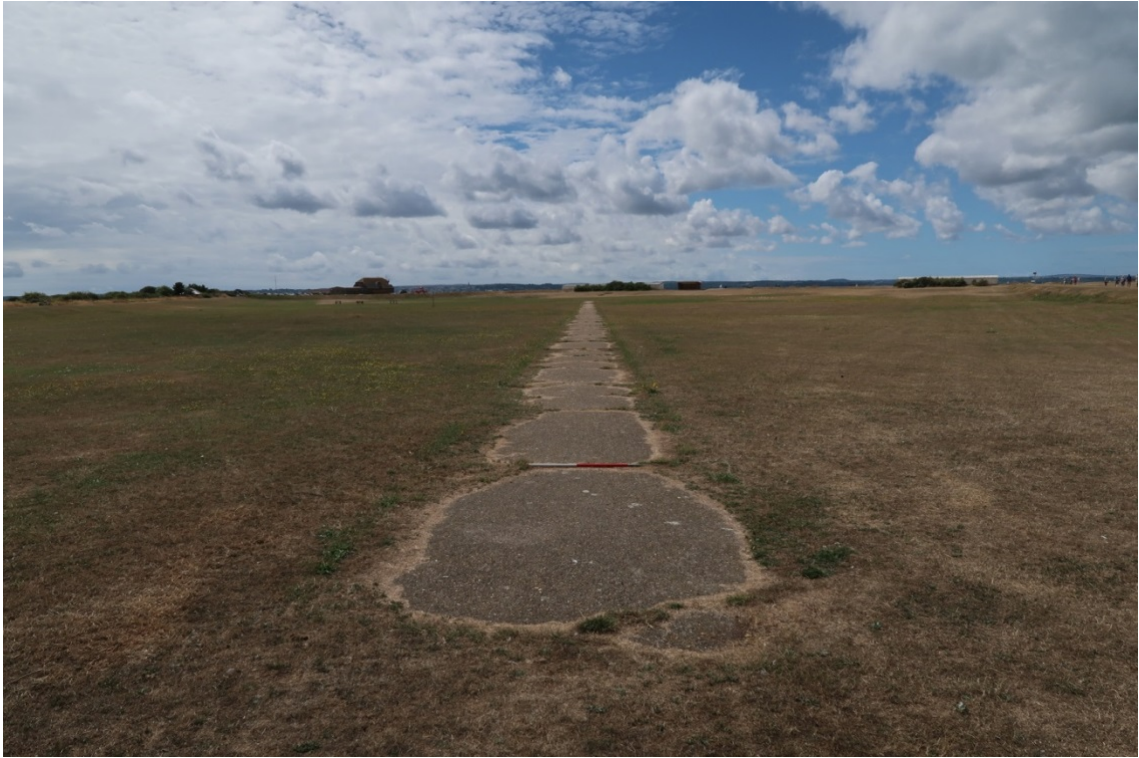
Figure 60. Looking south along the concrete path to the former bathing pool, scale 1m (© Historic England).

Two lengths of 2.3m wide concrete paths (2.16) were recorded to the west of the causeway (Fig 60). These paths would have linked the southern end of Anglesey Road with a now removed paddling pool at SZ 60010 98185, and the paddling pool with the beach. The northern path is first shown on pre-Second World War mapping (O S 1933). Both are seen in 1946 vertical aerial photography (Historic England Archive: *RAF/106G/UK/1322 V 5025 28-MAR-46*).

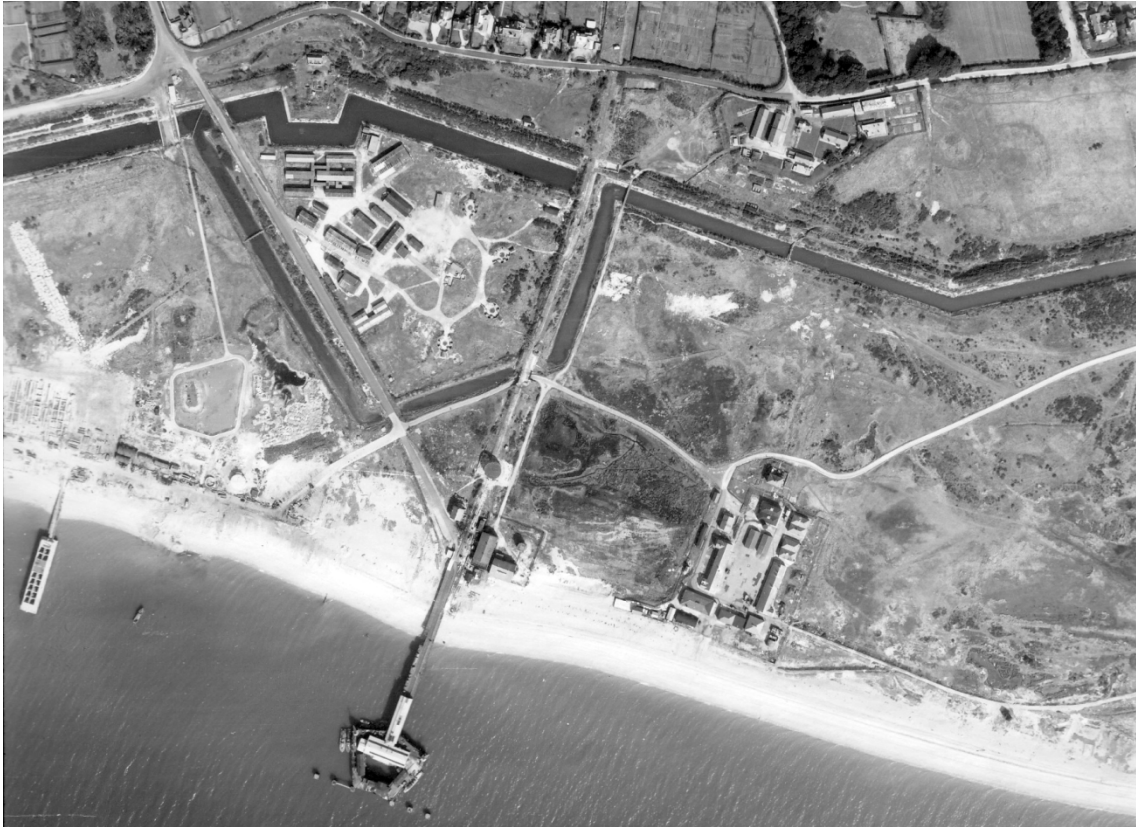
Figure 63. Gilkicker Heavy Anti-Aircraft Battery and its associated hutted encampment in March 1946, framed by the southern protrusion of the Stokes Bay Lines and Batteries 4 and 5. A mooring dolphin associated with embarkation hard G4 and Stokes Bay Pier are visible on the foreshore. Barrage balloon site 2.28 is a circular feature in the top right of the image. The bathing pool is visible on the left of the image and the School of Electrical Lighting and associated tramway is on the right of the image. RAF/106G/UK/1322 V 5037 28-MAR-46, Historic England Archive (RAF Photography).

An RAF air photograph of 1946 indicates that circular structures, possibly foundations, were located to the west and east of the battery in the Second World War period (Fig 63; Historic England Archive RAF/106G/UK/1322 V 5037 28-MAR-46). That to the west was accessed by the path cut thorough the western rampart. The eastern structure was larger, comprising two concentric circles in the adjoining field, with no obvious means of access from the battery site.

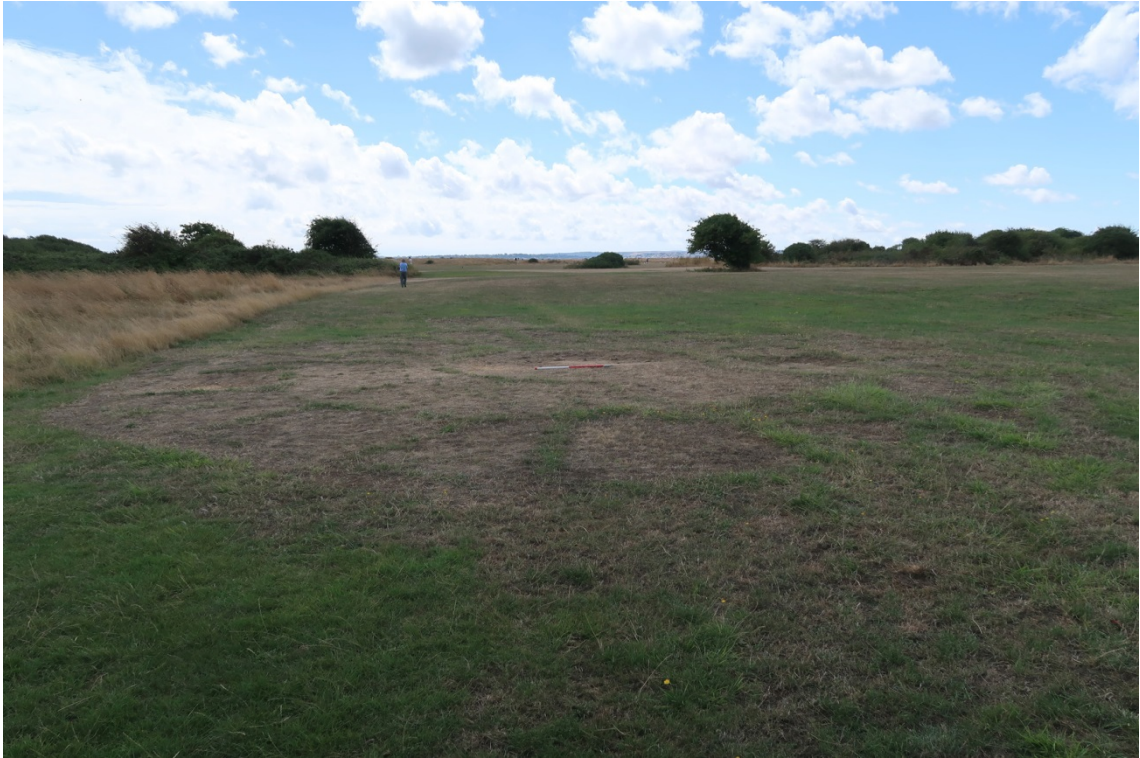
Figure 64. Parch marks of Gilkicker Heavy Anti-Aircraft Battery, scale 1m, (© Historic England).

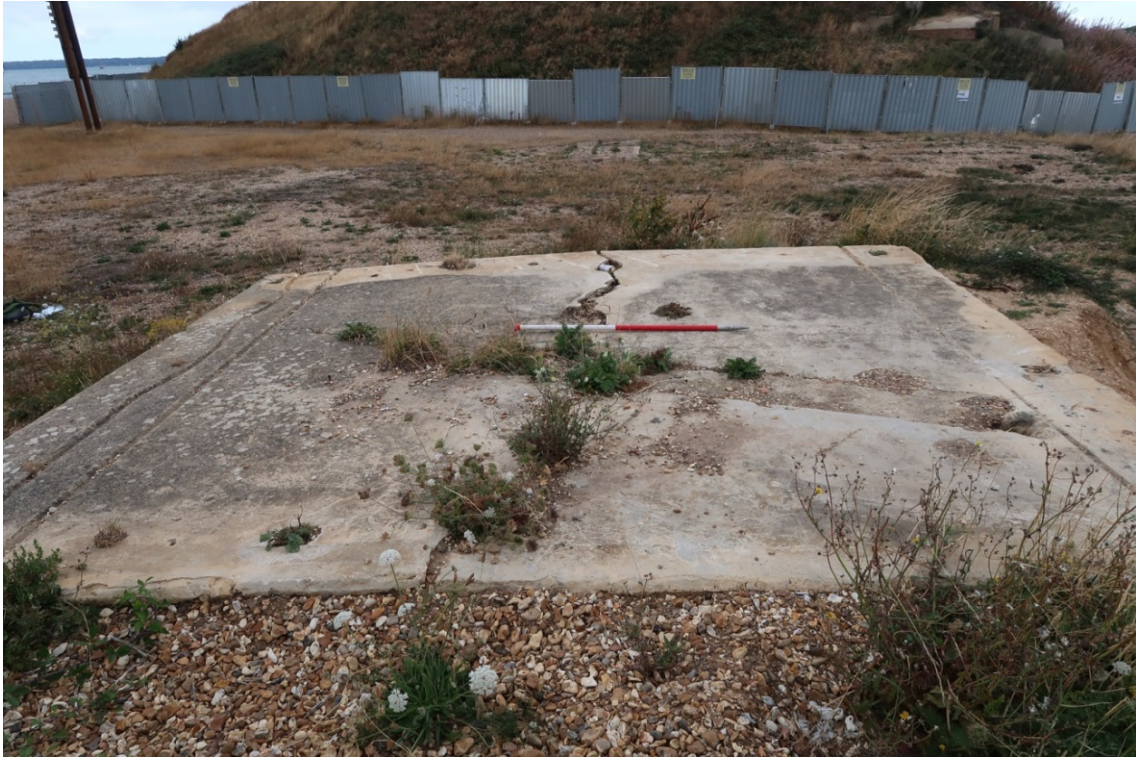
Figure 72. Concrete base for search light position 1, looking west towards Fort Gilkicker, scale 1m (© Historic England).

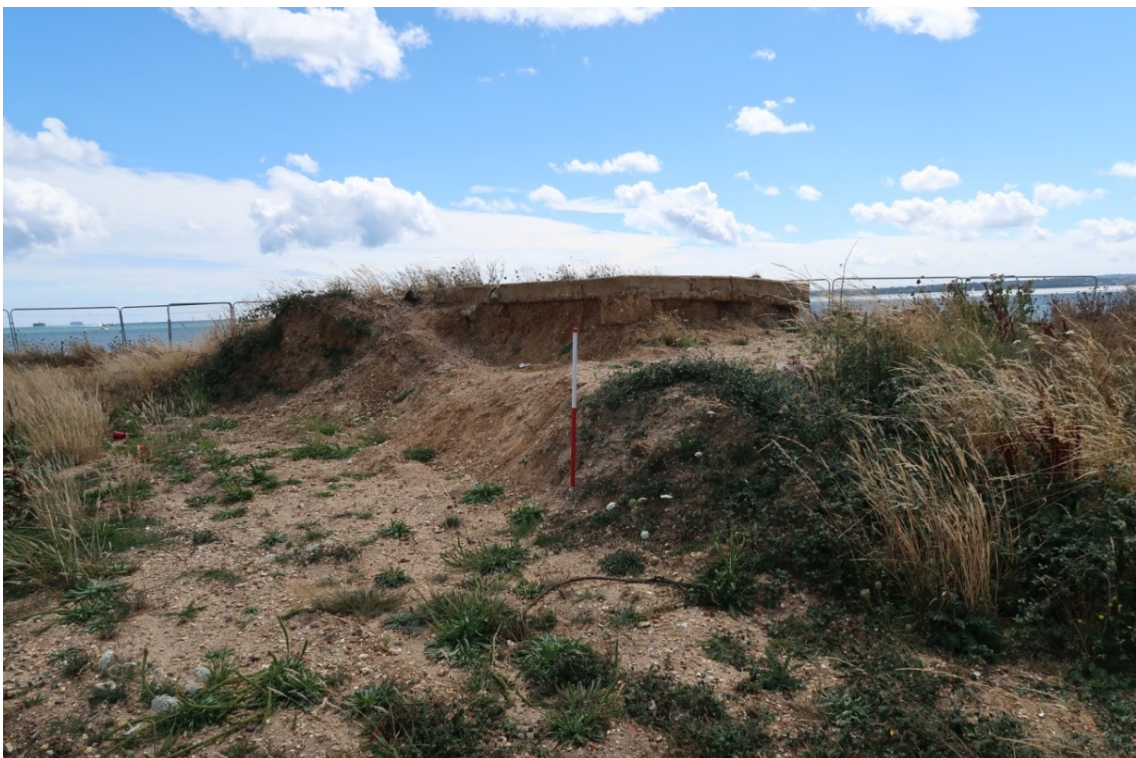
Figure 73. Mound and concrete base for search light position 1, looking south, scale 1m (© Historic England).

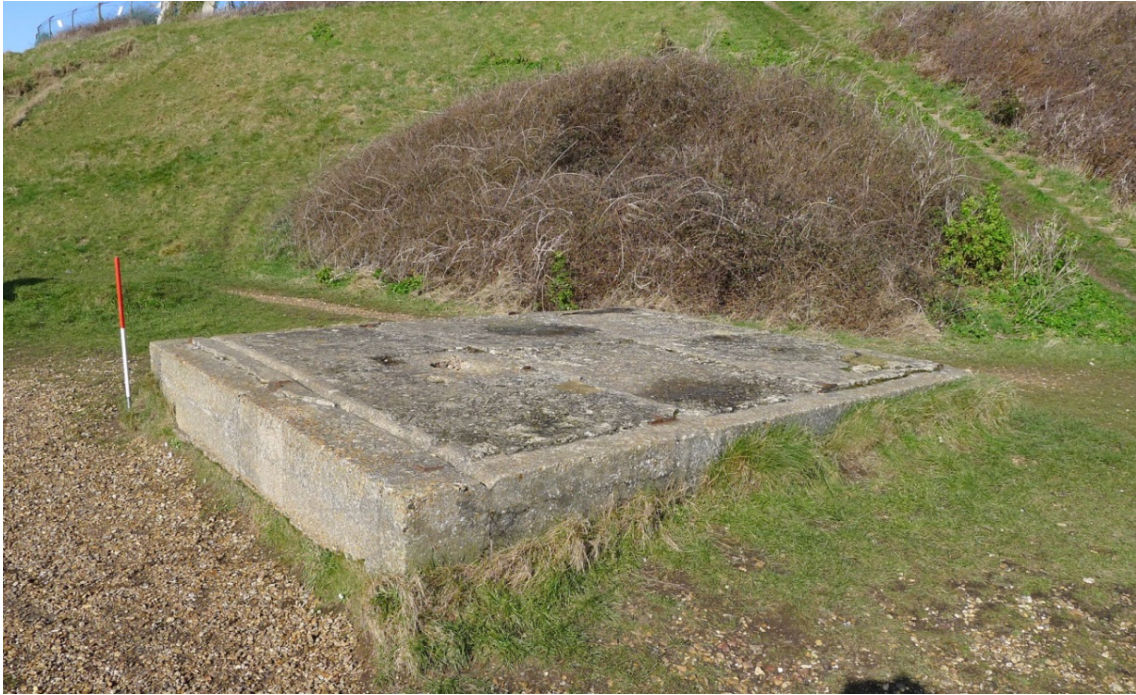
Figure 74. Concrete base for search light position 2, looking west towards Fort Gikicker, scale 1m (© Historic England, photograph Wayne Cocroft).

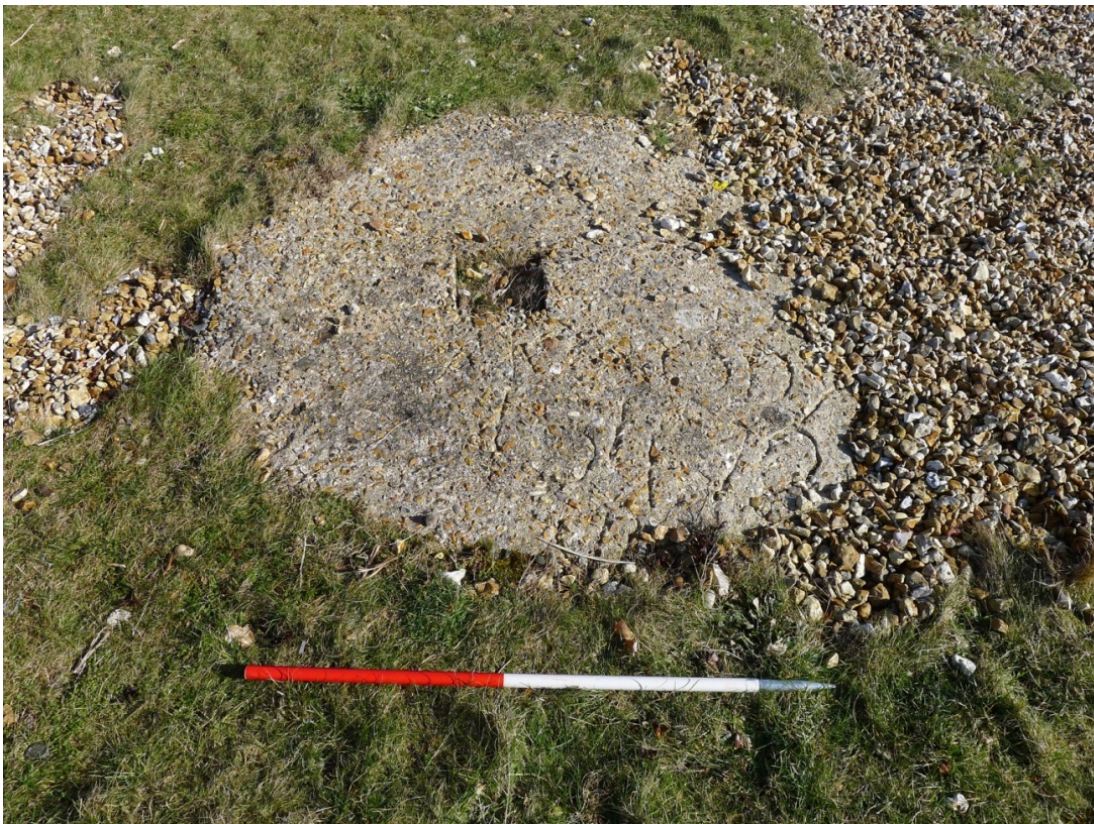
Figure 77. Circular concrete slab with square post hole to west of Fort Gilkicker, scale 1m (© Historic England, photograph Wayne Cocroft).
