SURVEY REPORT

Grand Shaft Barracks, Western Heights, Dover, Kent

**GRAND SHAFT BARRACKS
WESTERN HEIGHTS
DOVER, KENT**

Report by: P. Pattison & A. Williams
Survey by: M. Brown, P. Pattison, D. Garrow
Drawings by: M. Brown
Large-format photography by: S. Cole

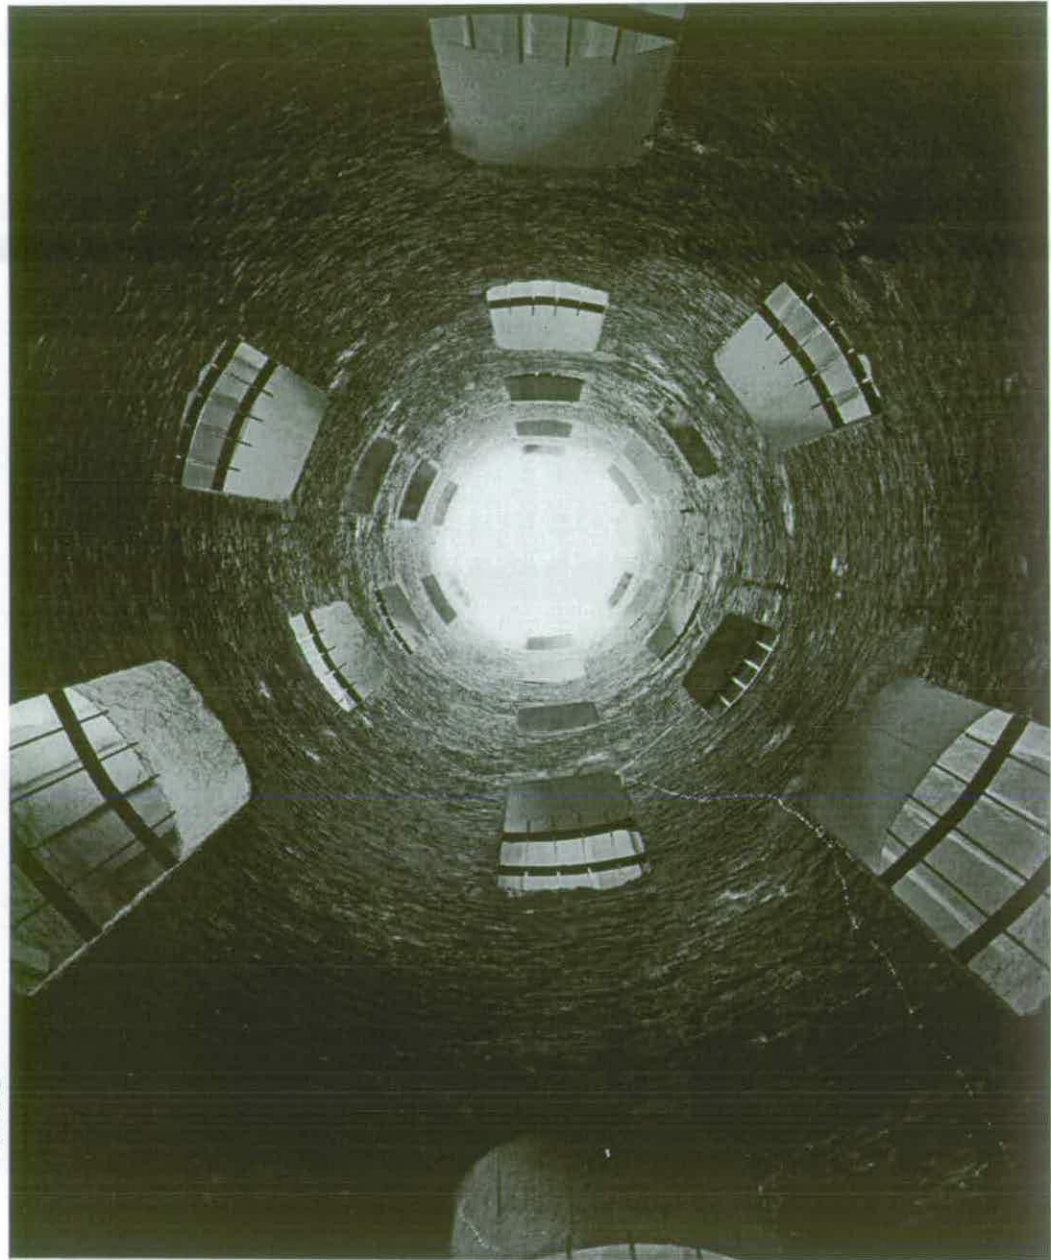
Figure 10
*A view up the central
lightwell of the
Grand Shaft (NMR)*

The Grand Shaft itself is 140ft (42.67m) deep, driven vertically through the chalk cliff and lined with Common-bond brickwork (Fig 10). In the centre of the shaft is a hollow column, in Flemish bond, which serves to support three intertwined spiral staircases, while also acting as a drain and a light well. The three staircases all have stone treads running between the shaft wall and the central column. Four borrowed-lights with semicircular heads, stone lintels and wrought-iron grilles are provided on each staircase. The exact spacing of the lights varies slightly with the geometry of each staircase but the interval between each one is roughly thirty steps. Each borrowed light has an accompanying small landing. The stone sills of the lights are canted into the stairs probably to increase the available light. At the bottom of the shaft, there are low semicircular arches at the rear of each stair: scars in the jambs suggest the position of doors, possibly to small cupboards that probably contained tools and maintenance materials. The shaft leads directly into vaulted gallery, at the end of which was a guard-room and main gate to the town (WD/2352; WD/2354).

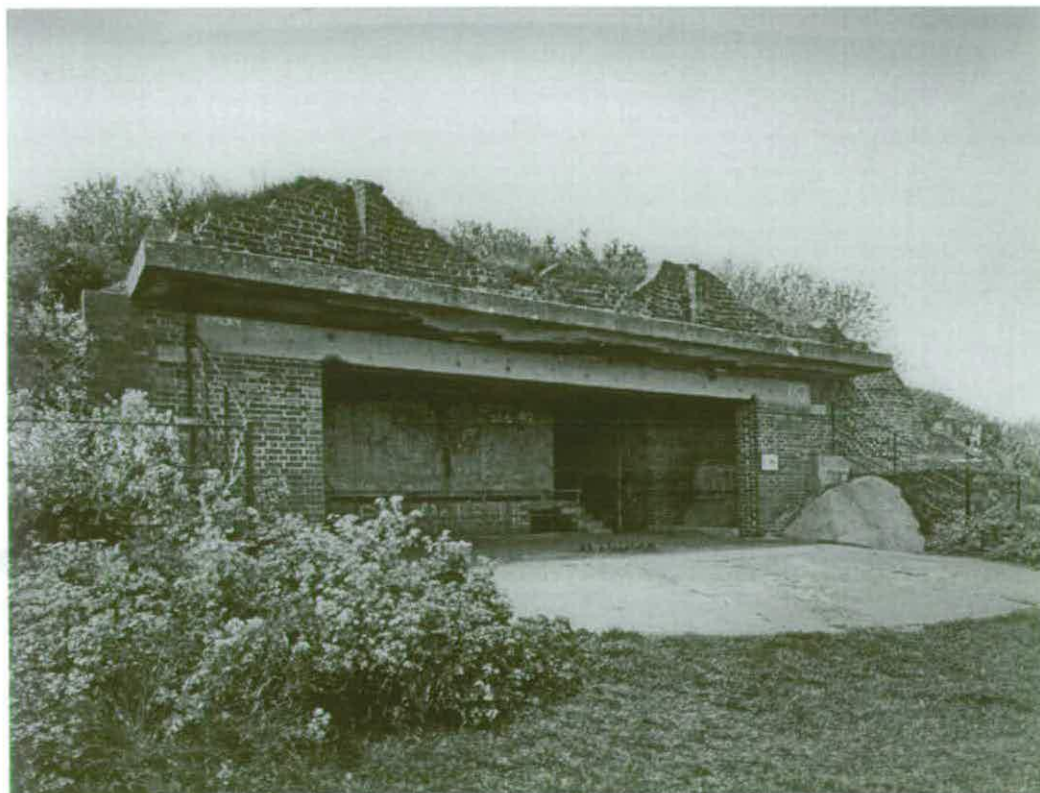
Figure 30
*St Martin's
Battery: gunhouse
for a 6-inch BL
gun, built in 1940
(NMR)*

During the Second World War phase, the three 6-inch BL guns were installed in covered gunhouses built in the old open RML emplacements. At the front, the old gun pits were filled with concrete to barbette level as a base for the new guns, which were protected by the brick side walls and reinforced concrete roofs of the gunhouses; broad openings at the front enabled a wide arc of traverse (Fig 30). The roofs continued to the rear over new two-storied structures that filled the back of the old emplacements: their elevations were built flush with the old shell and cartridge stores, creating a continuous range. The upper storeys formed gun

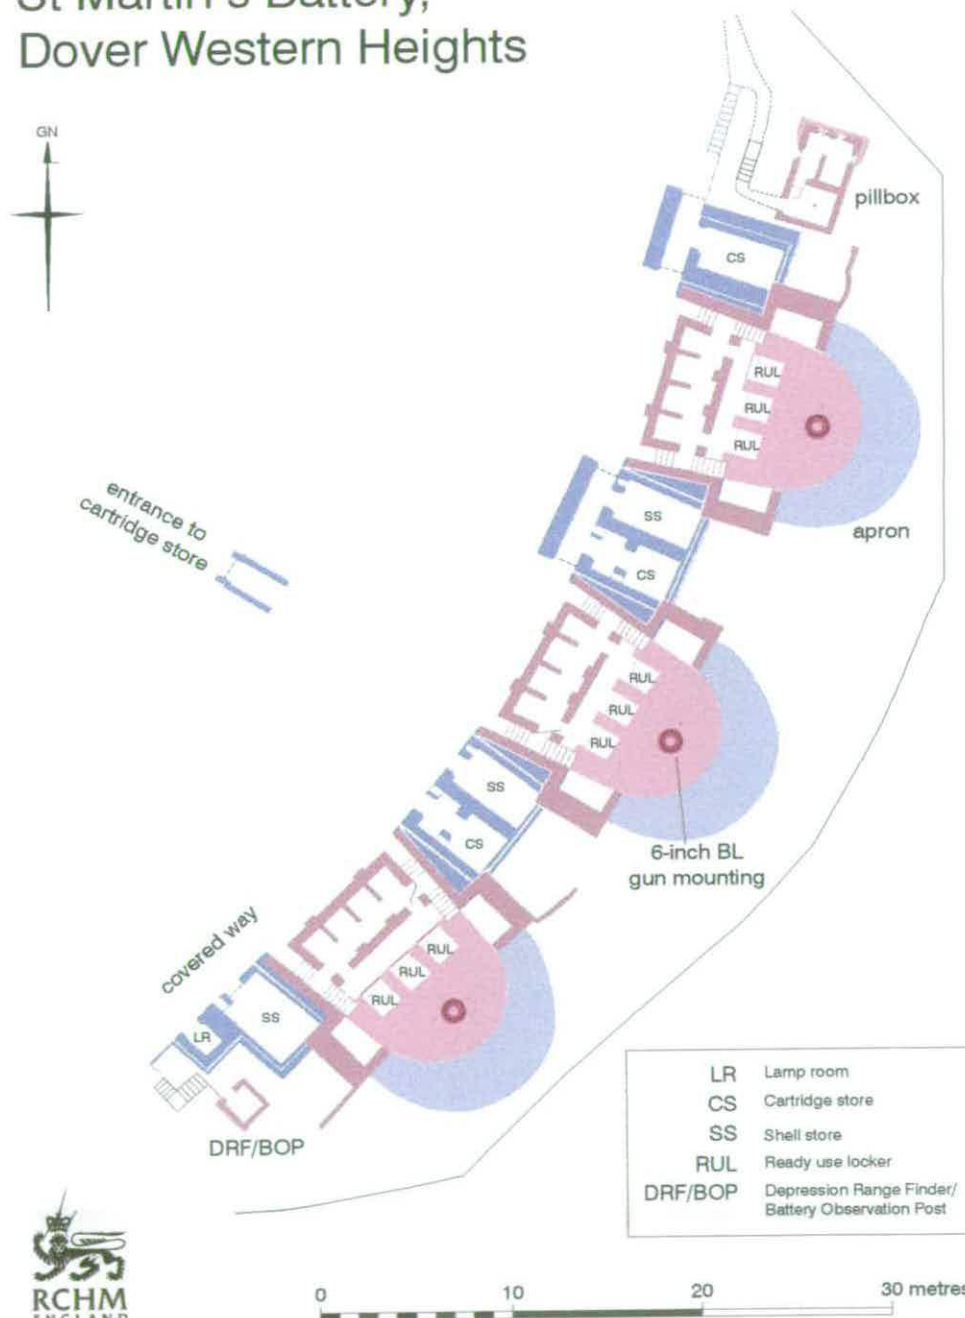
Figure 31
St Martin's
Battery in 1999;
simplified plan of
the main structure
(RCHME Crown
copyright)

Inside, the stores are of cavity-wall construction, in yellow stock brick laid to English bond, with elaborate airbricks at the ends of the cavities, lamp recesses and issue hatches. There is
