**THE WESTERN HEIGHTS,
DOVER, KENT**

REPORT NO 7

NORTH CENTRE AND DETACHED BASTIONS

19TH-CENTURY INFANTRY AND ARTILLERY FORTIFICATIONS

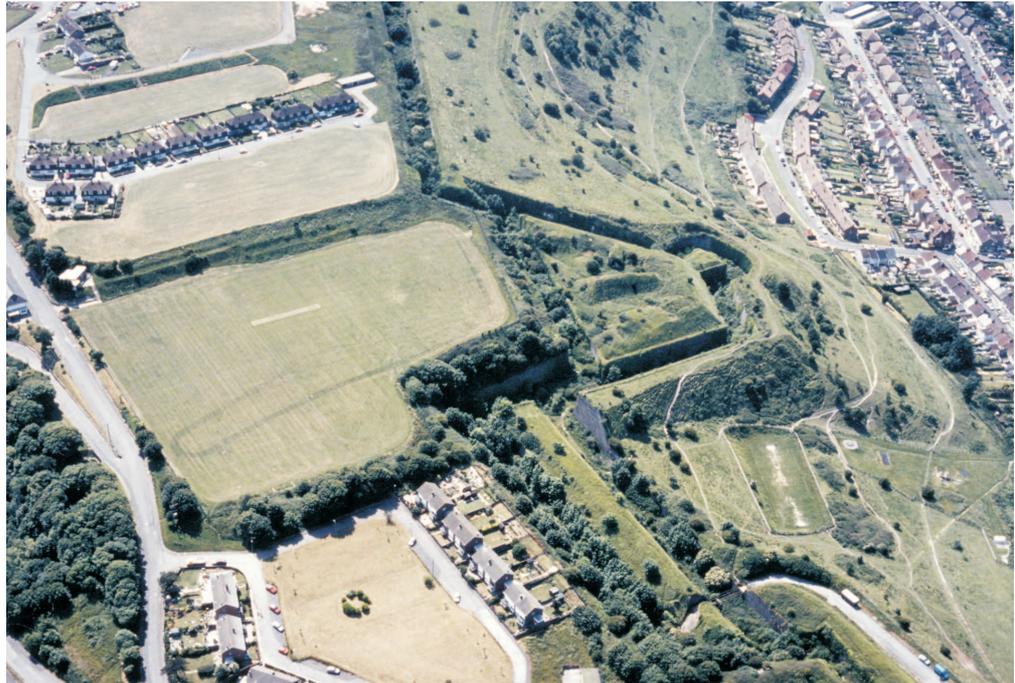
*North Centre and Detached
Bastions from the air in 1994,
showing the prominent northward
projection (the right of the photo)
in order to flank the slope of
Western Heights (©NMR: TR
3140/10, 30th June 1994)*

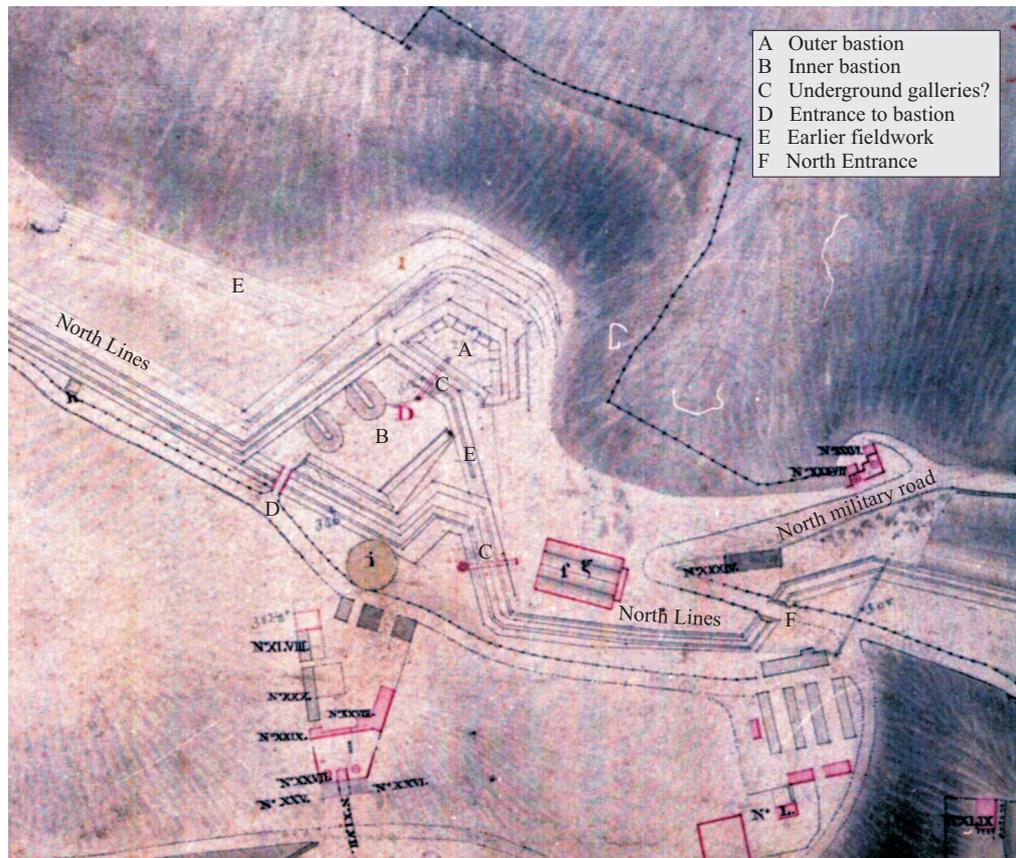
Figure 3
Plan of North Centre Bastion, showing the principal features in 1810. Text in black, excluding Roman numerals, is added by the author (extract of MR1/1349 © The Public Record Office)

The extent and nature of the Napoleonic construction is shown on several plans, dating to 1810, 1811 and 1830 (Fig 3; PRO: MR/1/1349; MPH/1/506; WO/55/2562). The plan of the bastion, which projected from the linear defences (the North Lines) along a short natural spur, resembled a triangle with a truncated tip, with longer east and west flanks tapering to a shorter northern face. Its purpose was defence of the land front, particularly to provide flanking fire along the north slope of the Heights. In form it was an unrevetted earthwork which had incorporated an earlier linear fieldwork, dating probably from the American War of the 1770s and 80s, which was aligned east to west along the north face of the Heights, outside and parallel to the later North Lines (Pattison 2001). The huge ditch and rampart of the bastion were constructed across this older work, producing two tiers of defence, each of which could be defended independently. The outer bastion was closed off from the inner by the modified rampart and ditch of the earlier linear work and connected to it by what appears to be an underground gallery. The inner bastion contained two traverses, projecting inwards at right angles from the west flank, while the gorge incorporated a dog leg such that the entrance could be flanked from inside the Heights.

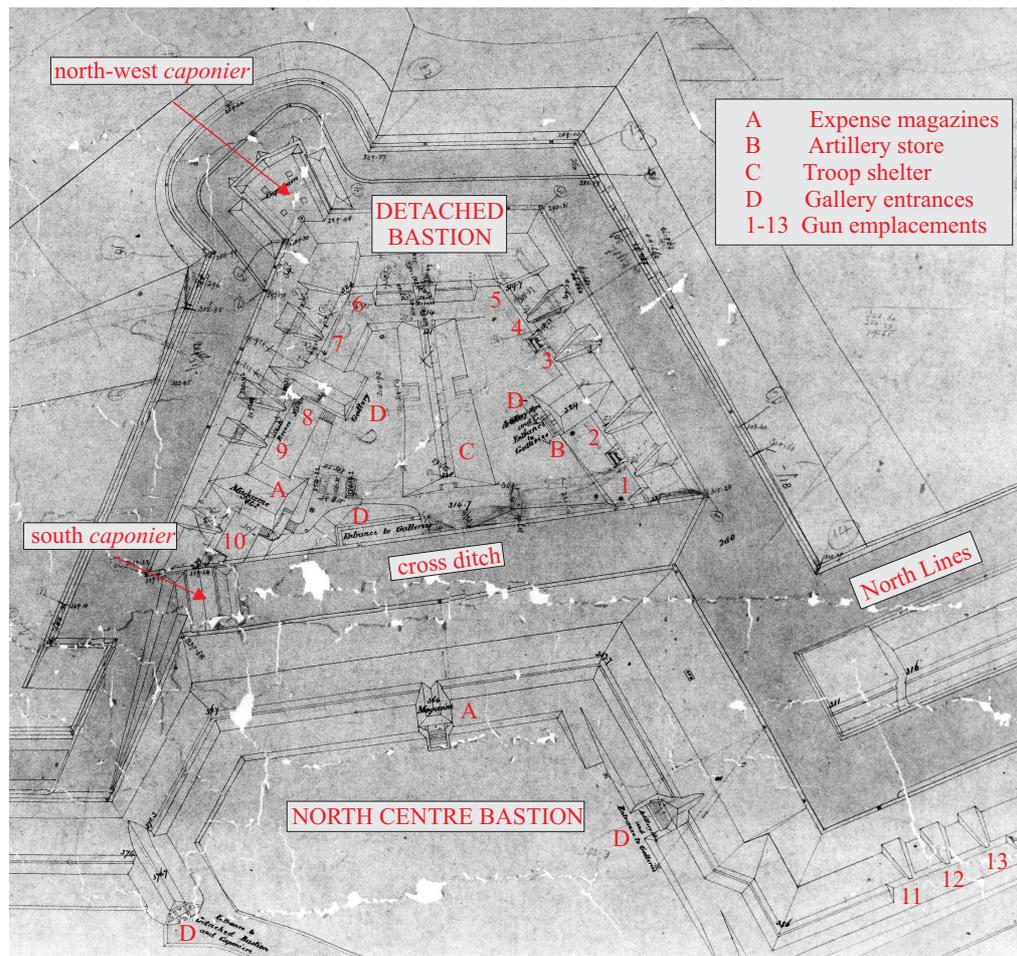
Figure 4
North Centre and Detached Bastions, from a plan made in the 1860s. Text in red is added by the author (extract of WD/2517 © English Heritage)

Captain Du Cane's work is embodied on a plan which, though not precisely dated, is of the 1860s; the only significant subsequent changes were made on the *terreplein* (Fig 4; NMR: WD/2517). His new fortifications, which took much up the same ground as the older works, comprised two distinct elements built to a more powerful and coherent

However, on the *terreplein* of North Centre Bastion, the three artillery positions (nos 11-13 on Fig 4) covering the east flank of Detached Bastion had been removed before 1881 and a single emplacement added to the north-east salient (NMR: WD/2300). This new emplacement was approached up a long ramp and may have been intended for a moveable artillery piece, possibly a 40-pdr RBL. It was altered in 1890, when a similar position was established in the other salient, at which time both had concrete gun floors and vertical *barbettes* to support the 40-pdr RBLs recommended in 1886; overbank carriages were required to fire over the high infantry parapet, which nevertheless was given embrasures. Ready-use shell recesses were made in the rampart for each emplacement. Despite these alterations, no artillery was allocated to the bastion in the armament return of 1892, although in 1900, each salient could nominally support two 40-pdrs (Fig 5; NMR: WD/2309; 2310; PRO: WO/33/2775).

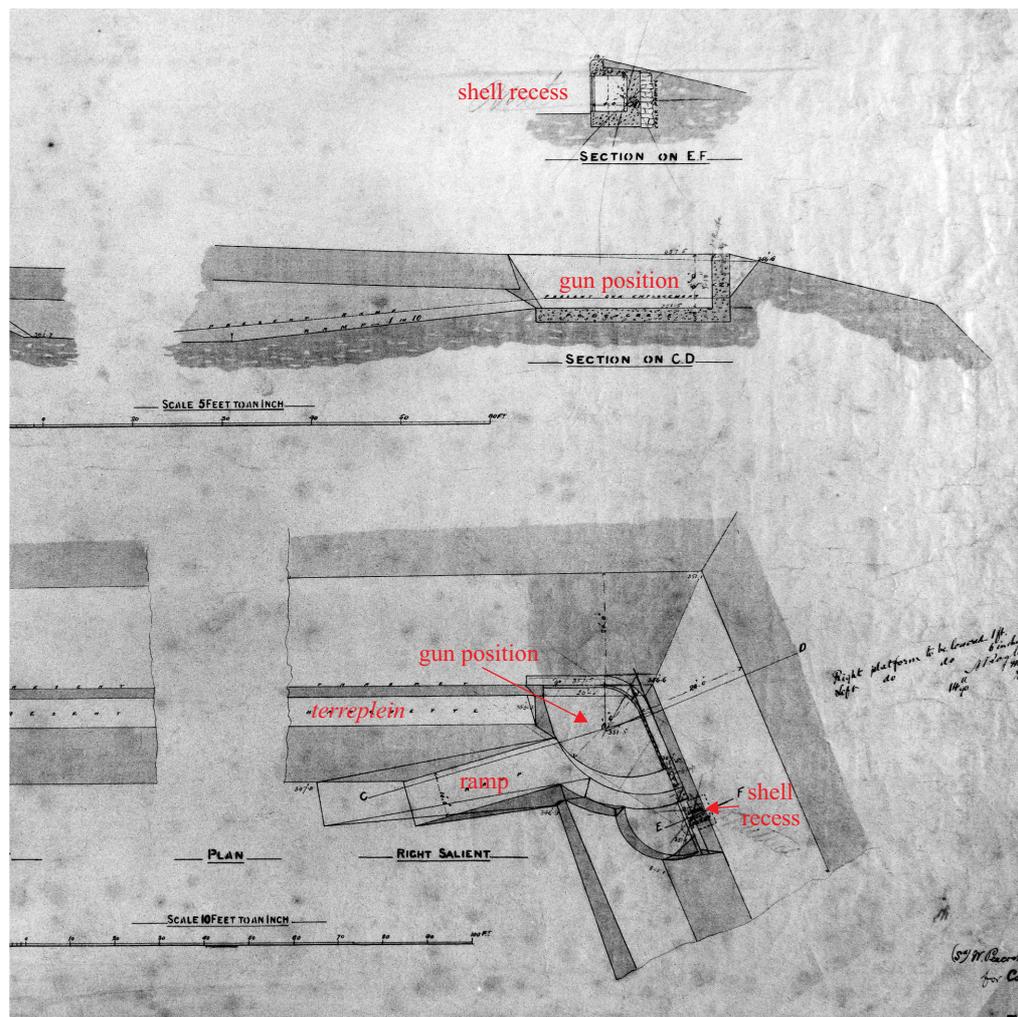
Figure 5
North Centre Bastion,
one of two gun
emplacements for
40-pdr RBL guns
established on the
terreplein in 1890, this
one in the north-east
salient. Text in red is
added by the author
(extract of WD/2309 ©
English Heritage)

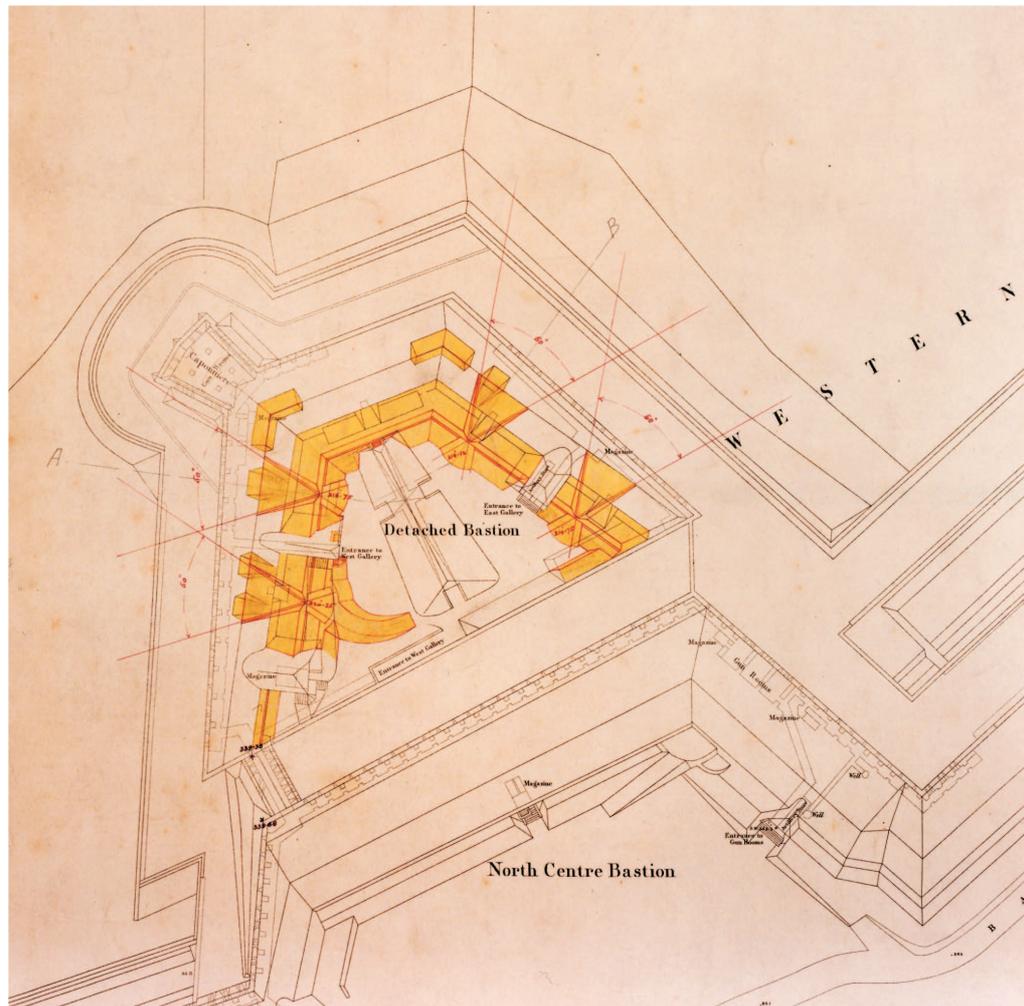
Figure 6
Detached Bastion; a plan of 1890 showing the proposed alterations to the terreplein (in yellow), to receive four 7-inch RBL guns. The work did take place (extract of NMR: WD/2300 © English Heritage)

The alterations to the *terreplein* of Detached Bastion are shown on a drawing dated 1889, over a base plan of 1881, from which it is apparent that the rampart had been altered previously- ie between 1867 and 1881. This had resulted in the infilling of four of the 1860s embrasures; one on the west face and three on the east. The 1889 drawing shows four emplacements for 7-inch RBLs, recommended by the 1886 Committee, to be mounted on blocked-up platforms but a slightly later plan is for 'L' pattern traversing slide carriages which required embrasures (Fig 6; NMR: WD/2301; 2300). The latter was adopted and the emplacements built with concrete *barbettes* and gunfloors incorporating racers for the traversing platforms. The rampart was thickened on the inside, the old embrasures infilled and new ones made. The expense magazine, artillery store and entrances to the galleries remained in the same locations, with some re-design and new ready-use shell recesses were built adjacent to the emplacements. In 1892 the RBLs were approved but not mounted and there is no evidence that they ever were; by 1902 Detached Bastion had no armament at all (PRO: WO/33/2775; WO/33/254).

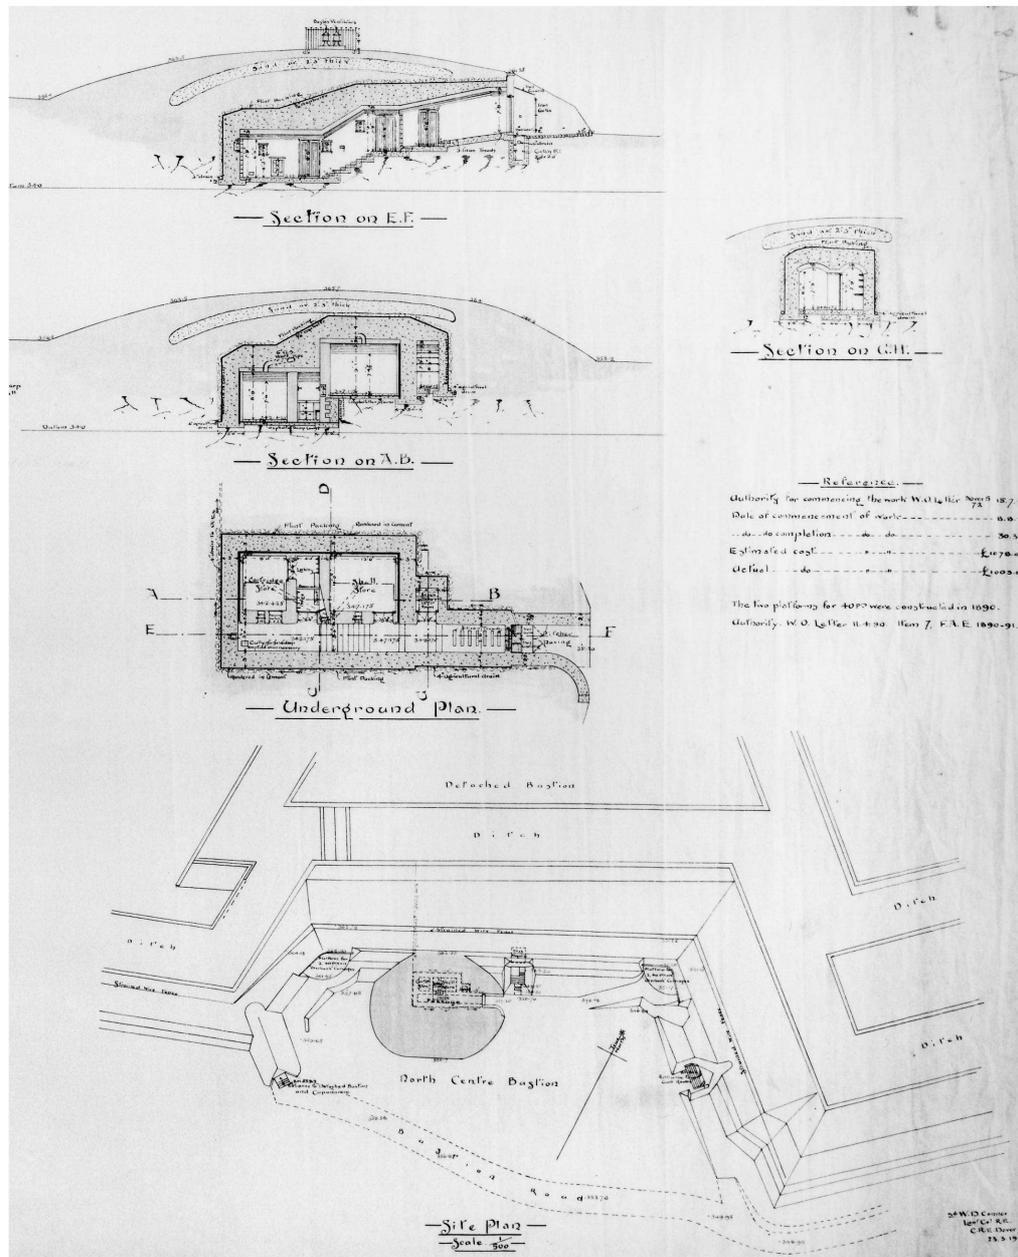
Figure 7
North Centre Bastion;
record drawings of the
shell and cartridge
store for moveable
armament, constructed
in 1898 (extract of
NMR: WD/2310 ©
English Heritage)

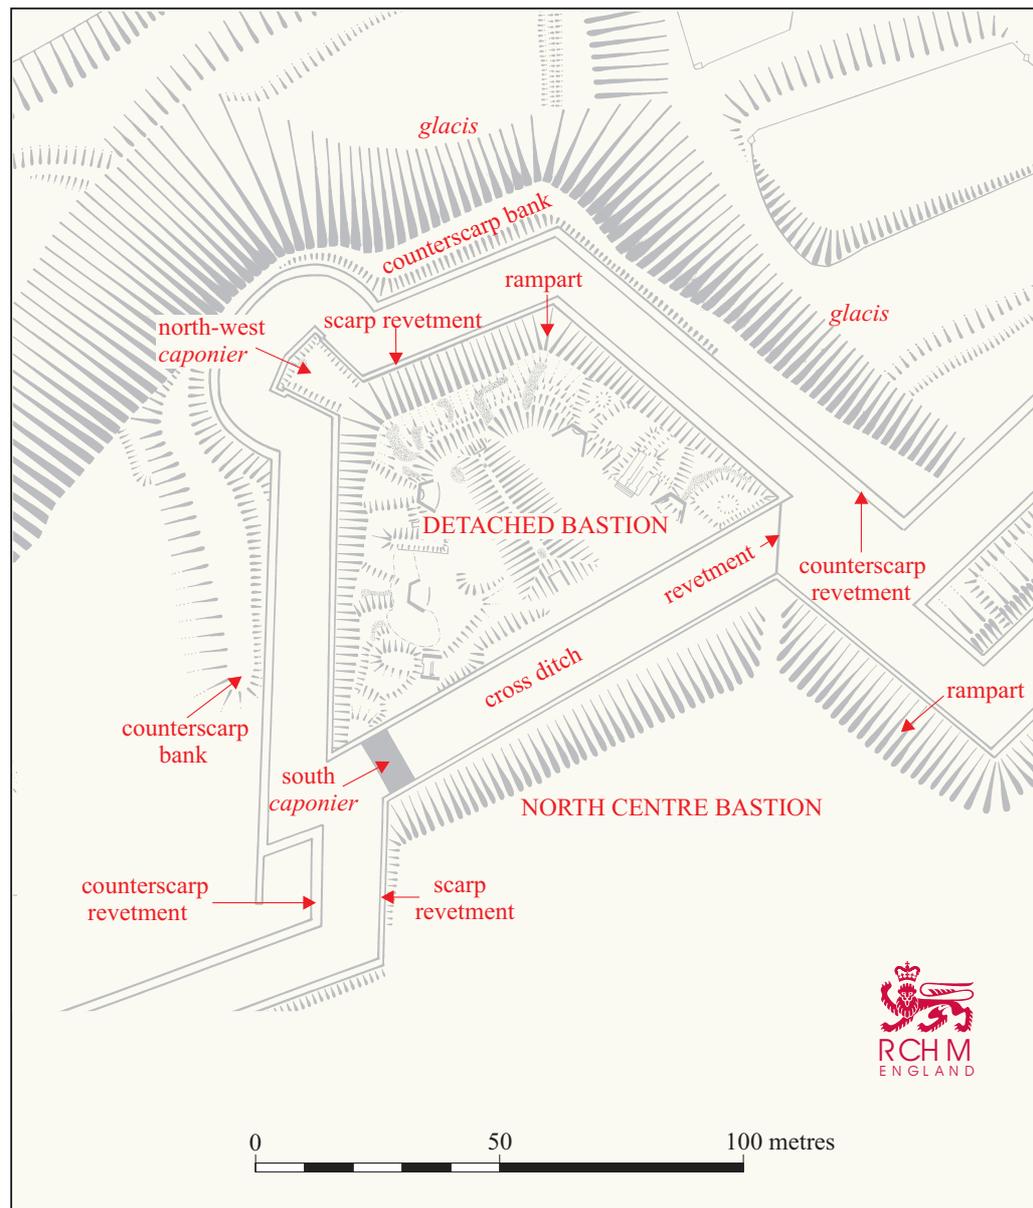
Figure 8
North Centre and Detached Bastions; RCHME plan of the earthworks (original at 1:1000 scale)

However, the archaeological survey revealed some evidence of later use, notably on the rampart of Detached Bastion where there are the earthwork remains of numerous slit trenches and weapons pits, including what appear to be machine gun emplacements. Coupled with evidence in the galleries of both bastions for electric lighting, the insertion of a doorway through the wall of the north-west *caponier*, other minor alterations and military *graffiti*, and a bridge between the bastions, it is likely that there were one or more temporary phases of light and emergency use, possibly during the First and Second World Wars (see Description section below).

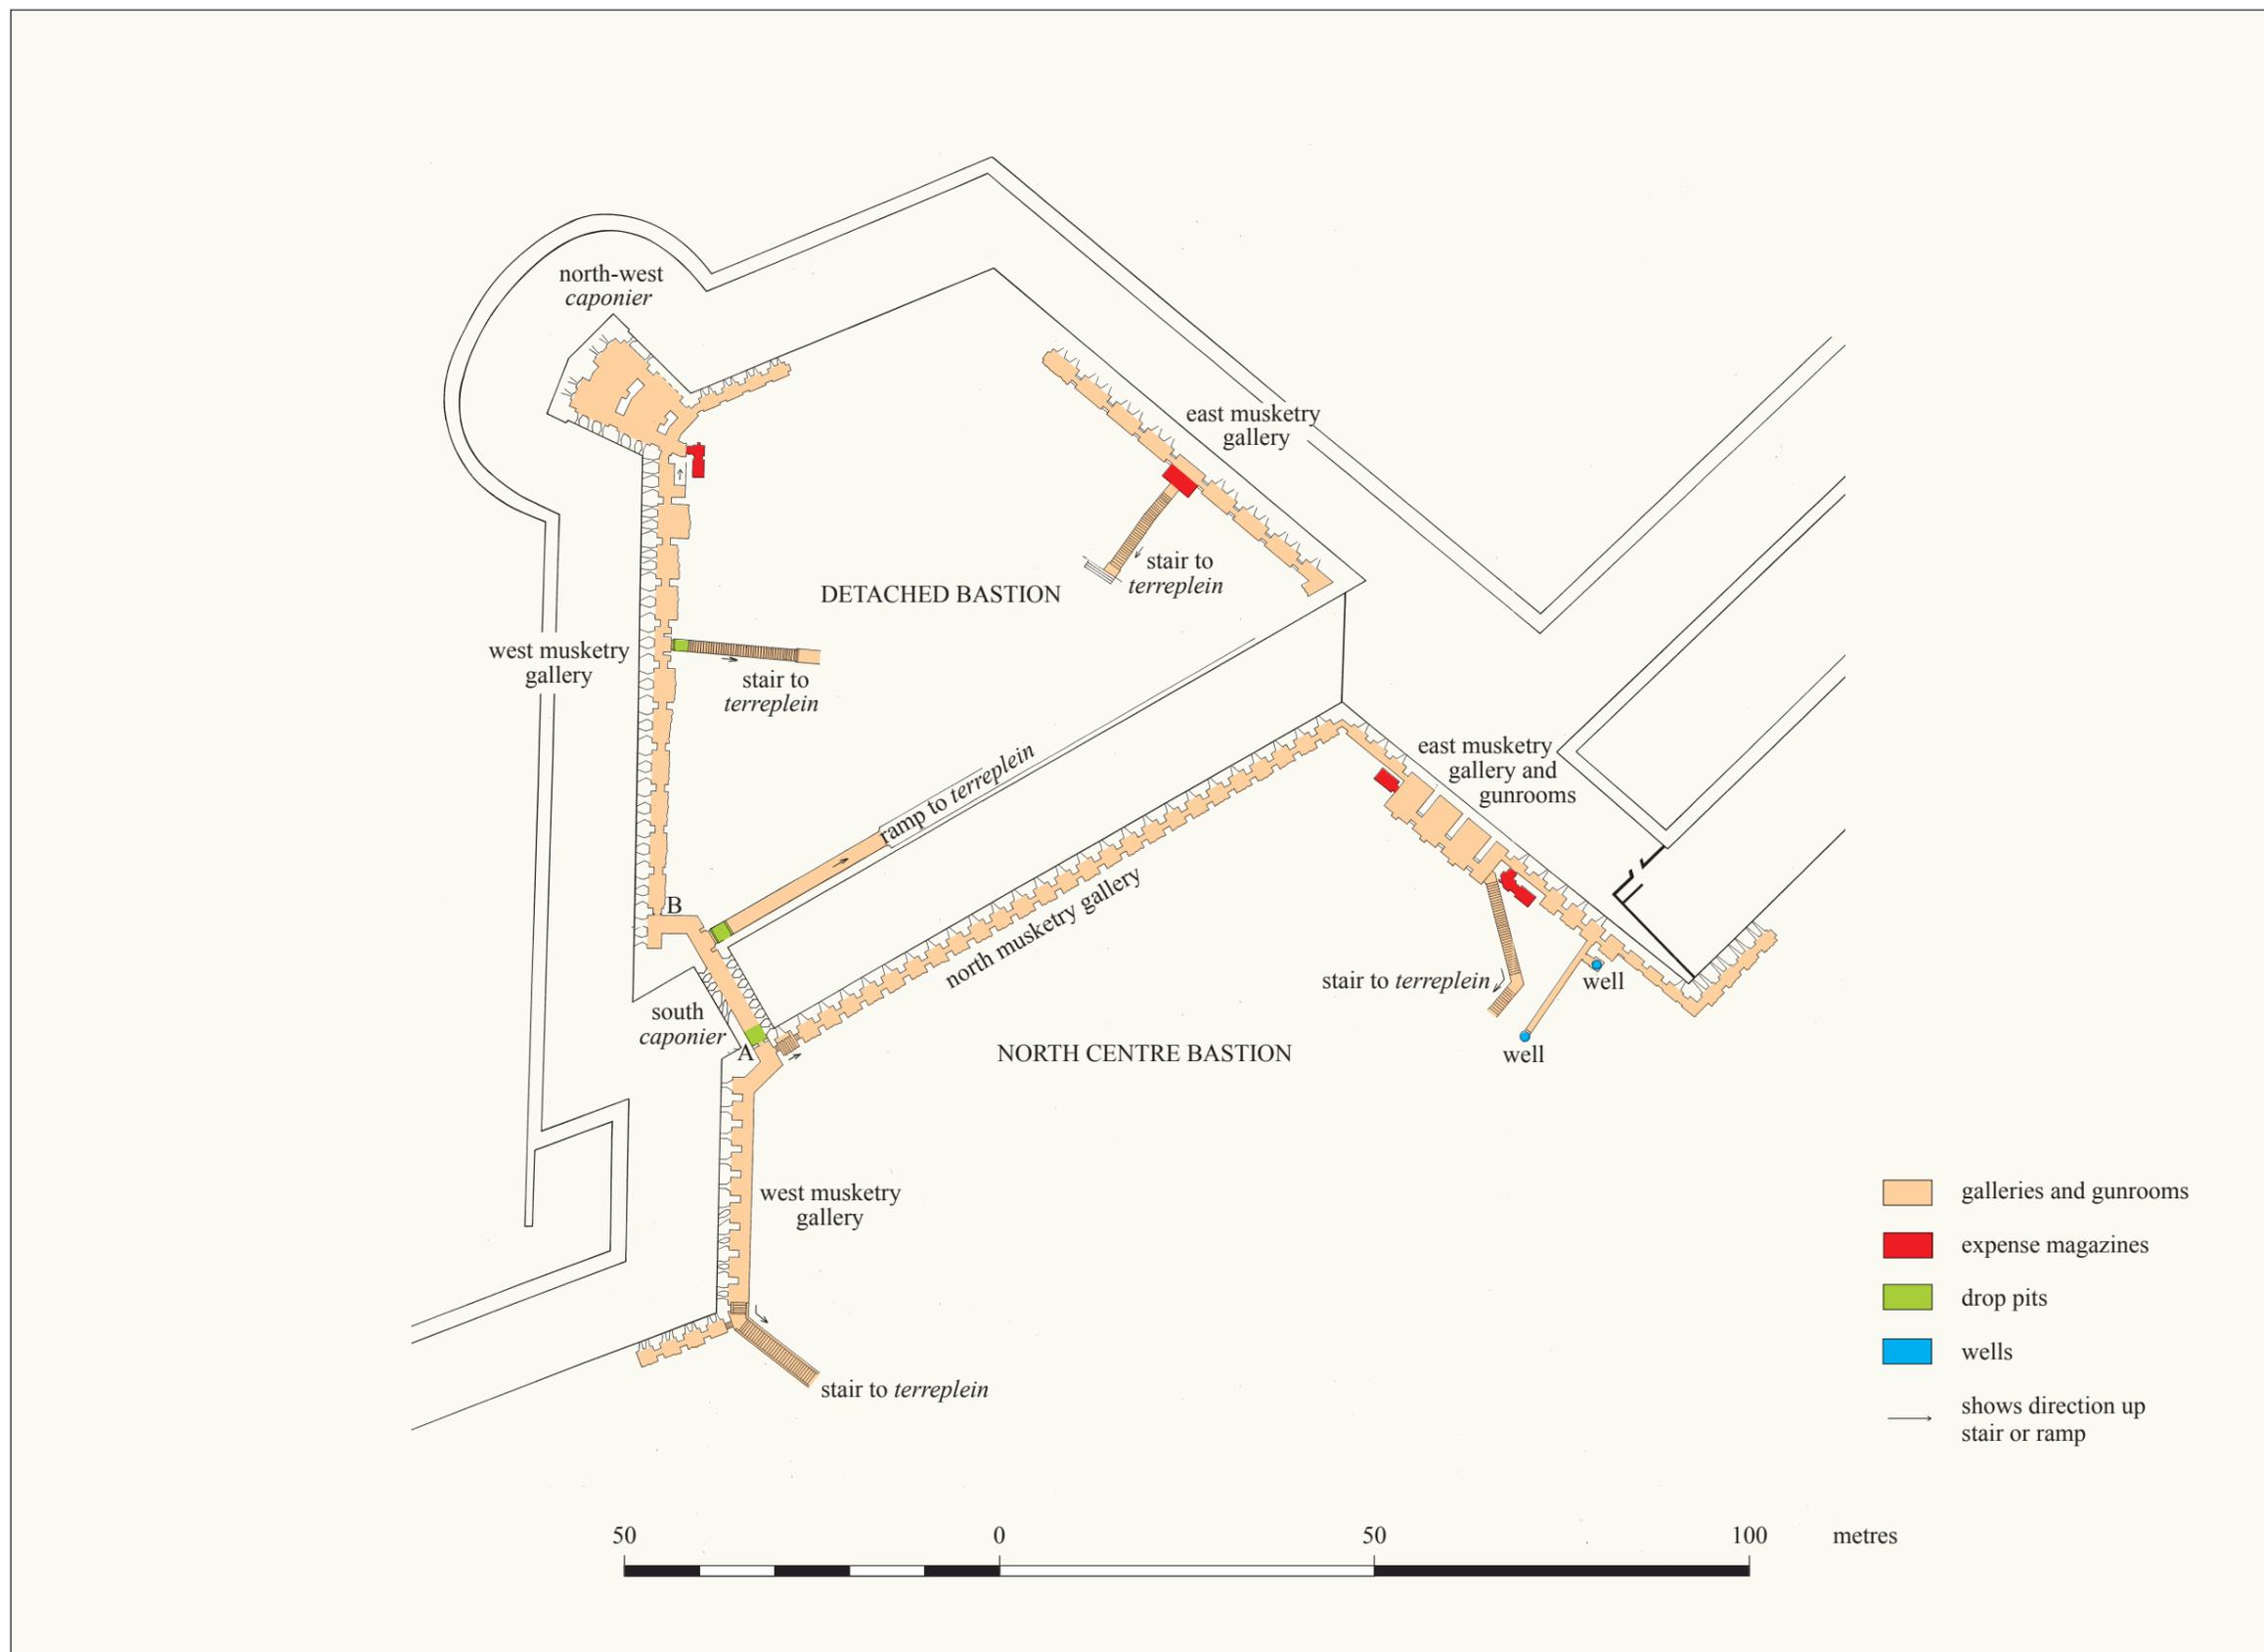
Figure 8a
North Centre and Detached Bastions; RCHME survey plan of the musketry galleries and gunrooms (original at 1:1000 scale)

Behind the scarp revetments there are three long galleries incorporating casemated rooms for both musketry and carronades, all for the defence of the ditch. These are constructed mainly in brick laid to English bond, usually with axial semi-circular vaults of stretchers, invariably whitewashed. Most of the casemates are small rectangular bays for musketry with loopholes in one face, except in the east gallery, where there are also three larger gunrooms with carronade embrasures. Each casemate has at least one small square smoke vent, situated in the front wall at the apex with the vault. The floors are usually concreted, although stone flags occur in the gunrooms, while brick and stone are used for steps. Stone is used also for load-bearing, notably for lintels to doorways (gritstone) where there are structural elements above. The musket loops are mainly brick, stepped and splayed in profile and plan, the splay varying according to the ground covered in the ditches. The apertures can be either horizontal or vertical, the former utilised to cover straight sections of ditch, the latter to cover the angled faces of the revetments. Most loops have a shallow segmental arched head with a relieving arch of two or three header courses. Cut sandstone is used for the lintels of the horizontal loops.

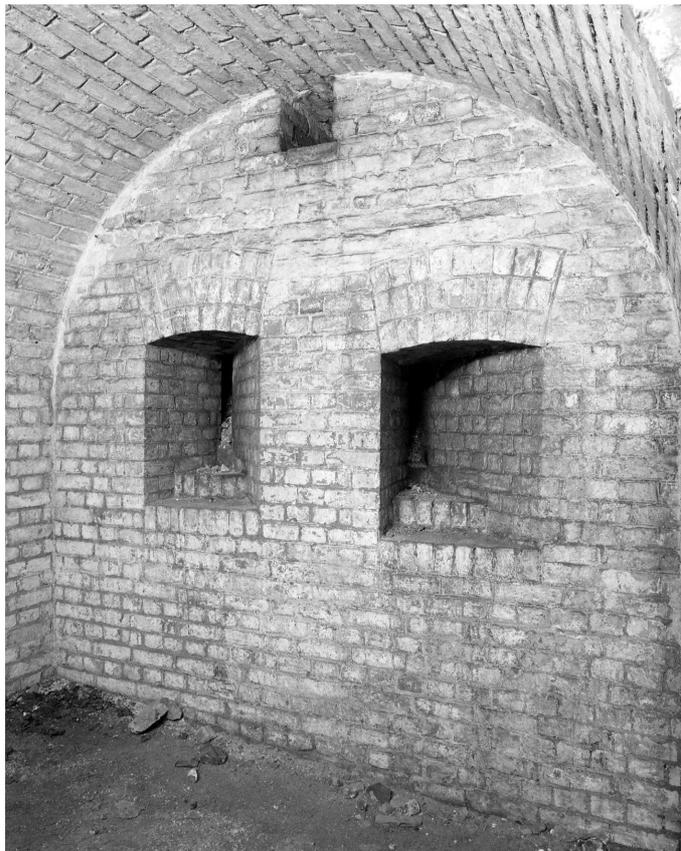
Figure 9
*North Centre Bastion;
photo of the face wall of
a casemate in the
shorter western portion
of the west gallery,
showing two musket
loopholes with angled
splays and a smoke vent
over (NMR: AA008610
© Crown Copyright
1998)*

This was approached down a moderately steep stairway from the *terreplein* but the entrance is sealed. The brick steps have stone treads, with low stone wheeling platforms on the flanks to facilitate hauling of artillery and supplies. The side walls at the head of the stair show no traces of the iron rings through which the hauling ropes passed. At the base of the stair there is a small landing, from which two shorter flights lead west and north respectively. The west flight of three narrow steps leads down into the short western portion of the gallery, comprising four musketry casemates connected by central rectangular openings in the party walls, each with a large rectangular gritstone lintel. The first casemate is slightly smaller because its rear wall is finished, whereas in the remaining three there is unrevetted chalk rock. The front walls are prominently battered and contain two vertical musket loops each, splayed to cover the west ditch northwards to the cross ditch and south *caponier*; the angle of splay becoming more acute westwards (Fig 9).

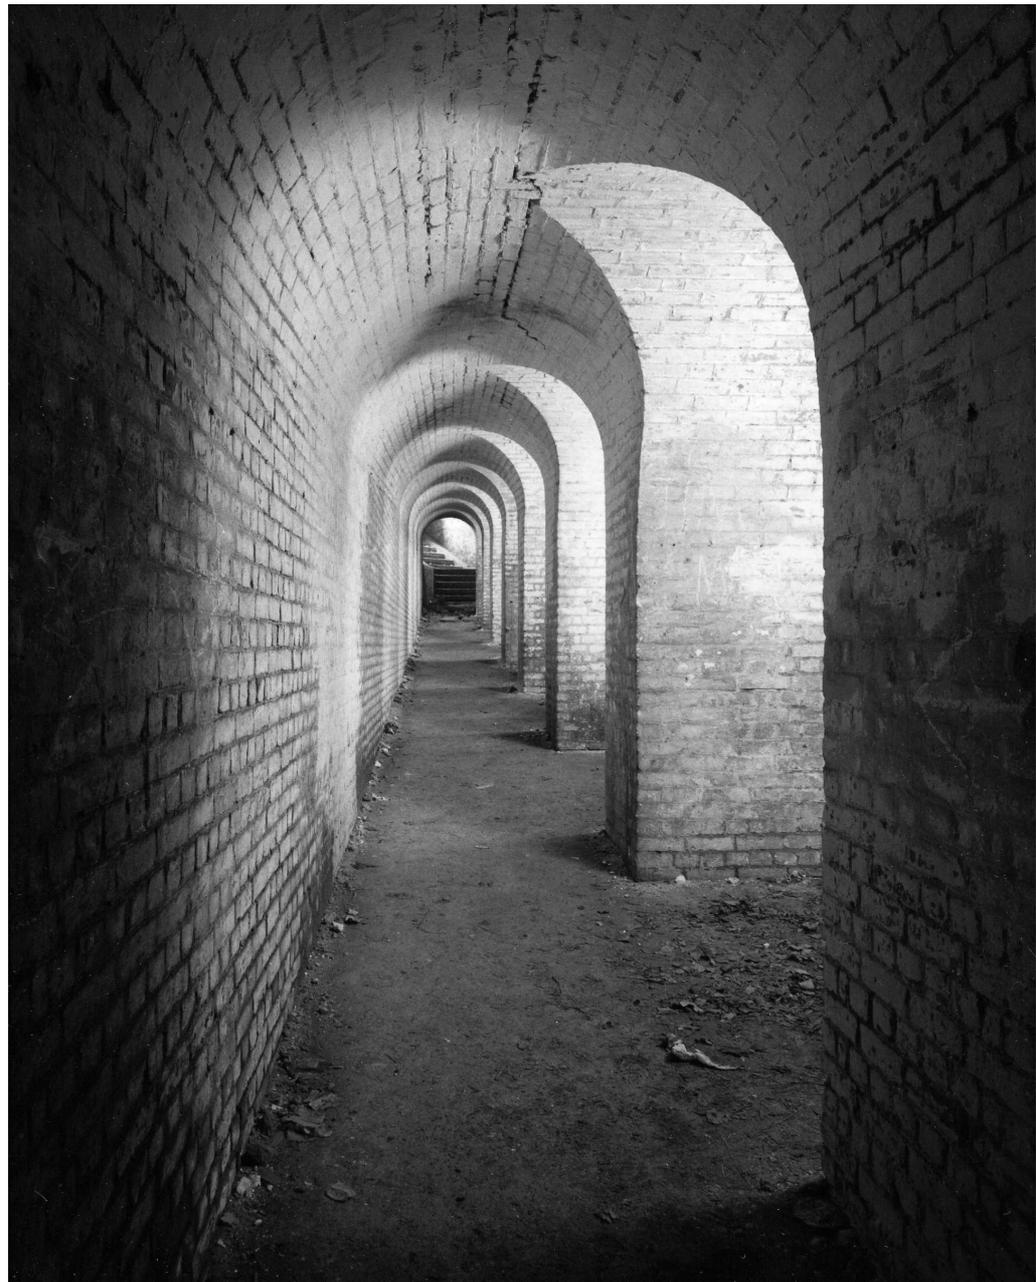
Figure 10
North Centre Bastion;
photo of the main
section of the west
musketry gallery,
looking west. The
musketry positions are
in the bays along the
right of the picture and
the steps to the
terreplein at the far end
(NMR: AA008609 ©
Crown Copyright 1998)

The north flight of five steps has wheeling platforms and descends to the longer section of the west gallery. This has a continuous axial vault along the rear of nine casemates, their individual vaults groined into that of the gallery at 90° (Fig 10). The northern five casemates have single horizontal musket loops that look straight out into the ditch, the remaining four each have a pair of vertical loopholes angled to sweep the ditch of the North Lines as it runs west towards the Citadel.

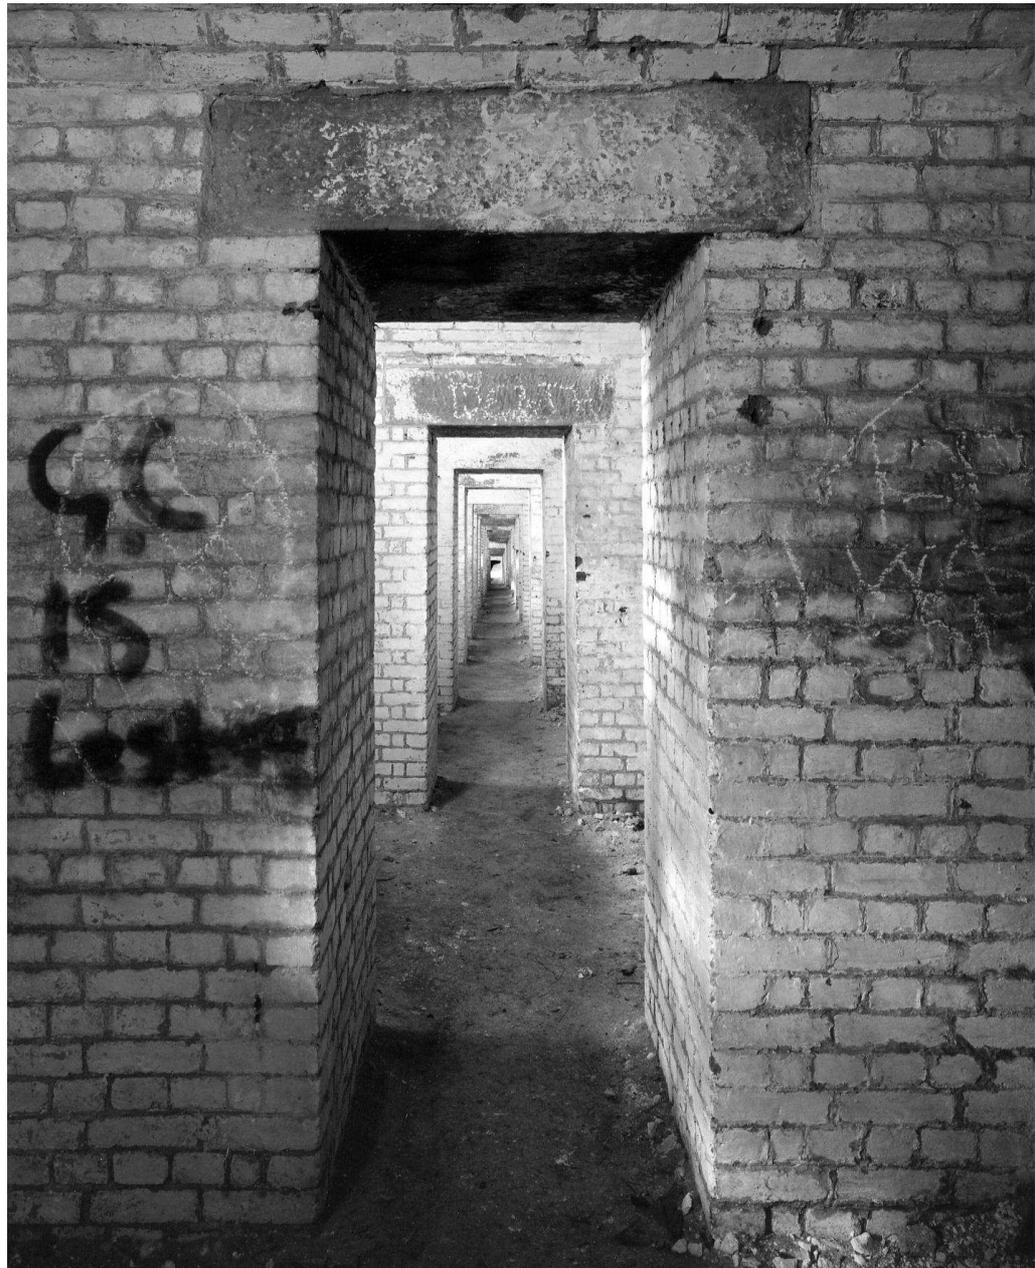
Figure 11
North Centre Bastion;
photo looking east
along the north
musketry gallery,
showing the flat-headed
doorways between the
casemates (NMR:
AA008612 © Crown
Copyright 1998)

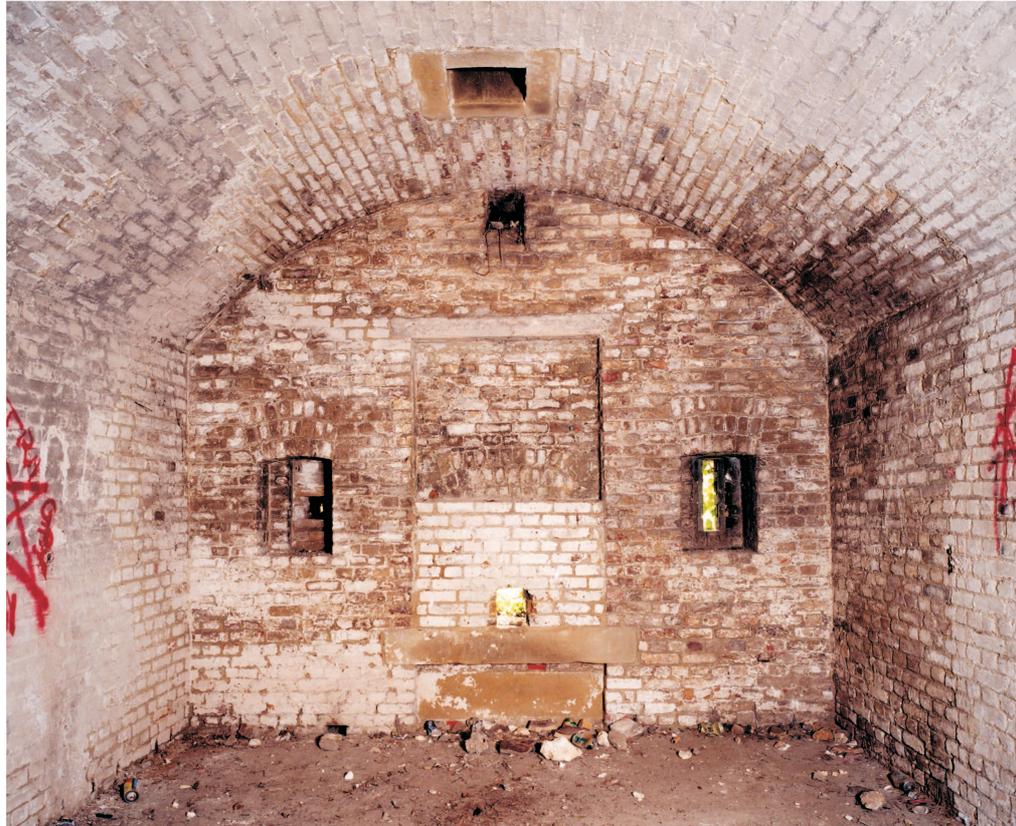
Figure 12
North Centre Bastion;
photo of one of three
gunrooms in the east
gallery, showing the
central carronade
embrasure flanked by
musket loops and smoke
vents in the vault
(NMR: BB 029684 ©
Crown Copyright 1998)

Next is a suite of three large identical gunrooms with stone flag floors (Fig 12). The doorways, towards the rear of the party walls, have flat heads. They have been reduced in

width by brick piers; the straight joints are obvious. These piers support large gritstone lintels, with arched upper surfaces and brick relieving arches over, and may be repairs of 1863. Each gunroom contains one carronade embrasure flanked by two musket loops in the front wall, all blocked. Each embrasure has a semi-circular arched head and a sandstone sill situated in the lower half of a rectangular panel, recessed one brick thickness. The panel itself also has a sandstone sill and lintel and formerly contained a wooden mounting which enabled the gun to be elevated and depressed. Each vault contains a ferrous ring for handling the heavy gun. There are two smoke vents to each casemate, one in the usual place in the front wall and a second, larger one defined by sandstone slabs, in the vault itself. One of the musket loops retains evidence of an iron fitting, comprising a small iron drum rotating in a vertical iron plate, itself anchored into the sandstone loop. The drum has a central circular hole through which the gun muzzle was inserted; the drum traversed by gentle pressure applied with the muzzle, to create an arc of fire in the ditch outside. Basic facilities in each gunroom comprise a ferrous bracket for a wall lamp and, in the rear wall, a fireplace with an iron lintel and a shutter vent over, and a stone lintel above it in the top of the vault. A stove flue, narrowing of the fireplaces and fittings for electric lighting are alterations probably of the 20th century.

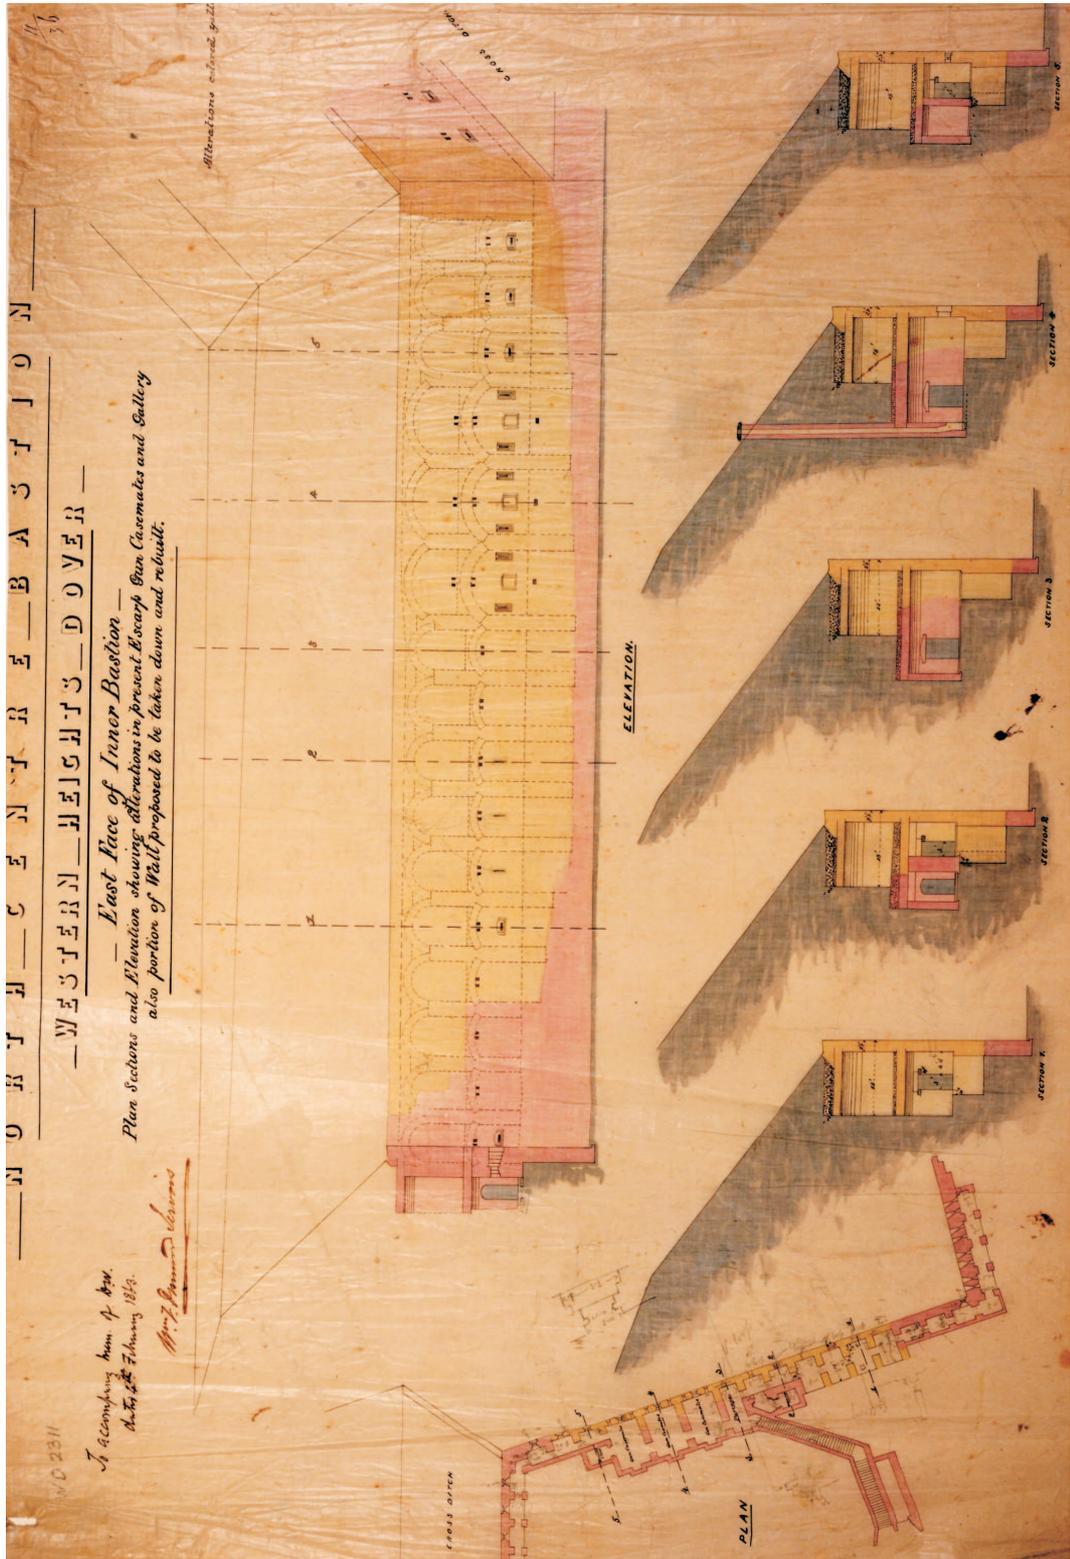
Figure 13
North Centre Bastion; east flank in 1863 (yellow tint shows extent of rebuilding required following structural failure in 1862 (NMR;
WD/2312 © English Heritage)

sequence southward, three musketry casemates, an expense magazine, three gun rooms for carronades, a single musketry casemate with steps up to the *terreplein*, another expense magazine, five musketry casemates, a well passage and nine musketry casemates. This complexity reflects the important role in covering the ditches and bridges on each side of the *tenaille* protecting the North Entrance to the Heights, as well as the east ditch of the bastion itself. It is also this face of the bastion which experienced structural failure leading to the repairs of 1863, involving the rebuilding of some $\frac{3}{4}$ of the scarp revetment and parts of the casemates behind it (Fig 13; NMR: WD/2311; 2312)

- WD/2312 *North Centre Bastion. Western Heights Dover. East Face of Inner Bastion. Plan, Sections and Elevation showing fractures in present Scarp Gun Rooms and Gallery also portion of a Wall proposed to be taken down and rebuilt.*

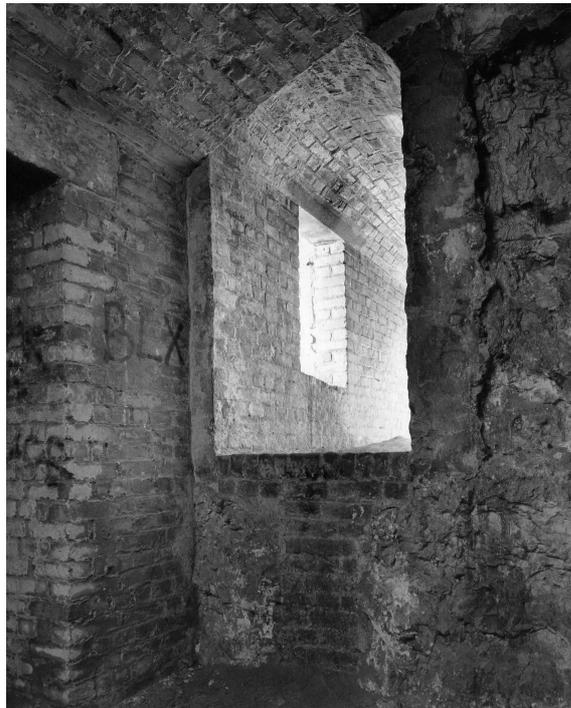
Figure 14
North Centre Bastion;
photo in the east
gallery showing the
entrance to the well
passage at the rear of a
musketry casemate
(NMR: AA008614 ©
Crown Copyright 1998)

The entrance to the well passage is raised 1.0m (3ft 3in) off the gallery floor (Fig 14). It has a semi-circular vault and is cut horizontally for 15.9m (52ft 1in) into chalk bedrock, ending in the circular chamber of **no 1**. The chamber rises to the surface as a brick column

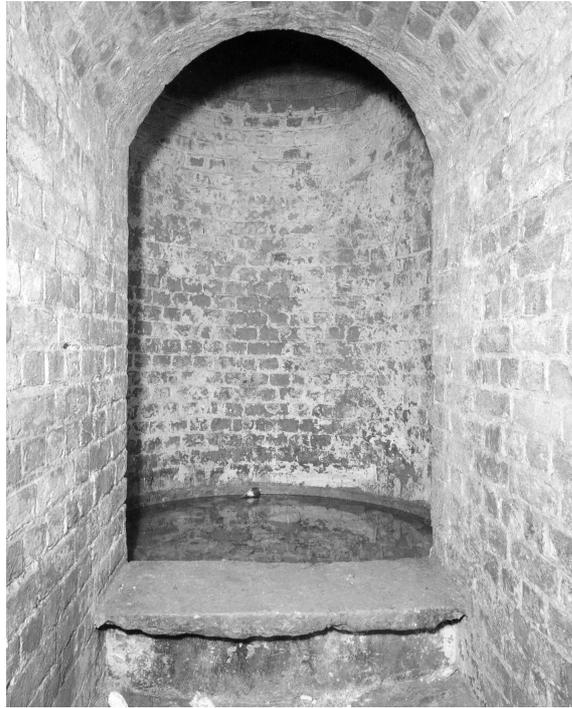
Figure 15
North Centre Bastion;
photo of well no 1, at
the west end of the well
passage (NMR:
AA008616 © Crown
Copyright 1998)

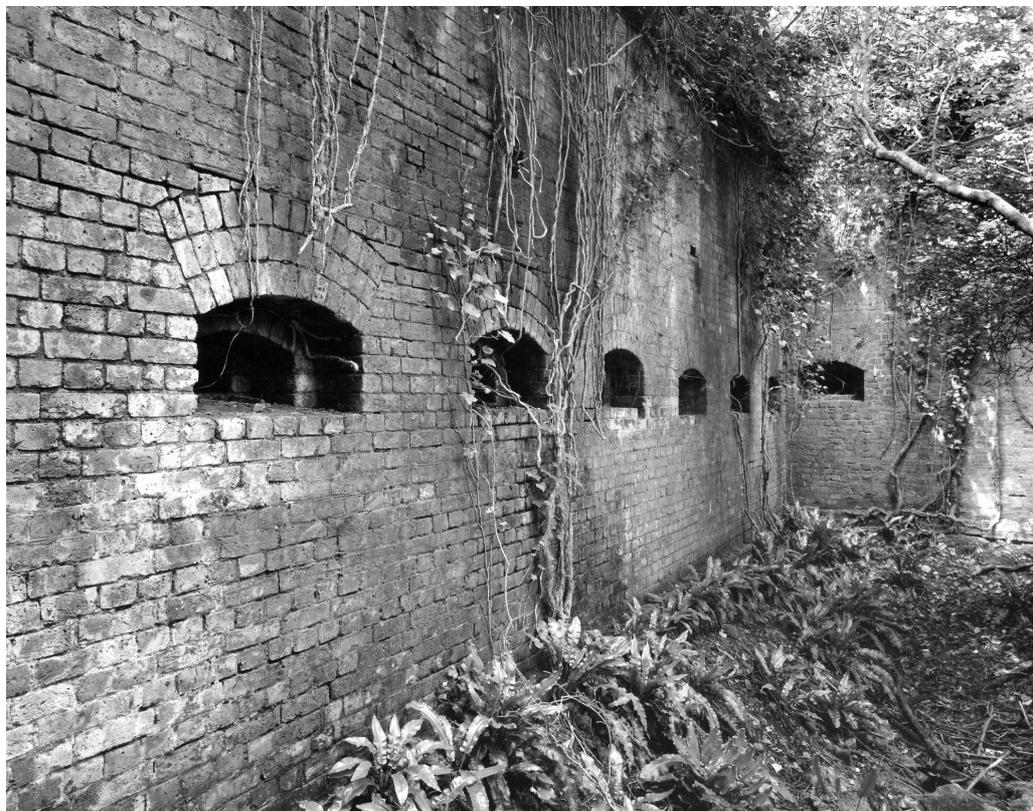
Figure 17
*Detached Bastion;
photo of the south
caponier, east face
exterior, showing
horizontal musket
loopholes (NMR:
AA008604 © Crown
Copyright 1998)*

This *caponier* linked the bastions and gave flanking fire for the cross ditch (Fig 17). It is a plain passage with brick walls, 1.4m thick, and a semi-circular vault. Both sides have musket loops, above which a stone cordon at the top of the external walls gives onto a roof pitched at a very shallow angle. Enemy access to the loops was prevented by drop ditches and strained wire fences on both sides. The eastern drop ditch is some 2.5m (8ft 2in) wide and 0.7m (2ft 3½in) deep, the western one 3.5m (11ft 6in) wide and 1.40m (4ft 6in) deep. Several ferrous fence supports lie abandoned in the ditch bottoms.

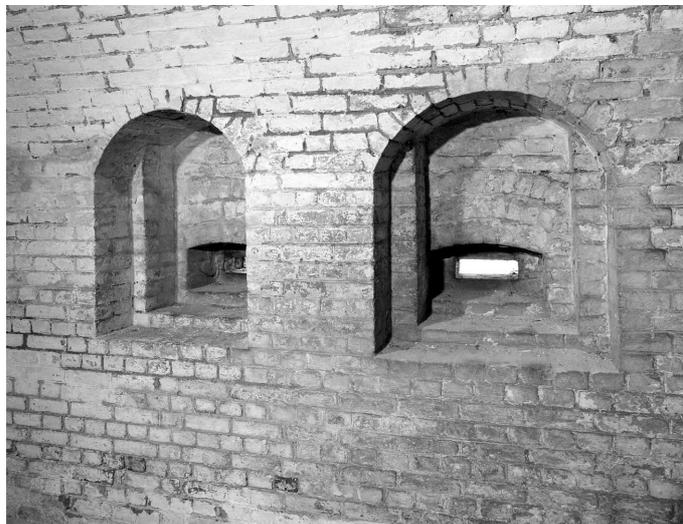
Figure 18
Detached Bastion;
photo of the south
caponier, east face
interior, showing
horizontal musket
loopholes (NMR:
AA008607 © Crown
Copyright 1998)

The east wall of the *caponier* is original and has eight horizontal musket loops, which look straight along the cross ditch between the two bastions; the southern two could be used only with the drawbridge down. The loops have sandstone sills and lintels and internally, they have stepped sides and bases, with segmental arched heads (Figs 18-19a; NMR: WD/2307). Five in the west wall form the alterations proposed in 1862, of which the three northern examples are identical to those on the east wall. The other two are
