**THE WESTERN HEIGHTS,
DOVER, KENT**

REPORT NO 7

NORTH CENTRE AND DETACHED BASTIONS

19TH-CENTURY INFANTRY AND ARTILLERY FORTIFICATIONS

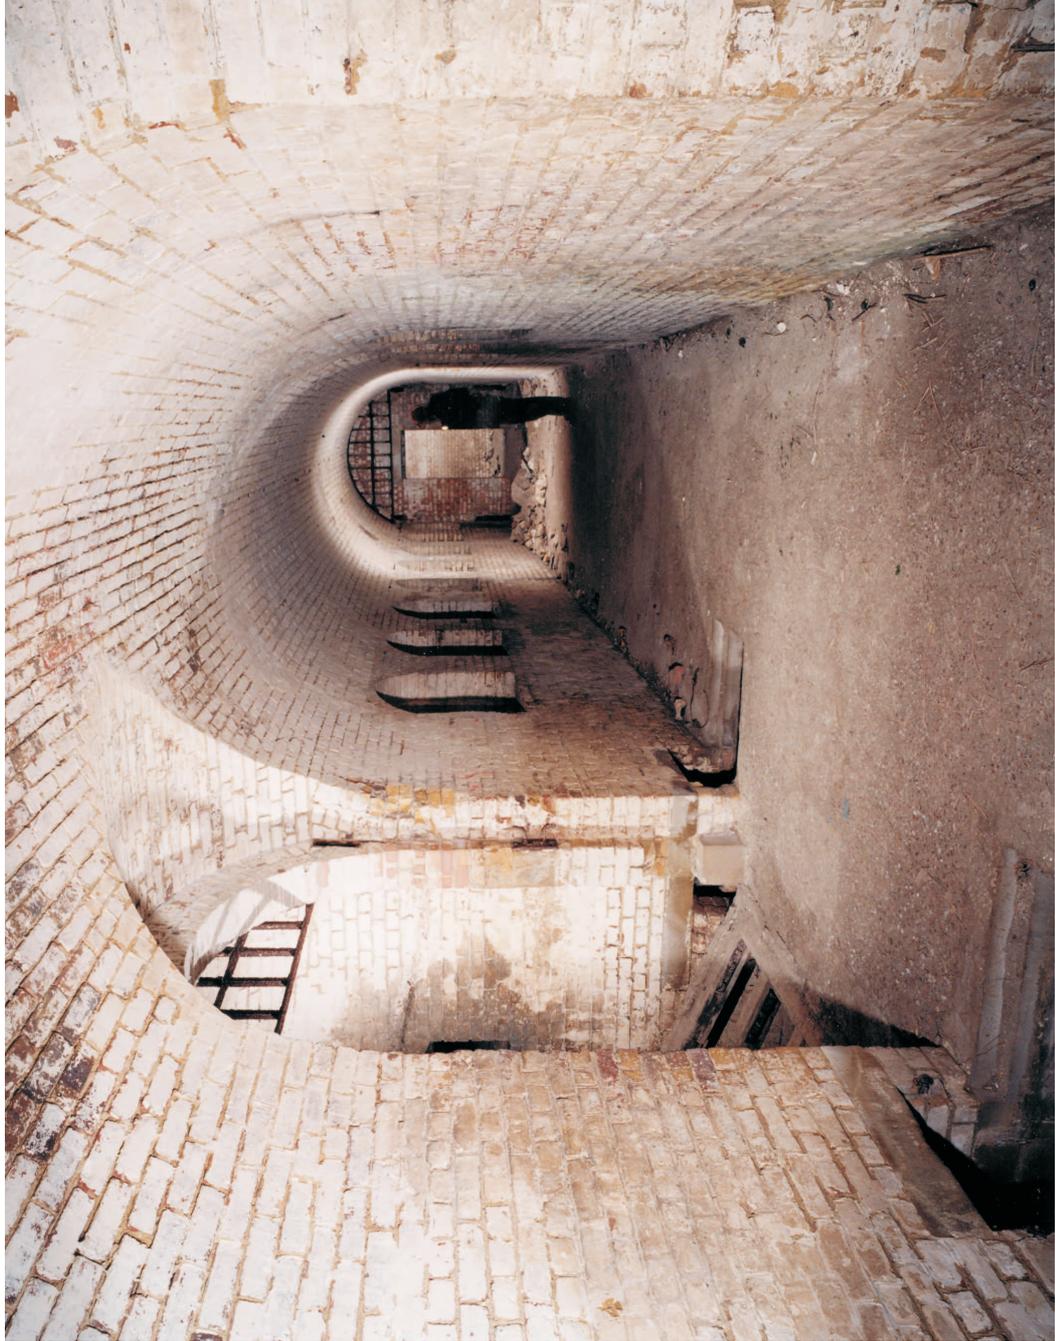
Figure 19a
Detached Bastion; the interior of the south caponier, looking south; at left is the entrance to a ramp leading up to the terreplein (NMR: BB 029680 © English Heritage 2001)

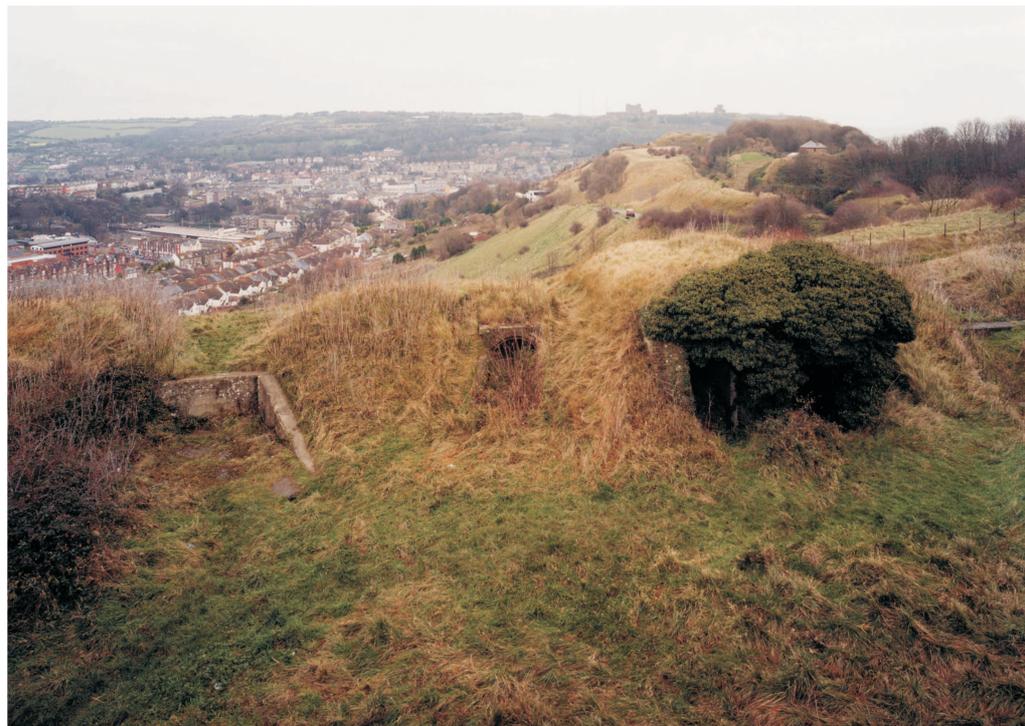
Figure 21
Detached Bastion;
photo of the east
terreplein, showing
emplacement no II (at
left), for 7-inch RBL
gun, c 1890, together
with its shell recess
(centre) and the
entrances to the
artillery store and east
gallery (NMR: BB
029679) © English

There are four identical **gun emplacements** let into the *talus*, **nos I to IV**. Each emplacement is made in concrete with a vertical front wall forming a *barbette* 1.35m (4ft 5in) high and 0.6m (2ft) thick, with flank walls ramped down and splaying to the rear, and a level gun floor (Fig 21). The floors each incorporate two steel racer arcs for guns

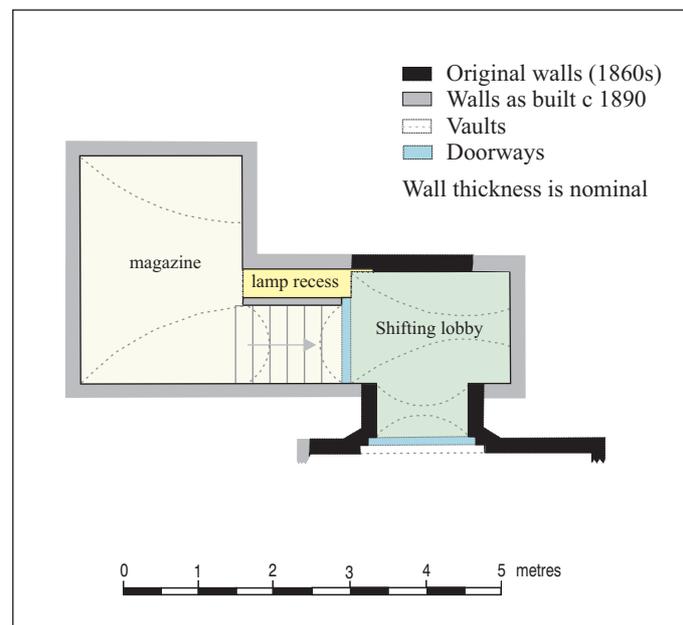
Figure 22
*Detached Bastion;
RCHME plan of the
expense magazine*

The expense magazine is approached along a short **covered way** (Fig 20) from the troop shelter. The structure was radically altered during the 1890s but retains some work of the early 1860s. The original arrangement is shown on a plan of 1882, when it was designated Western Heights Magazine No 13. It comprised two rooms, a shifting lobby and a magazine built in series straight back from the entrance, the whole covered by a bombproof traverse (NMR: WD/2411a). In the 1890s, the original magazine was sealed and replaced by a new sunken magazine, offset to the south and reached from the original shifting lobby, duly modified. The traverse remains largely unaltered.

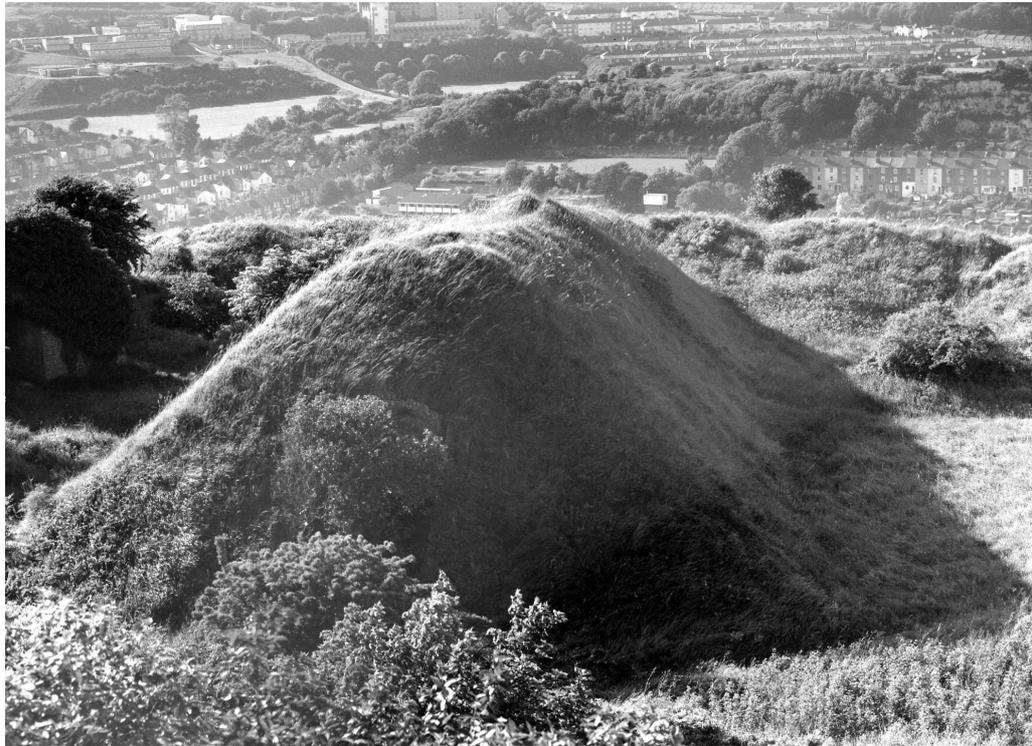
Figure 23
Detached Bastion;
photo of the troop
shelter, from the south
(NMR: AA008624 ©
Crown Copyright 1998)

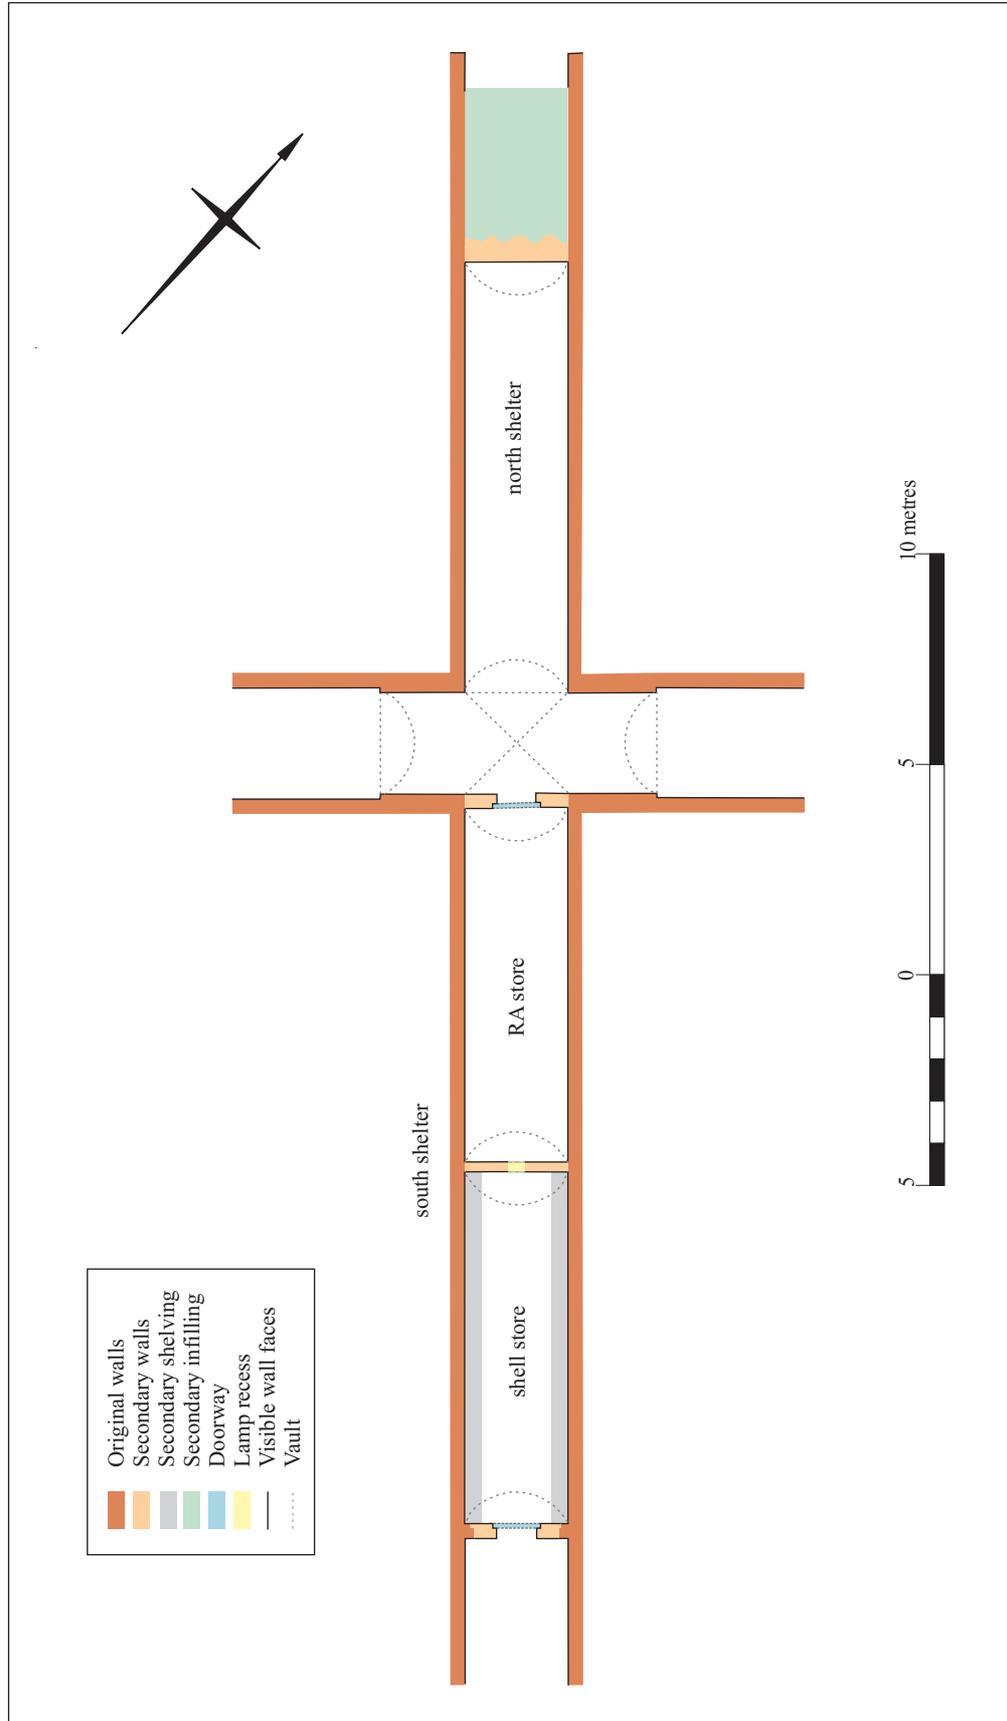
Figure 24: Detached Bastion; RCHME plan of the troop shelter, showing its partial conversion into a shell store and RA store c 1890

The entrance to the shell store is at the south end, recessed into the mound with original flank walls of the 1860s, ramped down to the mound profile. The entrance elevation has a semi-circular arched head, also original, below which the arch is infilled down to a lower, segmental arched entrance for the 1890s shell store. The infill contains a single red ceramic ventilator stamped with 'STANLEY BROS NUNEATON PATENT' - identical

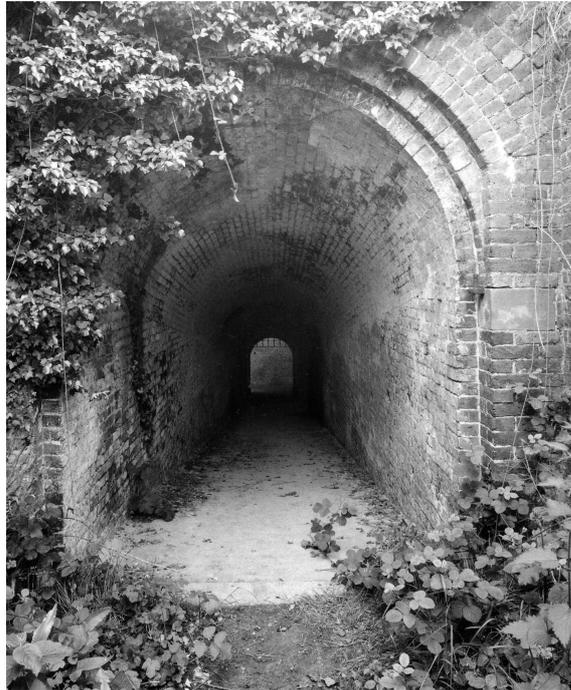
Figure 25
Detached Bastion;
photo of the southern
entrance to the west
musketry gallery from
the terreplein, showing
the typical entrance
arch and, centre right,
a pintle hinge for the
door, in its stone
anchor block (NMR:
AA008628 © Crown
Copyright 1998)

wedge through a hole in the arm. The entrance is of the usual form, the drawbridge ropes passing through iron pulleys set in stone blocks at the springing of the arch and secured on ferrous tiebacks halfway down the arch in the gallery. The gap between the square head of the bridge and the vault is taken up by an iron grille.

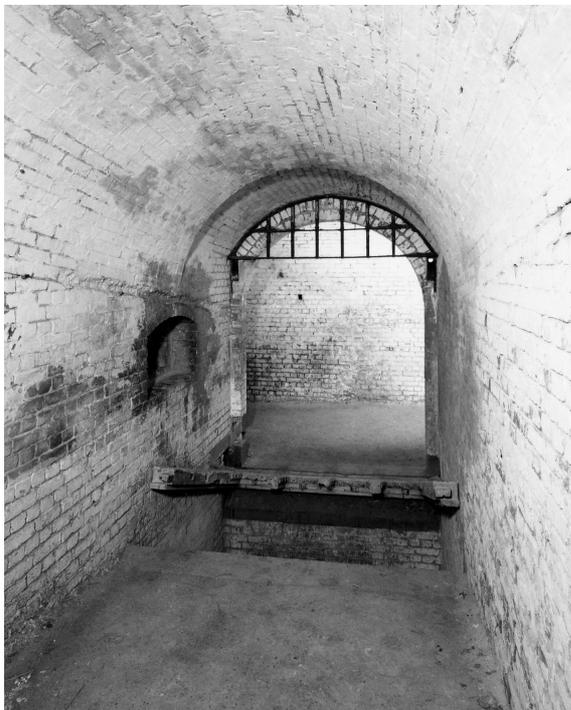
Figure 26
Detached Bastion::
photo of the drop pit
and lifting bridge at the
end of the southern
entrance to the west
musketry gallery from
the terreplein(NMR:
AA008629 © Crown
Copyright 1998)

These bridges enabled troops to seal the west gallery if the *terreplein* was taken by escalade. If so, the ditches

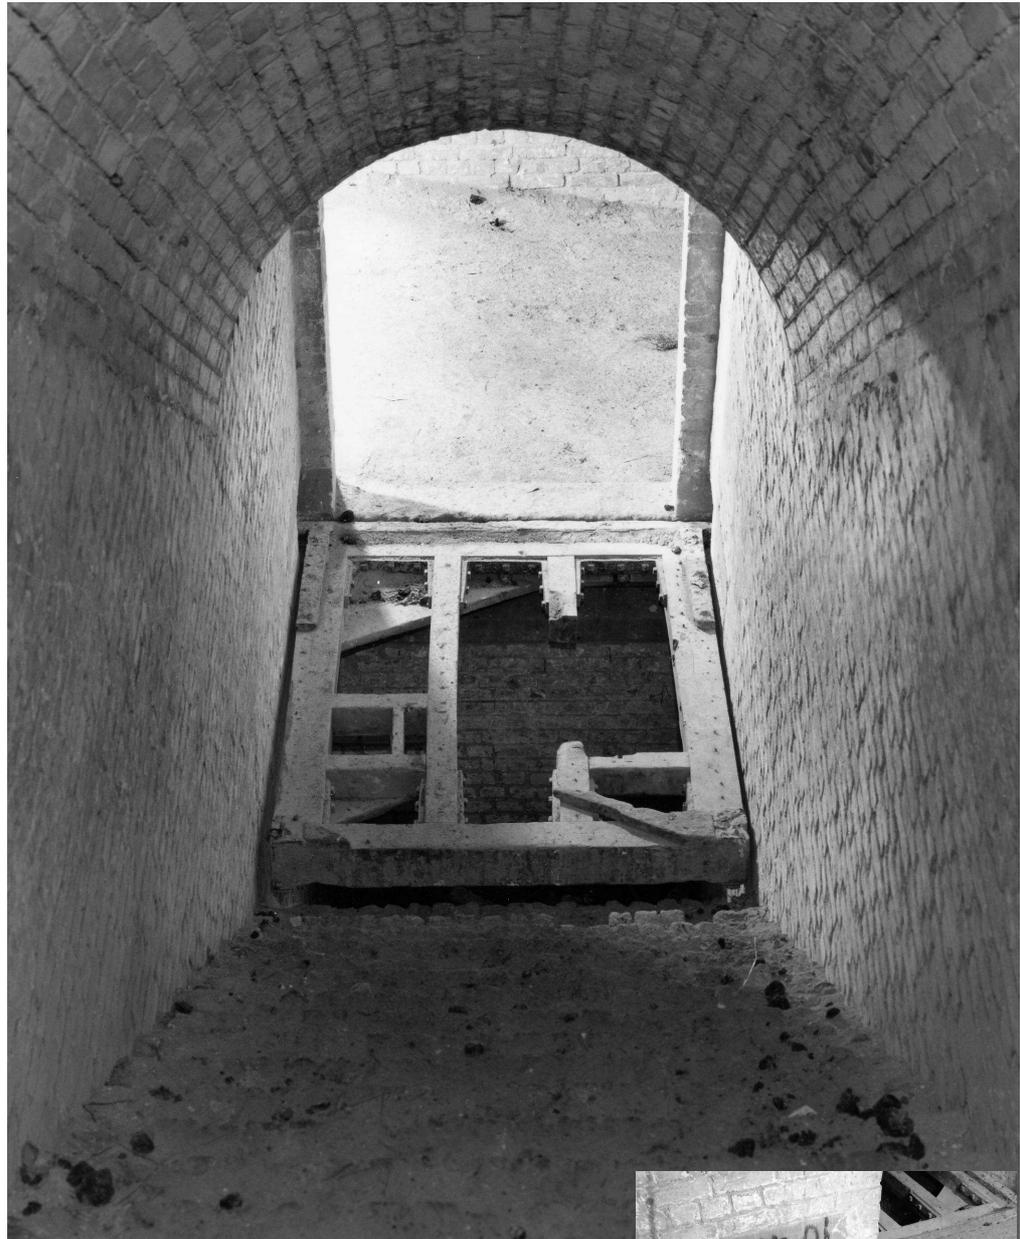
Figure 28
Detached Bastion; photo of the drawbridge guarding the northern entrance to the west musketry gallery, at the base of the passage from the terreplein (NMR: AA008632 © Crown Copyright

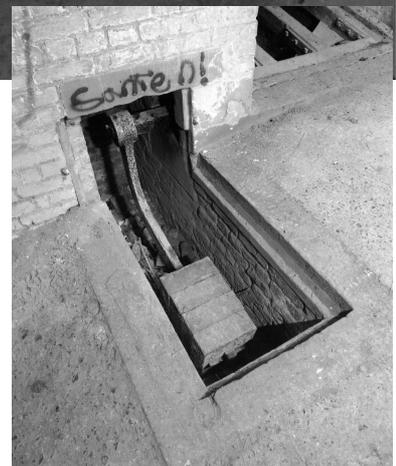
Figure 27
Detached Bastion; photo of the counterweights for the drawbridge guarding the southern entrance to the west musketry gallery from the terreplein (NMR: AA008633 © Crown Copyright 1998)

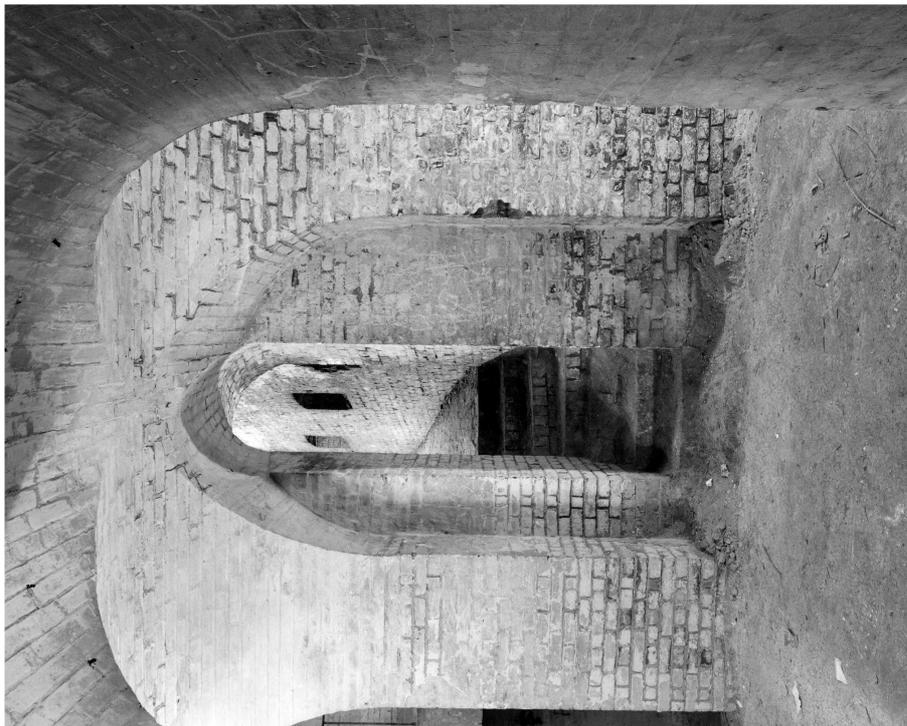
Figure 31: Detached Bastion; photo of the entrance to the west musketry gallery upper floor, viewed from the rear of the north-west caponier, showing elaborate brick vaulting (NMR: AA008636 © Crown Copyright 1998)

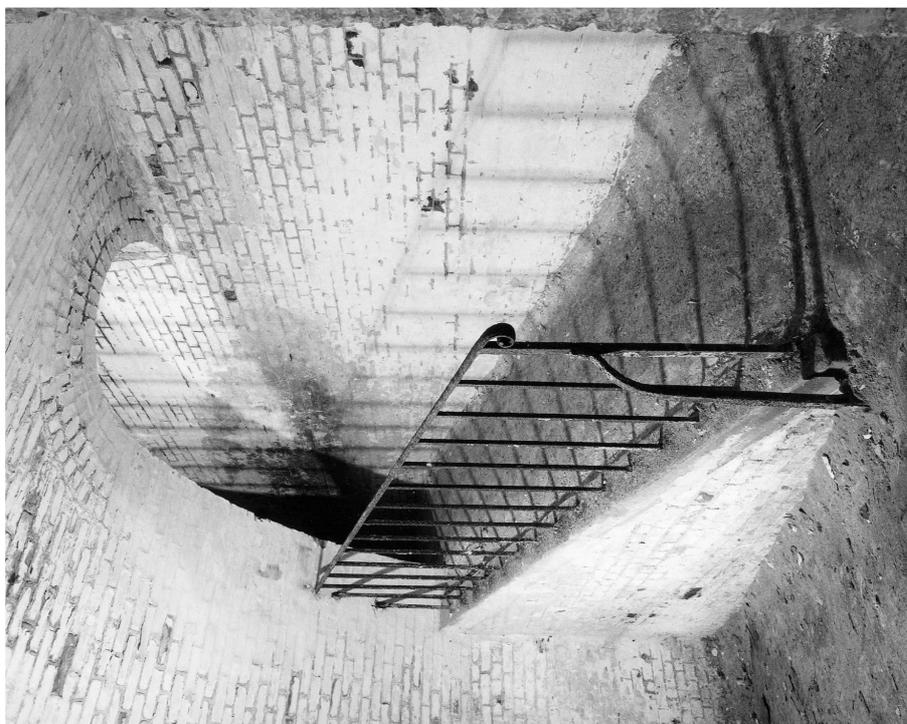
Figure 30: Detached Bastion; photo of the ramp between the lower and upper floors of the west musketry gallery (NMR AA008635 © Crown Copyright 1998)

down a moderate incline, through semi-circular arches in the centre of the party walls. Only the top casemate has a rear wall finished in brick; the others have bare chalk on which are several relief carvings of faces and figures, of unknown date (Fig 29). The first nine casemates have two horizontal loops each, looking straight out into the west ditch, while the last three casemates have three vertical loops each. The eighth casemate gives access to the *terreplein* and the last one to the first floors of the north-west *caponier* and west gallery via a ramp, guarded by a wrought iron handrail in a stone base (Fig 30).

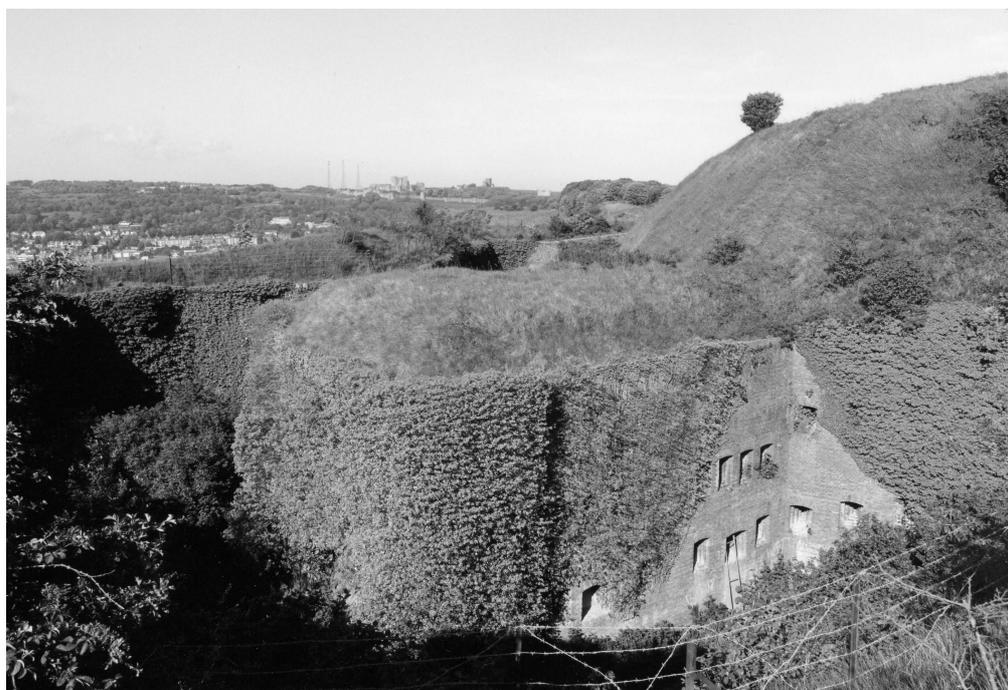
Figure 32
*Detached Bastion;
external view of the NW
caponier, from the west,
showing musket loops
and carronade
embrasures (NMR:
AA008621 © Crown
Copyright 1998)*

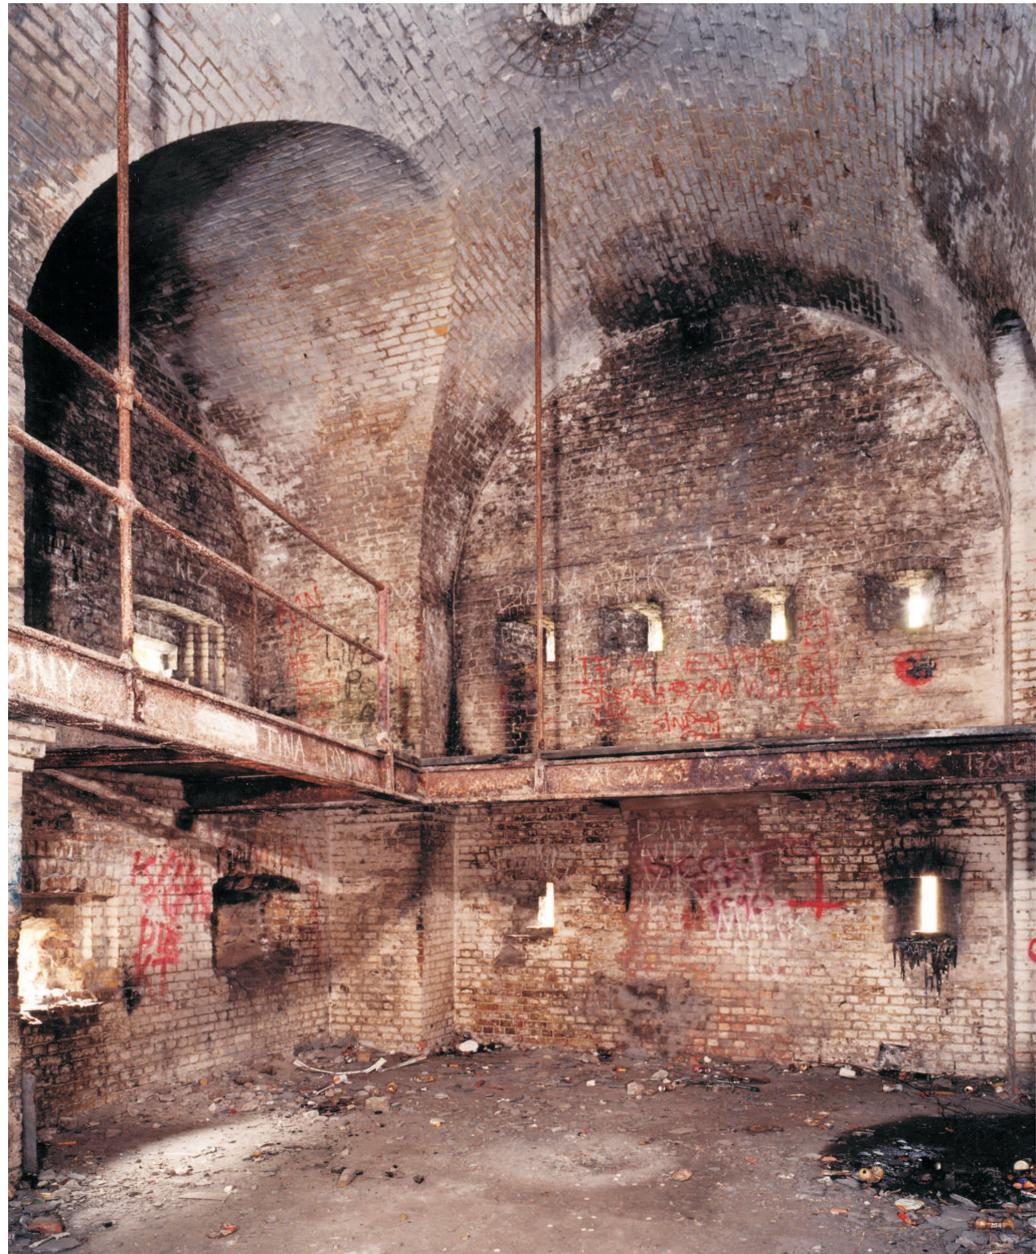
Figure 33
Detached Bastion:
photo showing the
interior of the NW
caponier, from the west
(NMR: BB 029681 ©
English Heritage 2001)

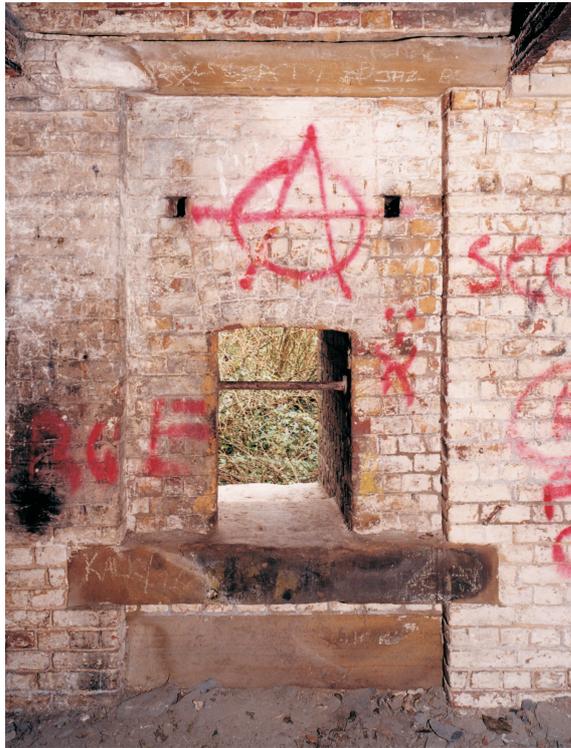
Figure 34
Detached Bastion; a carronade embrasure and mounting in the west flank wall of the north-west caponier (NMR: BB 029682 © English Heritage 2001)

The embrasure in the east flank wall has been adapted to form a doorway, the brickwork crudely broken out below the original level. This mirrors a similar occurrence in the *caponiers* at the Drop Redoubt which for the short period *c* 1893 -9 were in use to provide troop accommodation (Brown *et al* 2001). There is no documentary record of such a use here but it remains a possibility.

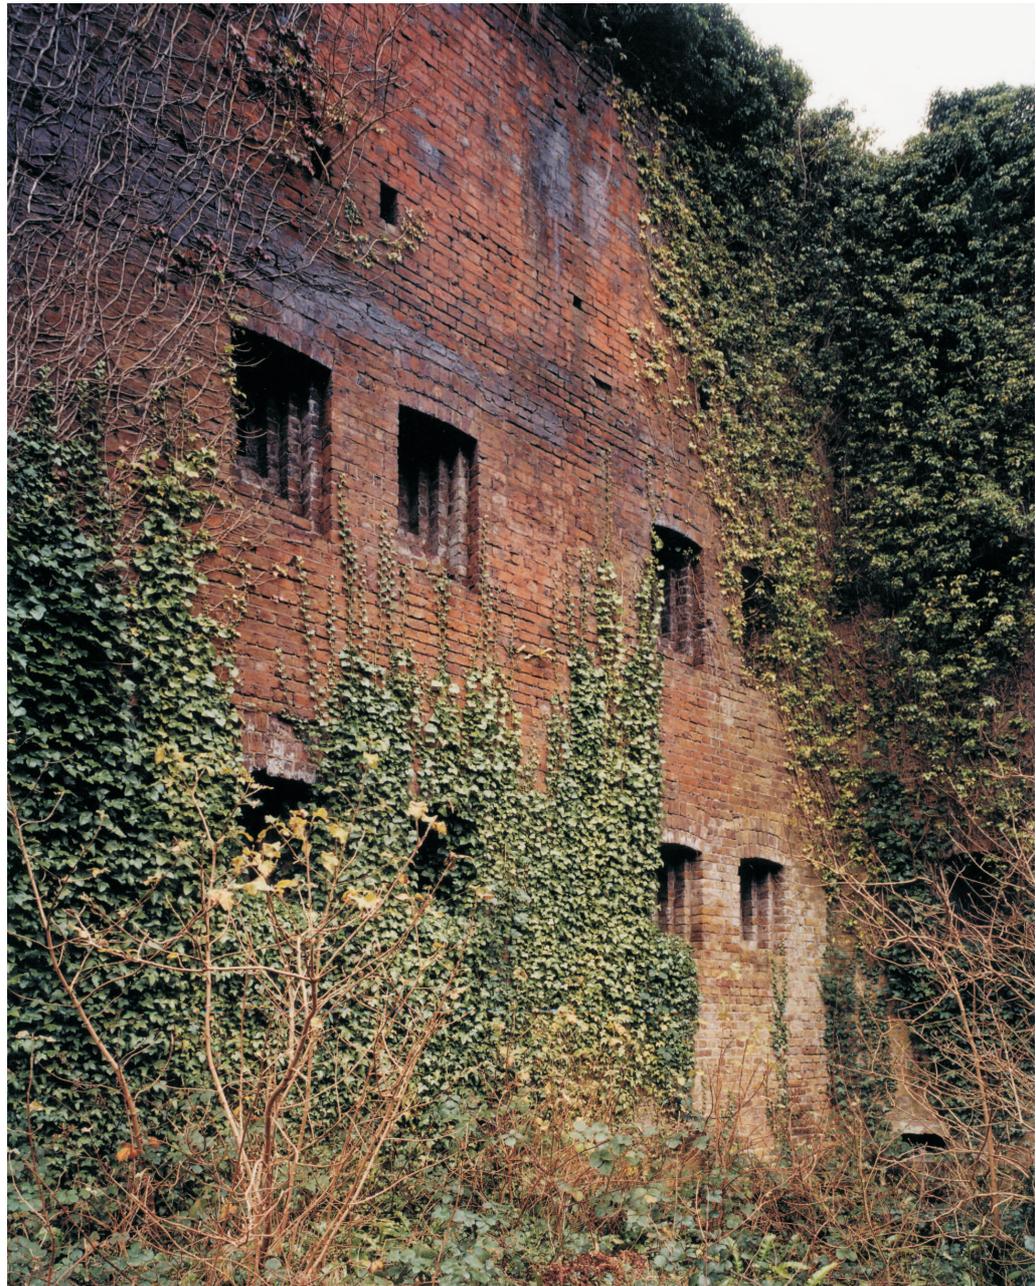
Figure 35
Detached Bastion;
musket loopholes of the
north musketry gallery,
seen from the north
ditch of the bastion
(NMR: BB 029678 ©
English Heritage 2001)
