THE WESTERN HEIGHTS DOVER, KENT

Report No 9: South Front Barracks
Later 19th and 20th-century barracks complex

SOUTH FRONT BARRACKS

19TH AND 20TH-CENTURY INFANTRY BARRACKS

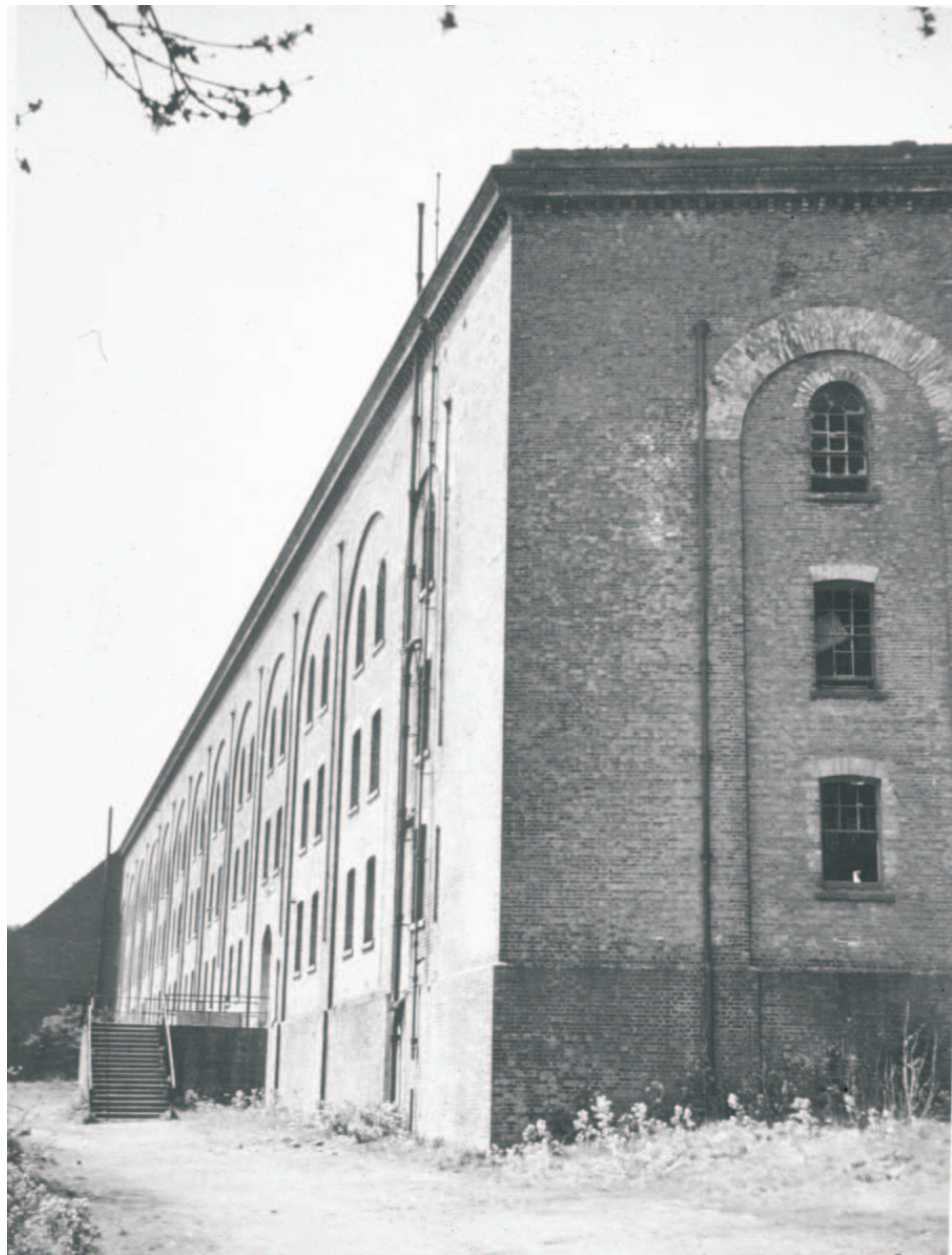
*The Casemated Barracks at South Front c 1958;
looking south-west along the south-east elevation,
within the ditch of the defensive Line (© Dover
Museum, ref D07880)*

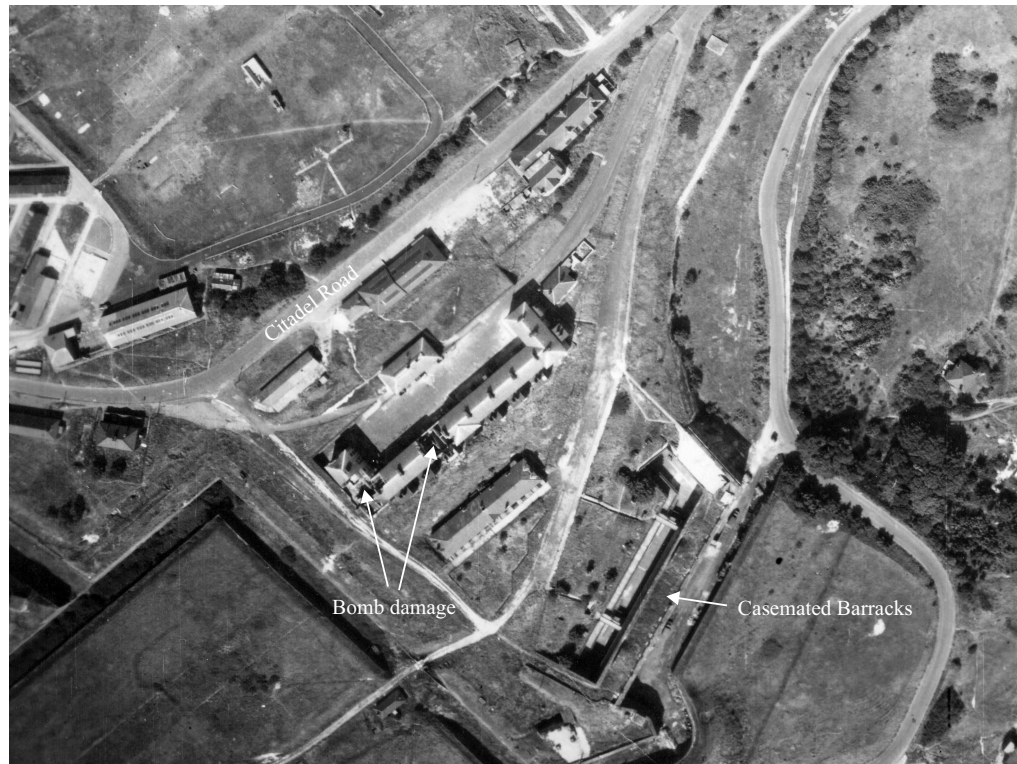
Figure 3
*South Front Barracks,
as seen from the air in
1945. Text in white is
added by the authors
(extract of NMR:
106G/UK/610/6362, by
kind permission of the
MOD)*

The Married Quarters were damaged during the Second World War (Fig 3).

Aerial photographs reveal that it had a gabled roof (Fig 3). Nothing now remains above ground although the site is not built over.

Aerial photographs show that this building had skylights in both slopes of the roof - still identifiable by the darker slates used to fill them in - suggesting that it might have been used as a garage for the light repair of military vehicles (Fig 3).

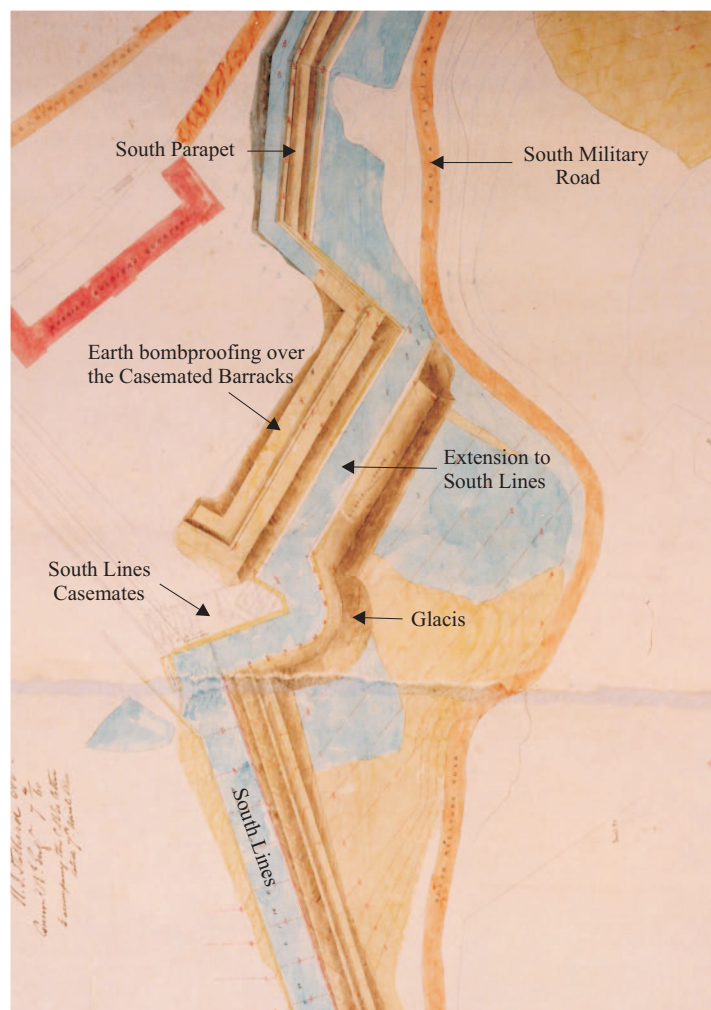
Figure 4
Plan showing initial proposals for a new South Front to the Western Heights, dated 1860. Blue and yellow represent cut and fill respectively. North is at the top of the drawing, while text in black is added by the authors (extract of PRO: MR/1/1300 © The Public Record Office)

An important element of the 1860s work involved re-designing the south-western approach to the Western Heights, including the provision of a new defensible entrance higher up the ridge than the original south entrance (See Brown and Williams 2001). A proposal plan of 1860 shows the new design (Fig 4). The approach would be closed by a new defensive line, running north-east, above the South Military Road, from the South Lines Casemates, then turning south-east to the cliff face above the harbour. The road would cross the last stretch on a drawbridge, through a gatehouse, into the fortress. The chalk face above the road would be cut back and surmounted by a new rampart, South Parapet, and spoil used to grade the ground to the south, so that it could be commanded by firing positions on the new line. Much of this proposal *was* carried out (Fig 5).

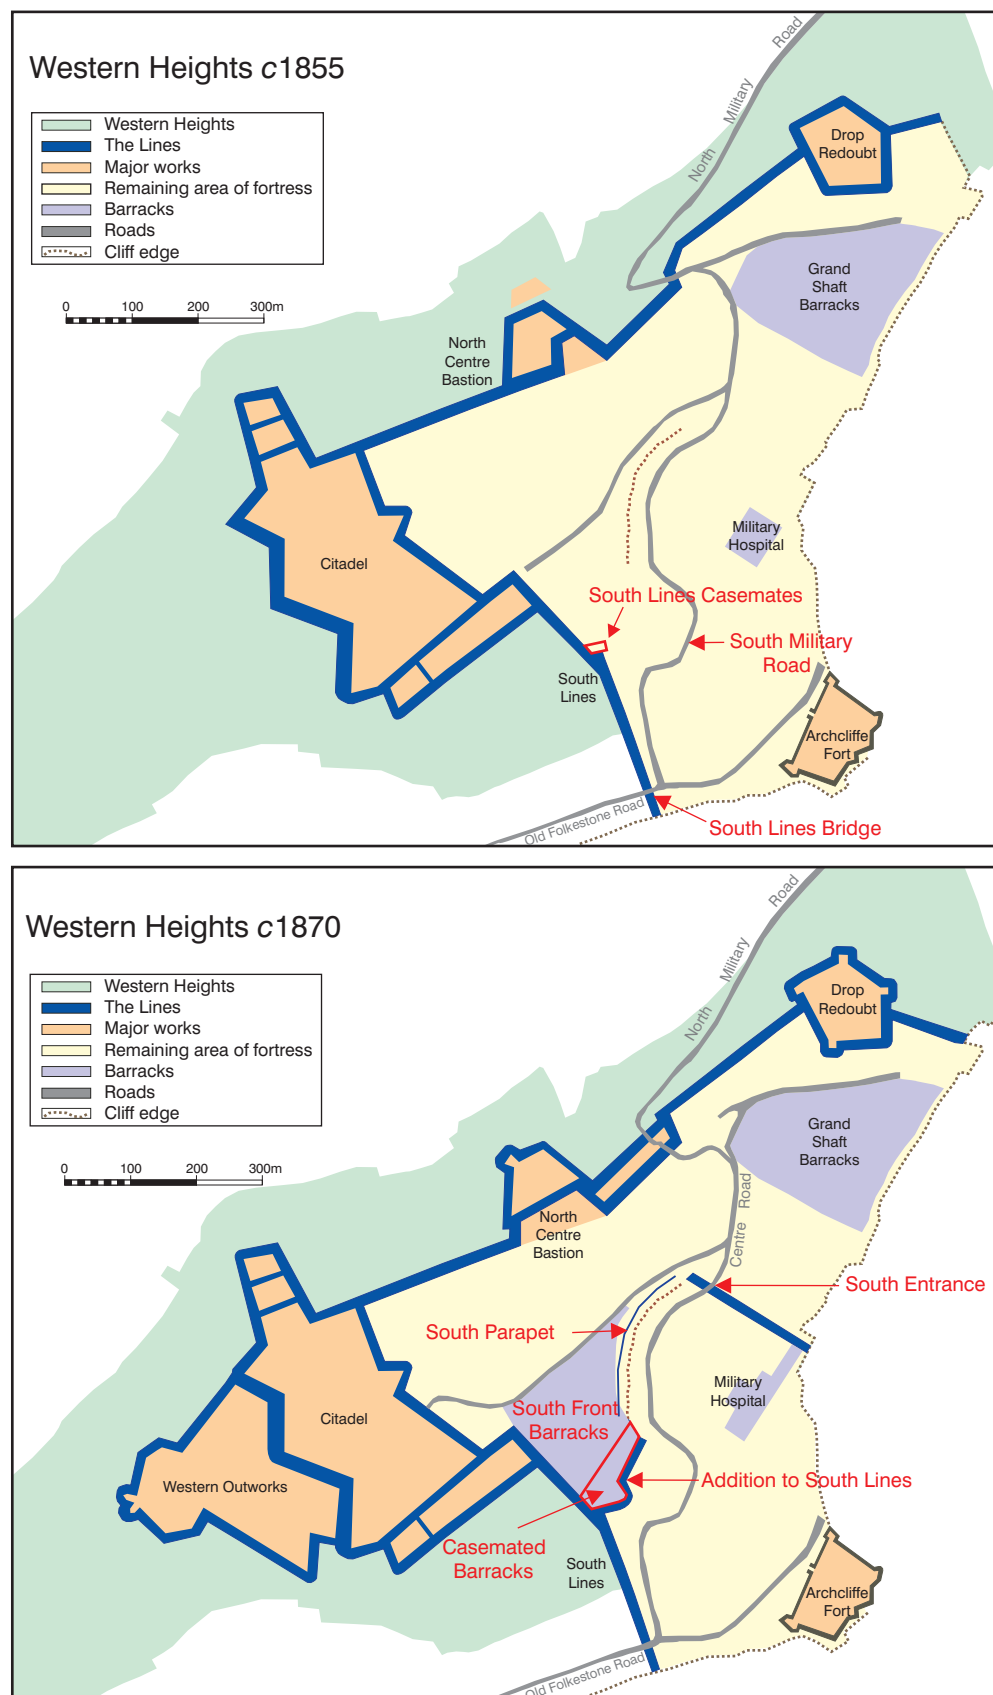
Figure 5
Plans of the Western Heights before (above) and after (below) completion of the new South Entrance and South Front Barracks, c 1855 and 1870 respectively

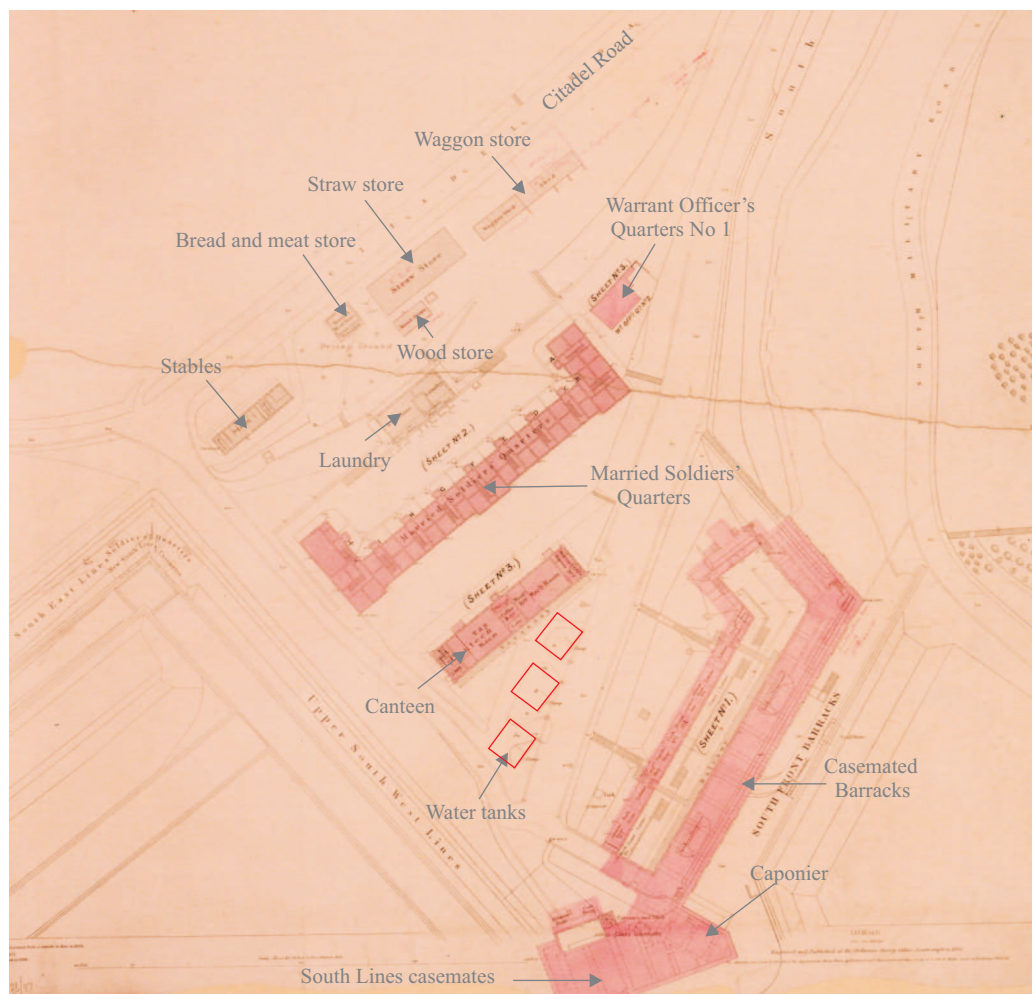
Figure 6
Plan of South Front Barracks, dated 1897.
Text in grey and the water tanks, emphasised in red, are added by the authors (extract of PRO: WO/78/2426/2 © The Public Record Office)

In 1871, the other buildings of the complex stood on terraces north-west of the Casemated Barracks up to and along Citadel Road. These comprised a Canteen and Recreation building (1st terrace); Married Soldiers' Quarters (2nd terrace), a Laundry (3rd terrace) and Stables and a Bread and Meat Store (Citadel Road)(PRO: WO/28.2755/9). By 1897 a Warrant Officer's Quarters had been added on the 2nd terrace, while a Straw Store, Wood Store and Waggon Store had been added on Citadel Road (Fig 6). By 1903, changes on

Built after 1871, only the rectangular outline of these two buildings is shown on the 1897 plan and their depiction suggest a wooden construction (PRO: WO/78/2755/9; Fig 6). By 1903 the Wood Store had been removed and the Straw Store replaced, or perhaps converted into a Troop Stable and Store for Mobilization Equipment and Vehicles (see below).

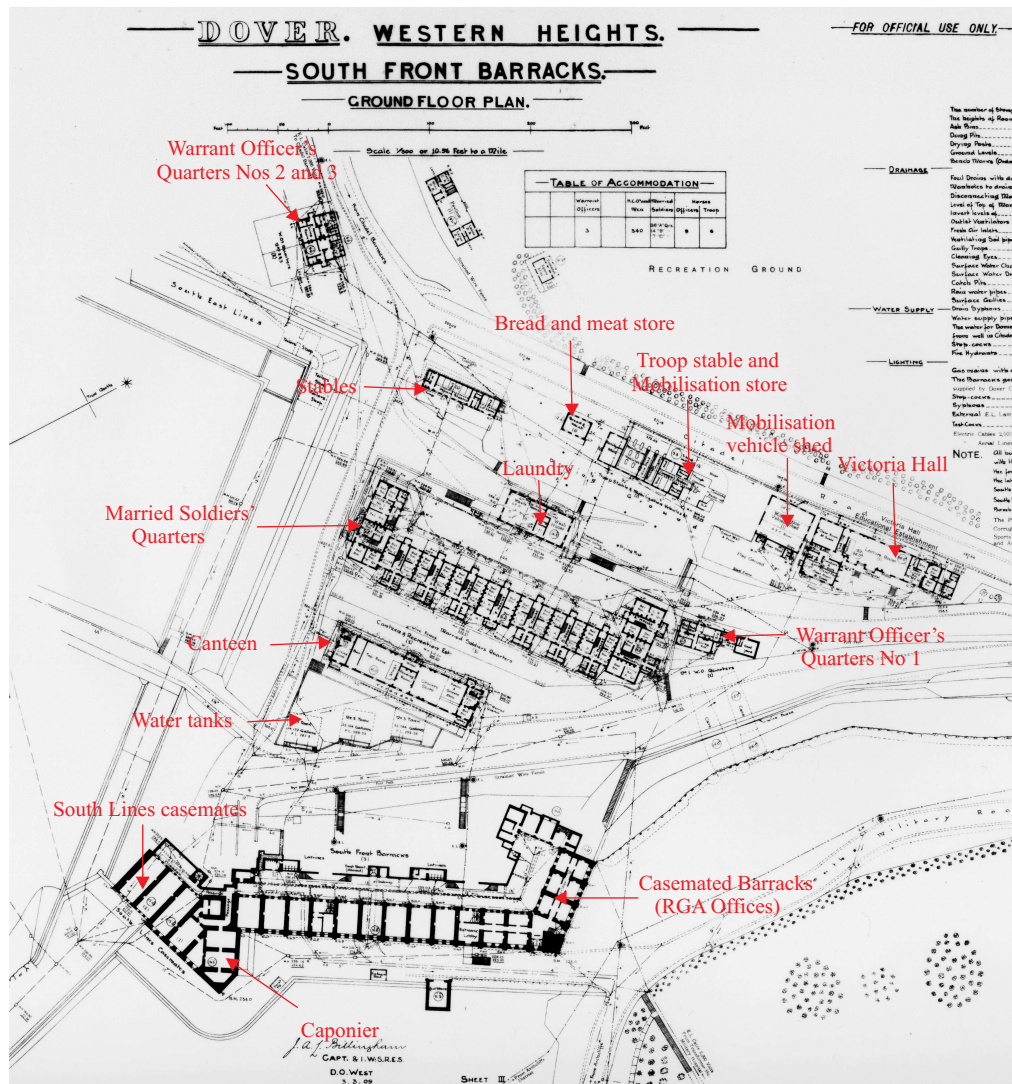
Figure 7
Plan of South Front Barracks in 1927. Text in red is added by the authors (extract of NMR: WD (1927a))

bedroom connected by new doorways in the party walls, with a scullery and WC contained in new structures projecting from the south-east elevation (Fig 7). In the wings, there were similar groupings of rooms, including three- and four-room apartments for the NCOs, also with new sculleries and WCs (known as 'B' and 'C' type quarters). The old communal lavatories were disused and the school for infants was no longer here; a new school had been built near Grand Shaft Barracks. A table reveals that the overall accommodation in 1927 was for 57 men and their families, of which 21 were NCOs.

A detached house for a Warrant Officer formerly stood just to the north-east of the Married Quarters (Fig 7), having been built at some time between 1871 and 1897 (PRO: WO/78/2755/9; WO/78/2426/3). It was named No 2 in 1896 but re-designated no 1 by 1903, following the construction of quarters for two more warrant officers on Citadel Road shortly before 1900 (see below) (PRO: WO/78/2426/3; NMR: WD/2320; WD/231). As built, it was a bungalow with a central through passage incorporating a lobby. Three bedrooms were located on the south-west side of the passage, with a scullery, kitchen and living room on the other side. A yard with WC, ash tub and coal store adjoined on the north-east. Although the house has been demolished, subsidence of ground in the garden of a modern semi-detached house on the site has revealed what might be its foundations.

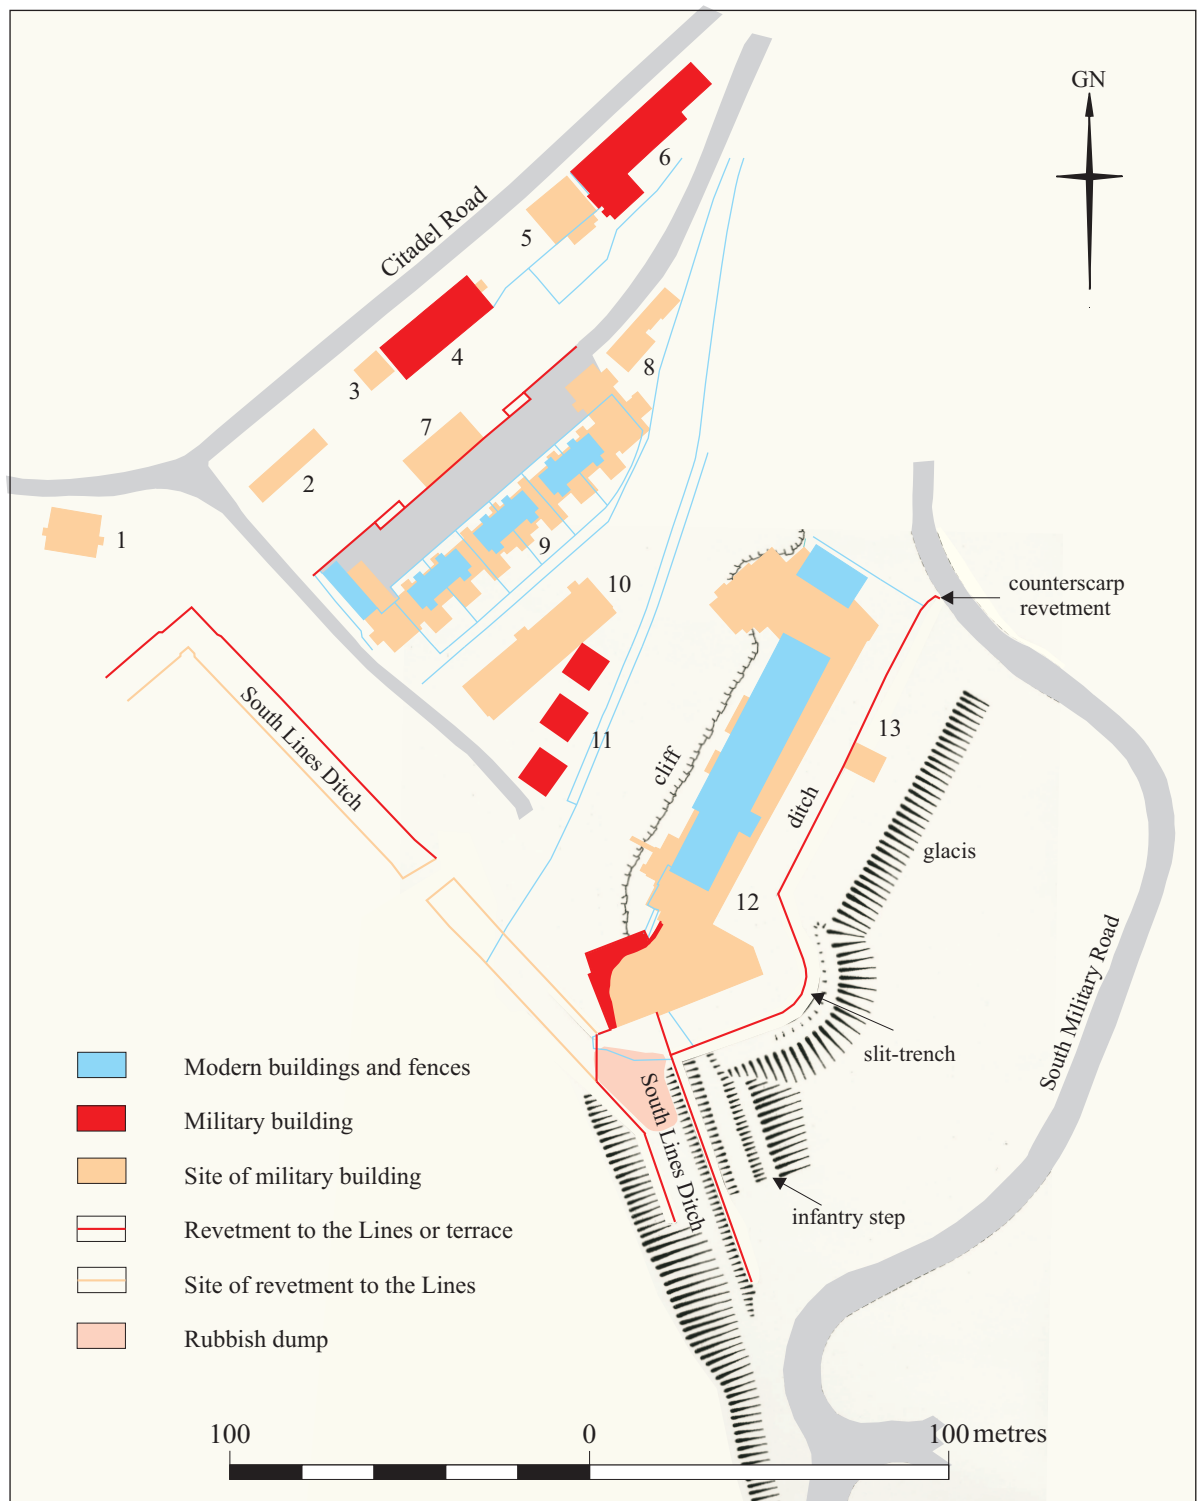
Figure 8

Plan showing surviving elements of South Front Barracks, with the location of demolished buildings from the plan of 1927

In the following description, for words and letters in **bold**, refer to figure 8.

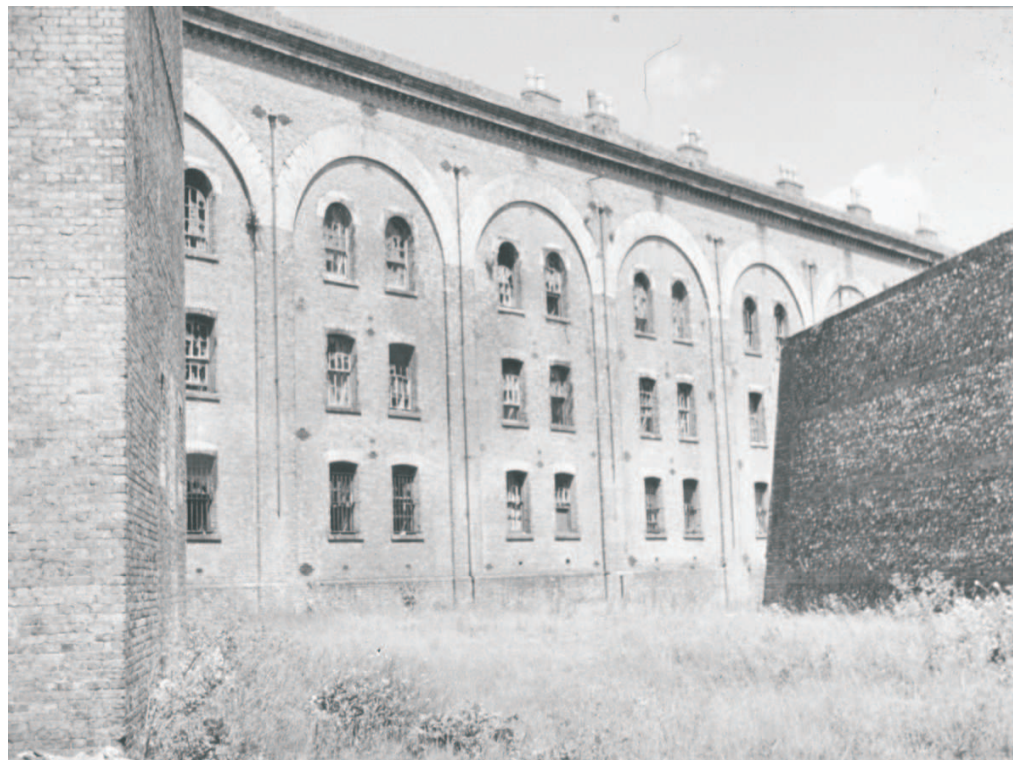
Figure 9
The Casemated Barracks, a photo of the south-east elevation from the ditch, with the edge of the caponier at extreme left. Taken c1958 (© Dover Museum, ref D07879)

The Casemated Barracks were built inside the fortress against the new Line, with the south-east elevation also forming the revetment to the scarp of the ditch (Fig 9). A steep *glacis* beyond the counterscarp of the ditch provided protection for the *caponier* and barracks against bombardment from the south-east.

This, the principal barrack, was a three-storey casemated range forming a truncated L-shape abutting the gun rooms of the extended South Lines Casemates. These gunrooms continued to cover the South Lines Ditch, while the extension formed a *caponier* which projected into the ditch of the new Line, thereby providing flanking fire along the barracks, whose south-east elevation formed the escarp of the ditch (Fig 9).

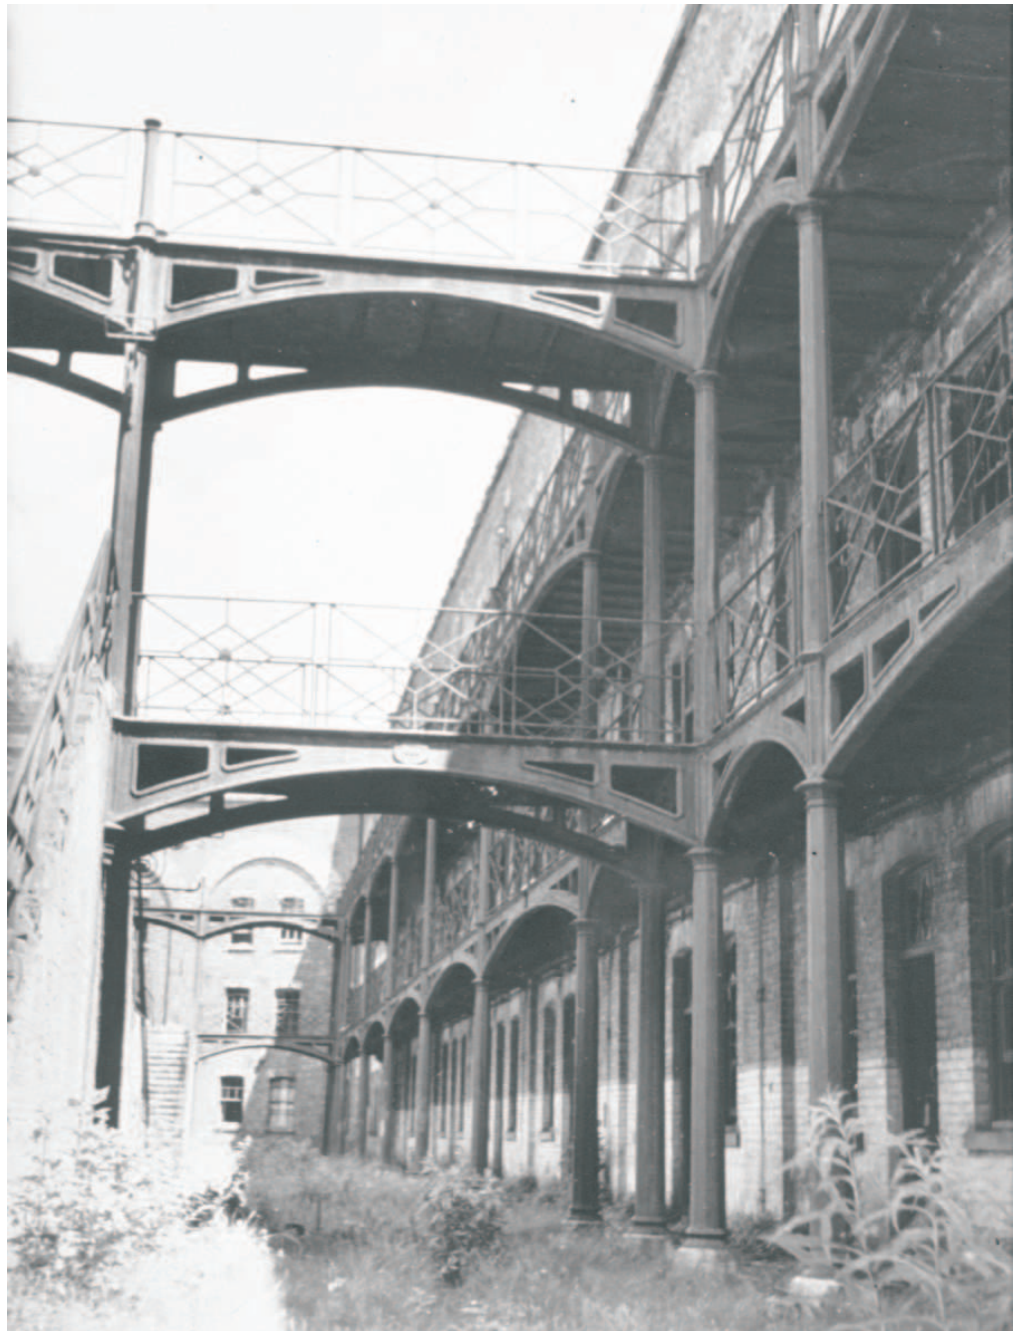
Figure 10
The Casemated Barracks, a photo of the gorge, looking north-east, showing the elaborate iron verandas and bridges allowing communications along and between the ranges. Taken c1958 (© Dover Museum, ref D07875)

(cover; Fig 10). The casemates of the north-west range were built into the chalk bedrock which had been stepped so that terraces could be left for lateral communication, each terrace partially over the casemates of the floor below.

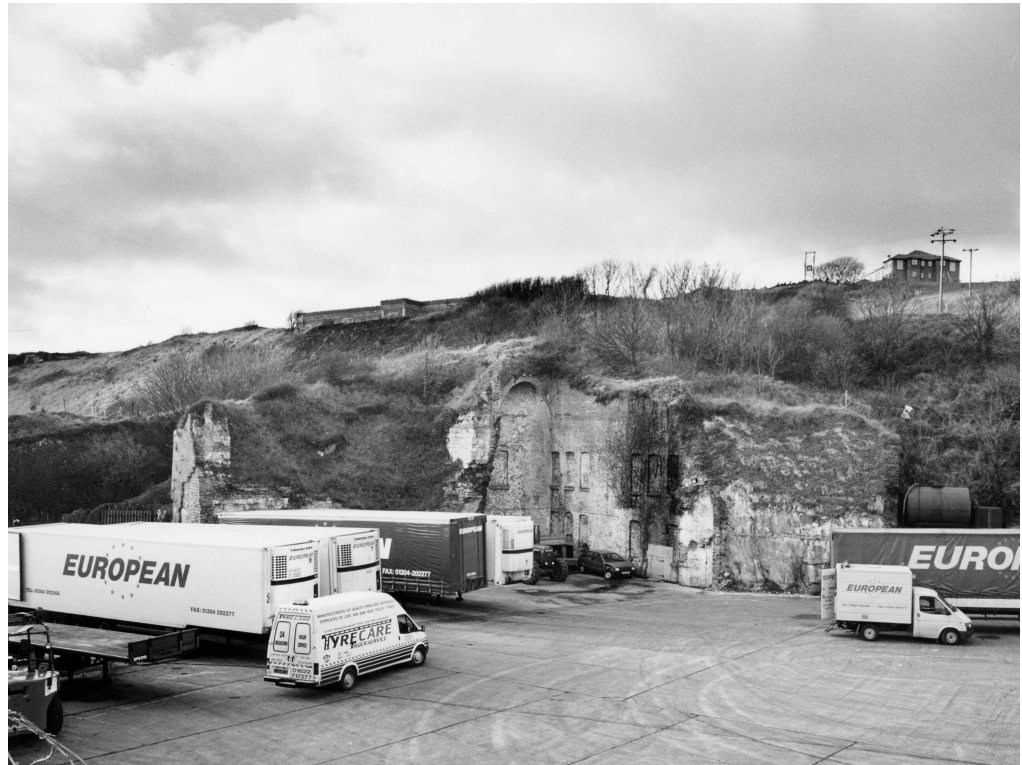
Figure 11
The remains of the South Lines Casemates, at the south-western end of the former Casemated Barracks (NMR AA028134 © Crown Copyright 1998)

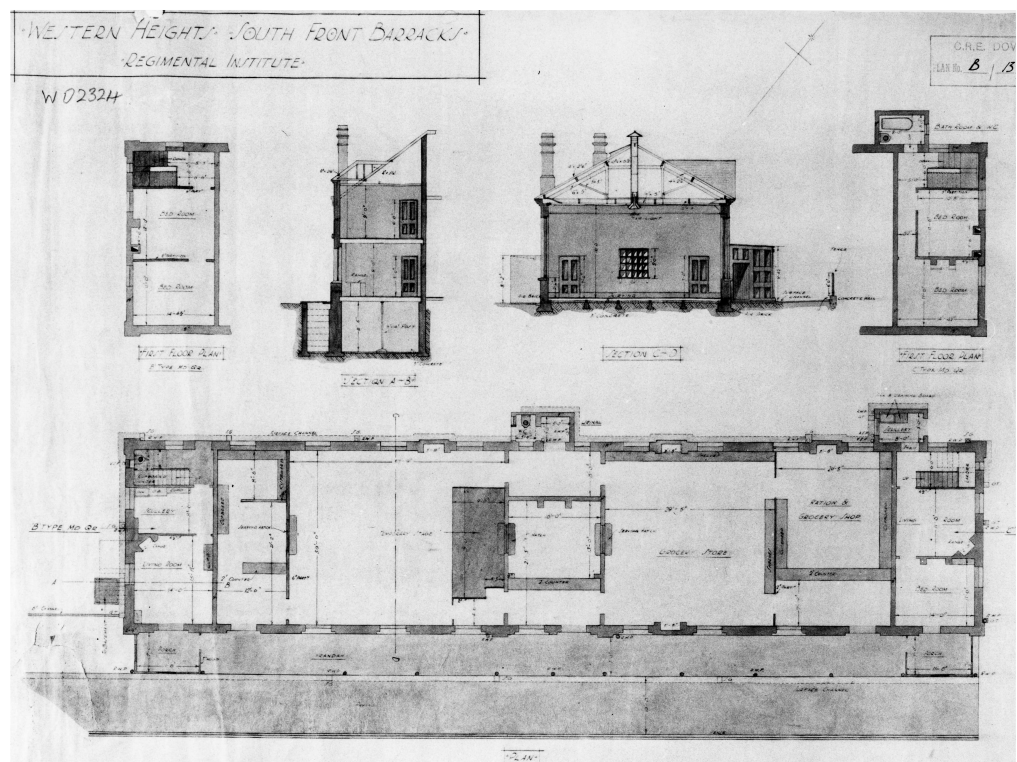
Figure 12
Record drawings of the
Regimental Institute, dated
1929 (extract of NMR:
WD/2324)

and faced in red brick (PRO: WO/78/2426/2 and 5). A later plan, of 1929, shows that it had a pitched slate roof incorporating gabled ends over the two-storey bays (Fig 12). The 1896 plan reveals that the south-western half of the hall still contained the Canteen, comprising a tap room with a stage, a bar and a coffee bar, while the other end contained both a Reading Room and a Recreation Room. By 1909, the north-eastern part had been converted to a Grocery Store and a Ration and Grocery Shop (NMR: WD (1909)). In 1927, the building is referred to as the Regimental Institute (NMR: WD (1927)).

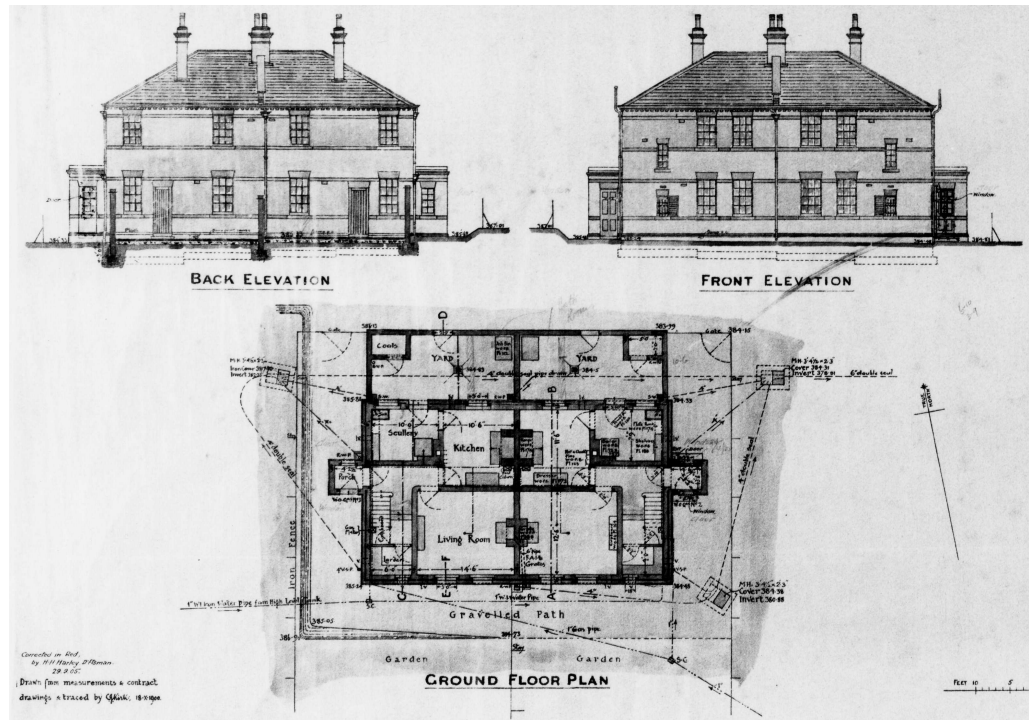
Figure 14
Record drawings of Nos
2 and 3 Warrant
Officers' Quarters,
dated 1900 (extract of
NMR: WD/2320)

This building was constructed after 1897 (PRO: WO/78/2426/2) and before 1900, when a detailed record plan was made (Fig 14). The record plan shows that they were built as semi-detached houses for Warrant Officers, No 3 on the west and No 2 on the east. Both houses were well-appointed, comprising kitchen, scullery and living room on the ground floor, with flat-roofed porched entrances in the east and west walls respectively, and three heated bedrooms and WCs on the first floor. There were yards to the north, incorporating a coal store, and small enclosed gardens on the south.

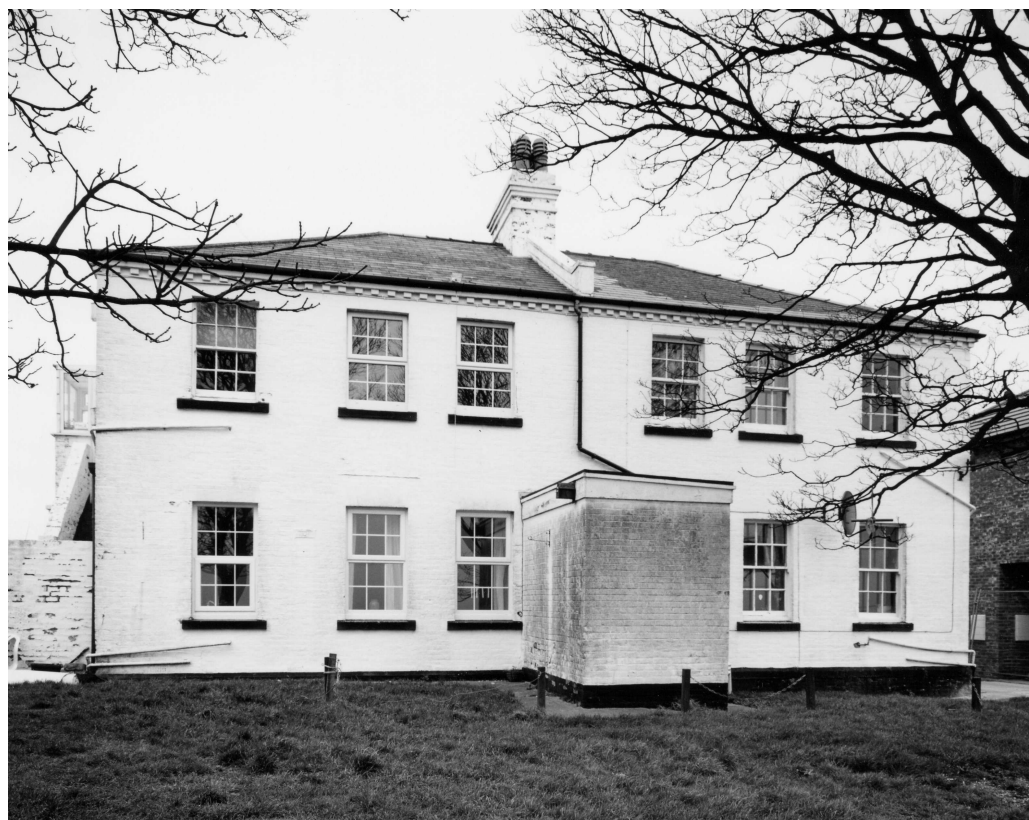
Figure 15
Photo of the Warrant
Officers' Quarters Nos
2 and 3, south
elevation, in 1998
(NMR: AA028136 ©
Crown Copyright 1998)

These brick houses face north on a small area of level ground on the south side of Citadel Road just west of the South Lines. They are double-fronted, of two storeys and three-by-three narrow bays with a hipped slate roof and a centrally placed dividing wall carried clear of the roof as a fire break (Fig 15). White paint obscures the original grey brickwork with its red brick bands at plinth, ground-floor window head, first-floor window head and eaves level. The porches survive along with the large shared, central stack (smaller stacks probably for coppers in the sculleries and the grates in the rear bedrooms have been demolished).

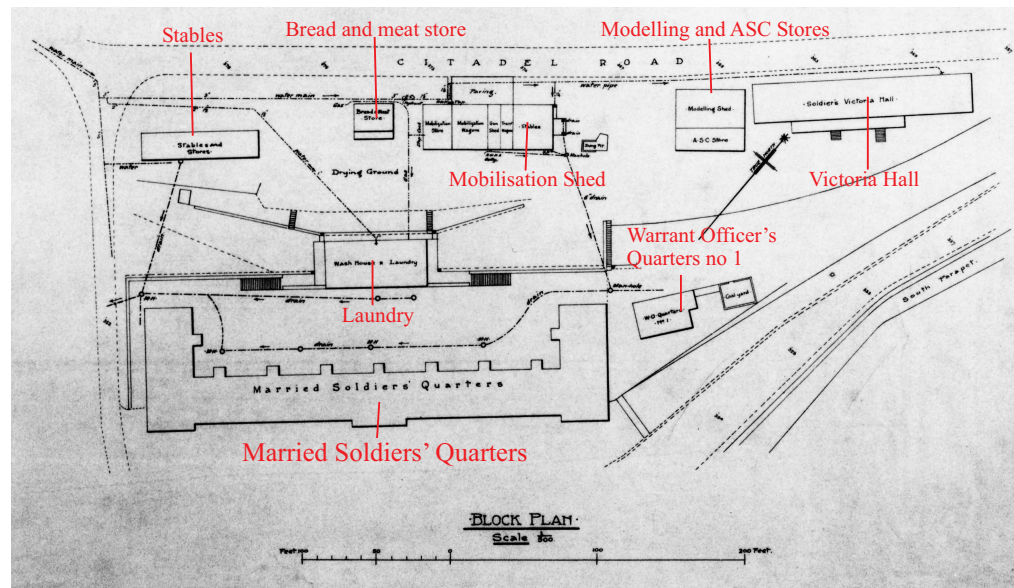
Figure 16
Record plan of
the buildings on Citadel
Road in 1903; text in
red is added by the
authors (extract of
NMR: WD/231
©English Heritage

This was a long rectangular building housing horses both for the officers' and for draught purposes (Fig 16). It was constructed before 1871 and still (PRO: WO/78/2755/9). There had been no changes in its function in 1909 and 1927 (NMR: WD (1909); (1927)). Nothing remains above ground but the site is not built over.

The large square Modelling Store was present by 1903, adjacent to Victoria Hall (Fig 16). Between 1909 and 1927 it was converted for use as another Mobilisation Vehicle Shed (NMR: WD (1909); (1927)). The building has gone though the site is not built over.

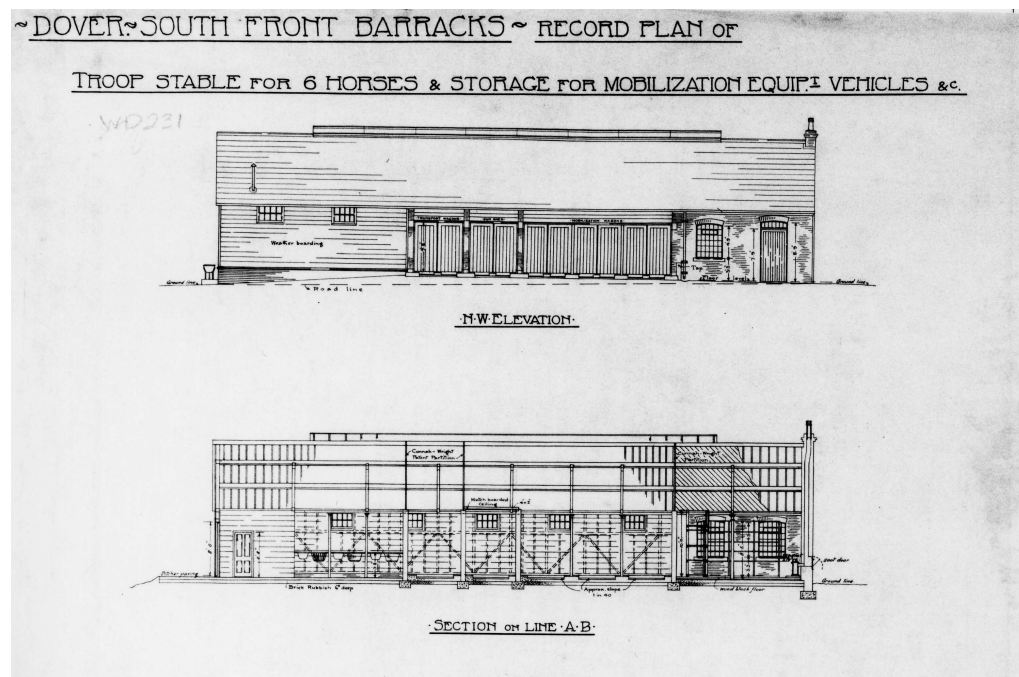
Figure 17
Record drawings of the
Troop Stable and Store
for Mobilization
Equipment and
Vehicles, dated 1903
(extract of NMR:
WD/231)

This structure, replaced by the surviving Motor Transport Building after 1927, is shown on a record plan of 1903 as a seven bay, single storey building with a pitched slate roof incorporating a ridge ventilator (Figs 16 and 17; NMR: WD (1927)). The entire building stood on a concrete base with the posts of the timber-framed Mobilisation Store standing on concrete pads (WD 231). It seems likely that these survive in the western four bays of

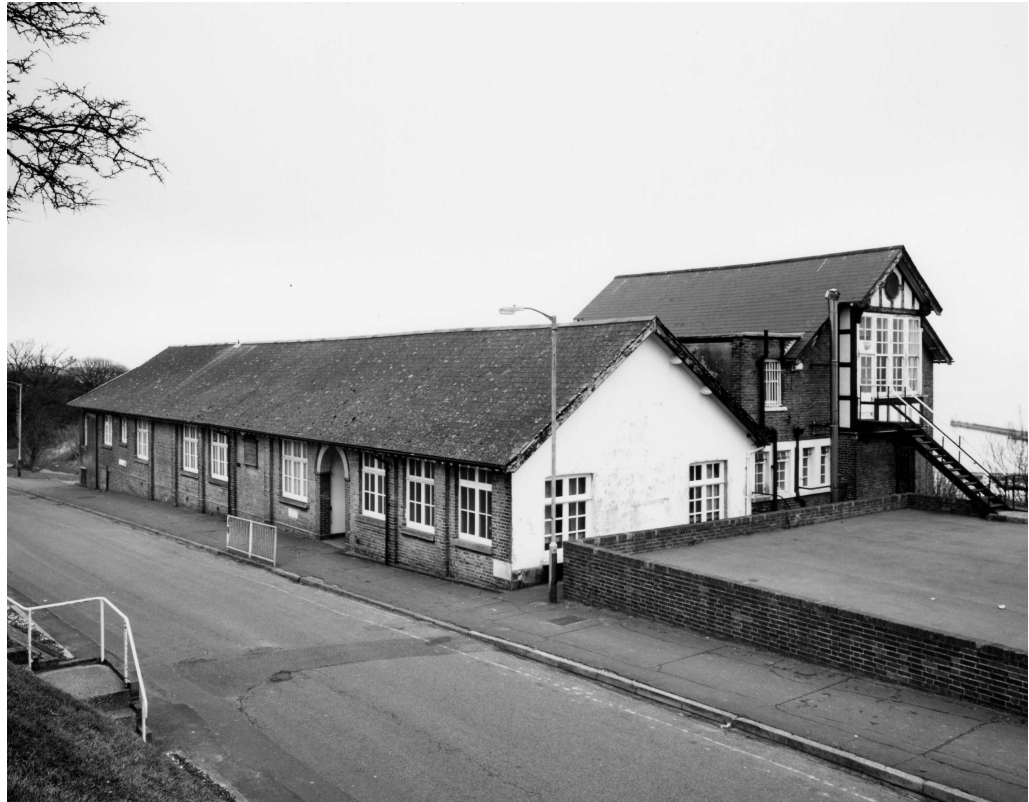
Figure 18
*Photo of the Victoria
Hall Establishment,
from the east in 1998
(NMR: 028135 ©
Crown Copyright 1998)*

It is a brick-built, thirteen-by-three bay single-storey building of pier and panel construction in English bond, with an oversailing pitched roof. The 1903 extension consists of a two-storey three-by-four bay wing built at the south-west end, with a lean-to veranda along two-thirds of the south-east wall of the 1898 building. The south-east elevation has also been considerably altered probably after the completion of the veranda (Fig 19).
