# **CHALK MINING**

and associated industries of

# **FRINDSBURY**

**Research Report 3**

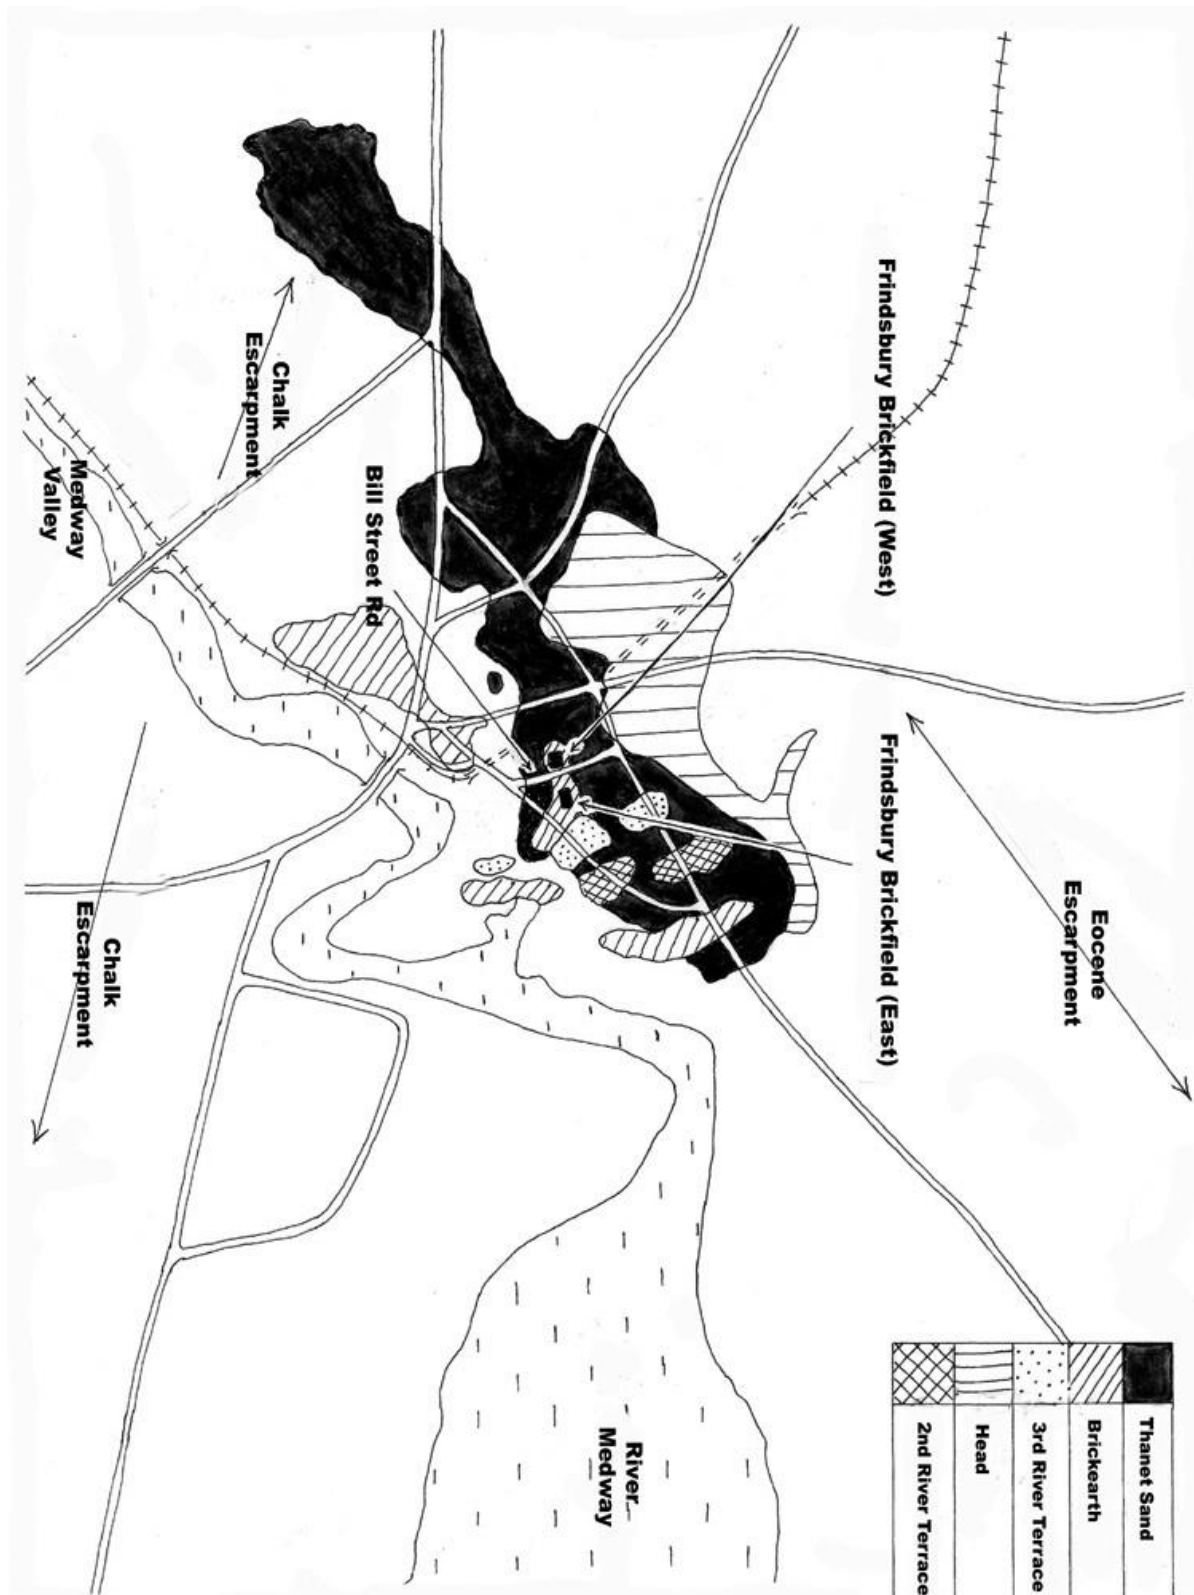
**Fig.7 Geological Sketch Map of Frindsbury**

It can be seen that the Brickearth deposits are of Recent origin and this dates them back no more than 1 million years. This table can be used in conjunction with the geological sketch map (see Fig.7). The strata found in the area of study are :-

**BRICKEARTH** – this is a Recent deposit and it is a general name given to buff / red / brown structureless loam. It is mostly non-calcareous and needs the addition of chalk for the production of stock bricks. This type of material is also referred to as Head on the geological map of the area and is thought to have been formed by solifluction, probably during the interglacial periods of the Ice Age. Brickearth could also be a water-borne deposit and can be found in the area associated with the four river terraces.

The relation of the geology to the area of study can be seen from the section at Fig.6. This shows the Frindsbury Brickfield excavations on both the west and east sides of Bill Street. These excavations can also be identified on the geological sketch map (see Fig.7) as two small "windows" where the Brickearth has been removed exposing the Thanet Sands below.

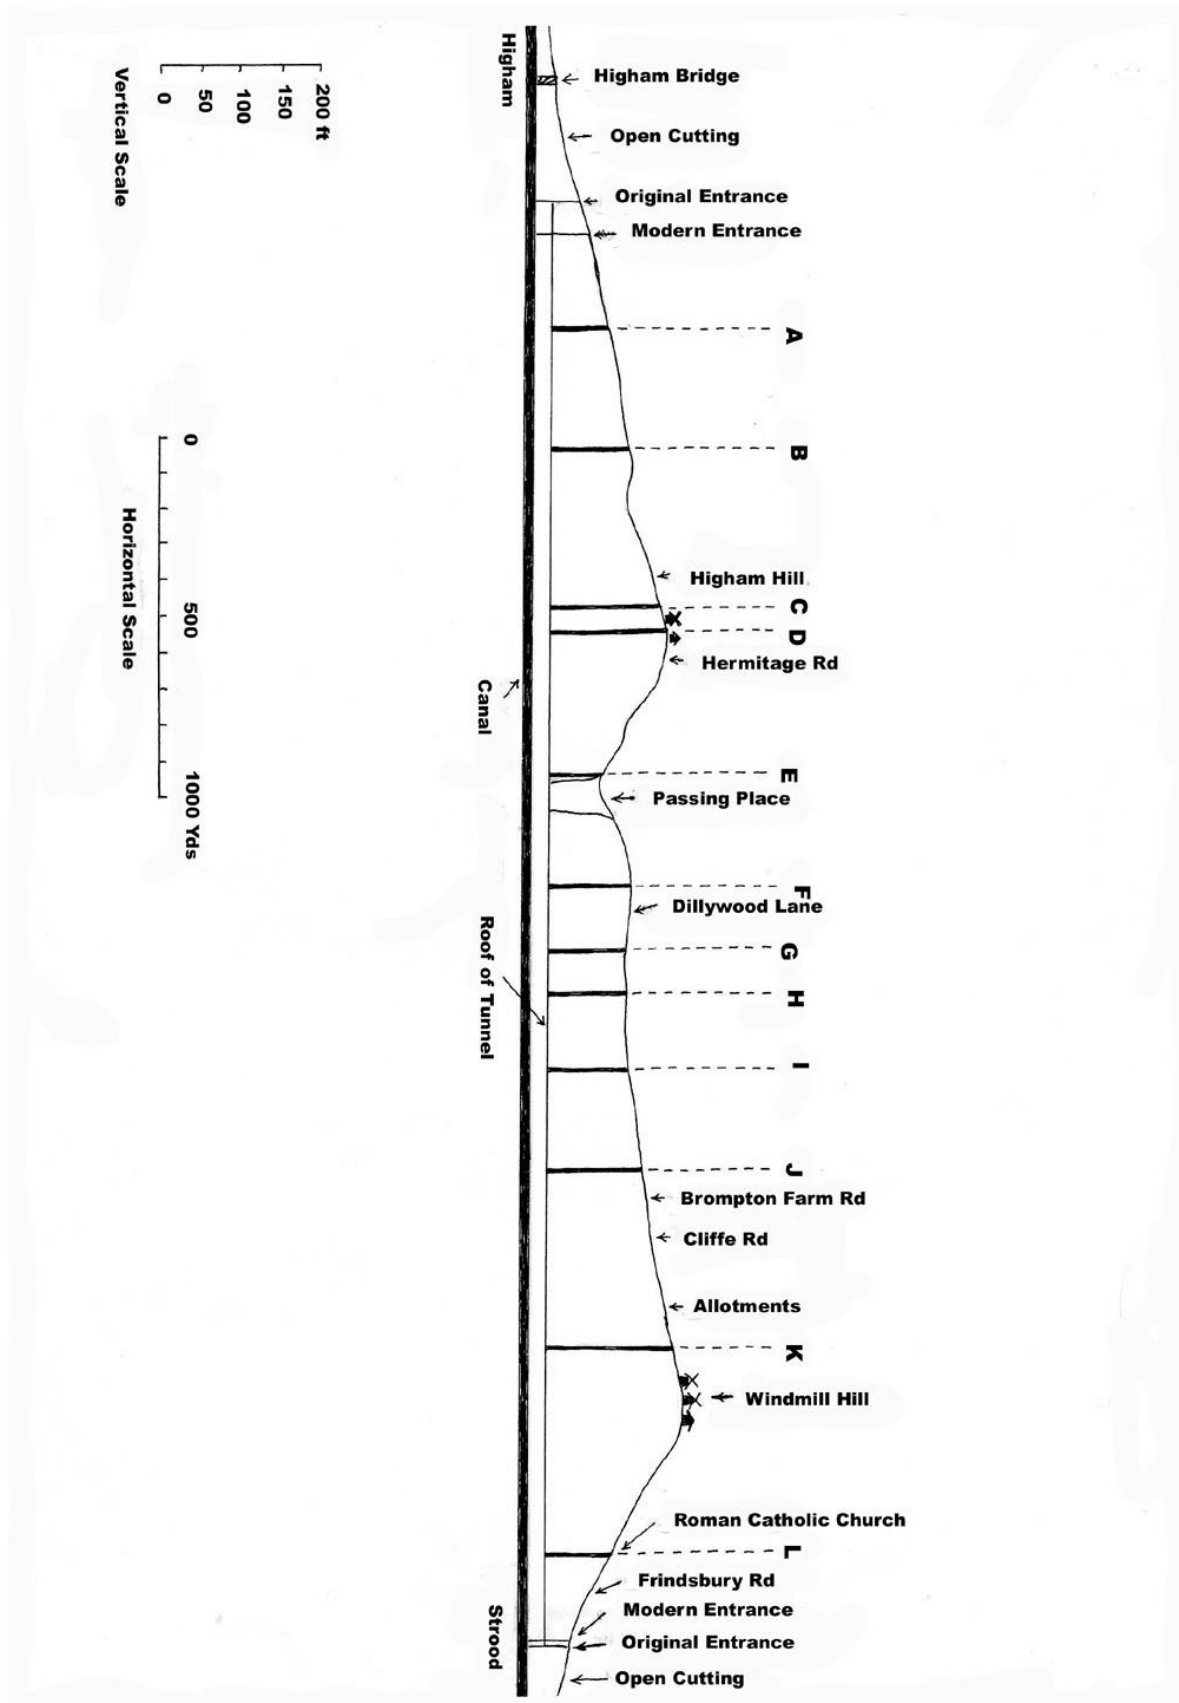
**Fig.8 Strood – Higham Tunnel**

the tunnel was laid out by William Clark, who was Chief Engineer to the Canal Company. He rapidly found that the undulations of ground and the surface brushwood made it very difficult to survey the route and he eventually hit upon the idea of using a transit instrument (used for astronomical observations). A wooden observatory was built on the summit of Higham Hill, from where a line of sight was possible to Higham Bridge, used as the base marker. A second observatory was built on Windmill Hill (see Fig.27- C) at the point where Everest Lane is now found. This observatory had a line of sight to Higham Hill as well as the Strood portal, which completed the surveying leg. Clark wasted 10 days in attempting to graduate the transit instrument and eventually found that its wooden stand was susceptible to expansion through temperature, explaining the puzzling differences in readings. This was soon solved by the simple expedient of replacing the stand with brick pillars capped with stone. From the two observatories, the locations of 9 working shafts were laid out and these were sunk to the level of the proposed canal base. Once sunk, two wooden frames were installed at either side of the shaft tops on the line of drive and cast iron plumb bobs were hung from these to the shaft bottoms. The instrument was then taken to the shaft bottom of each and the line of drive could be calculated underground by lining it up on the two plumb bobs. The tunnel was driven simultaneously from each portal and from the 9 working shafts, the surveying being accurate enough to ensure continuity when the various sections met up.

These shafts were fitted with horse whims for haulage and would also provide necessary ventilation to the linked sections of tunnel. Although most of the tunnelling was in the soft chalk, they encountered hard sections in several places underlying the high ground and it was necessary to use gunpowder here instead of hand picking. Under the valleys, the chalk was very loose and included veins of Fullers Earth, requiring a great deal of support. During driving, the miners inserted a great many 9" pine timbers to temporarily support the roof but even these were sometimes crushed by the weight. It was necessary to build brick arches at these locations, sometimes these could be started from the tow path level but at other times they stretched from the canal floor itself. In particularly bad places the miners drove side headings in which they built walls to hold up the arching, which was 18" thick at the base narrowing to 14" at the apex.

The tunnel is too deep to have any effect on surface subsidences but the ventilation shafts are another matter. A report in 1844 mentioned that the original shafts were then covered over and partly filled in, presumably because a complete fill would be too heavy to be supported by brick arching in the tunnel. If the shafts have been securely capped then there should be no problems but it is interesting to note that there are apparent voids between the caps and the top of the infill. Any slippage of a cap could thus cause a subsidence.

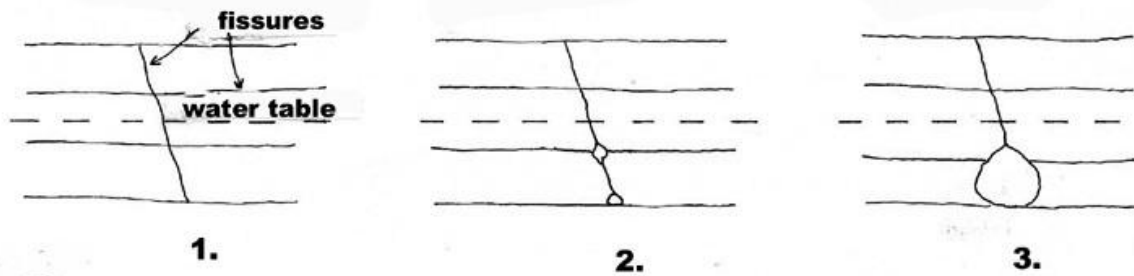
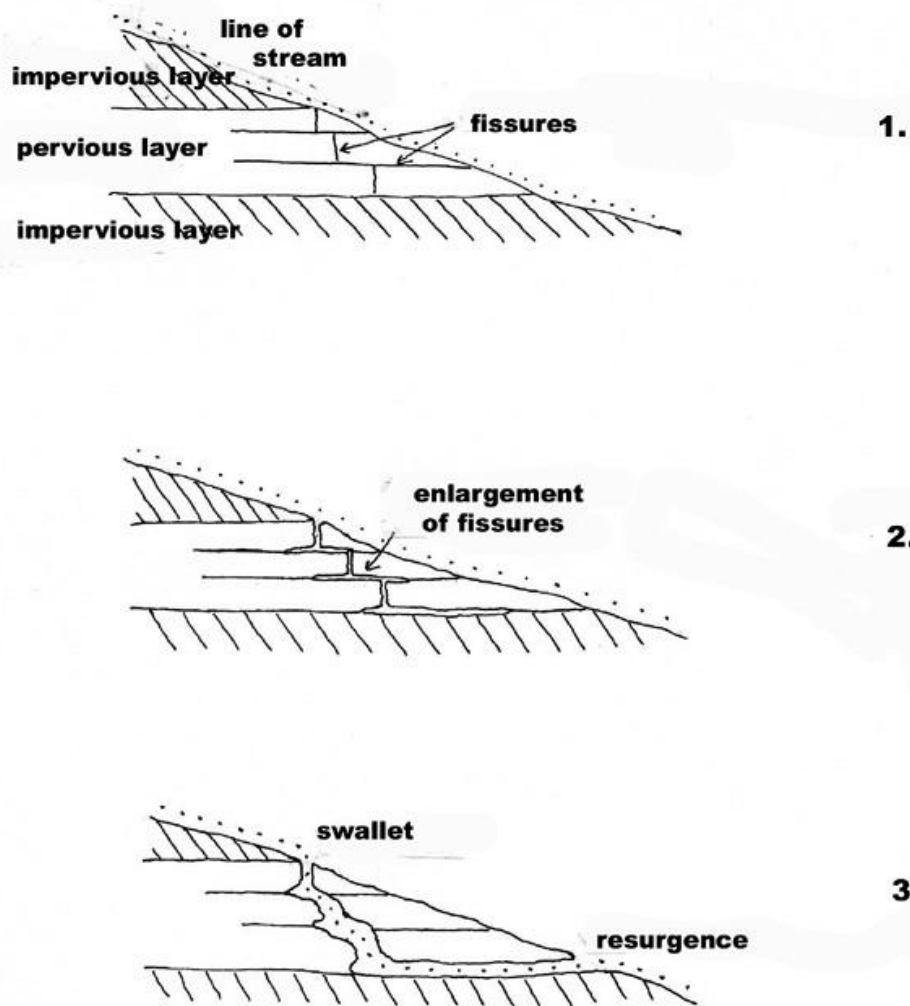
**Fig.9 Cave Formation**

**PHREATIC**

**VADOSE**

anything but a minute vadose system to form. It would be too insignificant to have any surface subsidence effect.

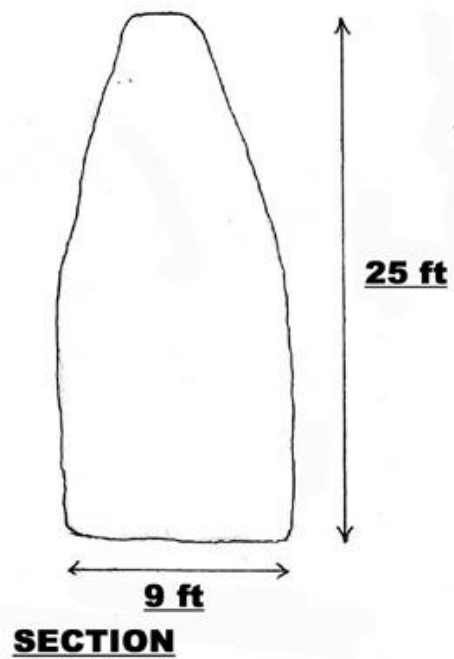
**Fig.12 Pillar & Stall Mines**

**PLAN (based on Dartford Chalk Mine)**

original passages so that a box-like system was formed as the mine got bigger (see Fig.12). Large areas of chalk were left behind (pillars) to support the roof between the passages (stalls). The passages were quite large, being up to 9ft wide at the base narrowing to 3ft in the roof, which could be up to 25ft high. The cross section was in the form of an arch to give extra stability to the passages. Some of the mines were very large and one at the Gregory's brickfield, Plumstead was reported by the Geologists Association in 1906 to contain over two miles of passages. The largest example of a chalk mine in the South East are the Chislehurst "Caves" which extend for about 6 miles (despite larger claims by the proprietors).

The known workings of this type in Kent were always on one horizontal level above the water table and thus pumping was unnecessary since the mines were dry. Haulage up the shaft was by a simple hand windlass and underground transport of the chalk would be by wheelbarrow or narrow gauge trucks, depending on the size of the workings. Chalk mining was relatively easy since it was soft enough to use handpicking methods rather than gunpowder, thus large amounts could be extracted with a small workforce. These mines were fairly stable, despite their size, since roof support was carefully maintained by the large pillars of solid chalk and roof arching. This notwithstanding, there was a temptation when mines were known to be closing to indulge in pillar robbing. This involved the removal of some of the pillars since they were easily worked from all sides and were an economical method of getting chalk at a time of financial constraints. Another technique to get cheap, easy chalk was to enlarge the roof of the passages leaving them squared off at the top rather than arched. This did not bother unscrupulous mine managers since it saved them money and temporarily prolonged life of the mine. Unfortunately, it weakened the roof of workings and would cause subsequent collapse. This is the most dangerous feature of all since the location of most underground workings of this type are unknown. A collapse of the passage roof will allow overlying strata to fall into the workings, creating a large hole which gradually (or suddenly) works its way to the surface. This could happen at any time or anywhere over the underground workings.

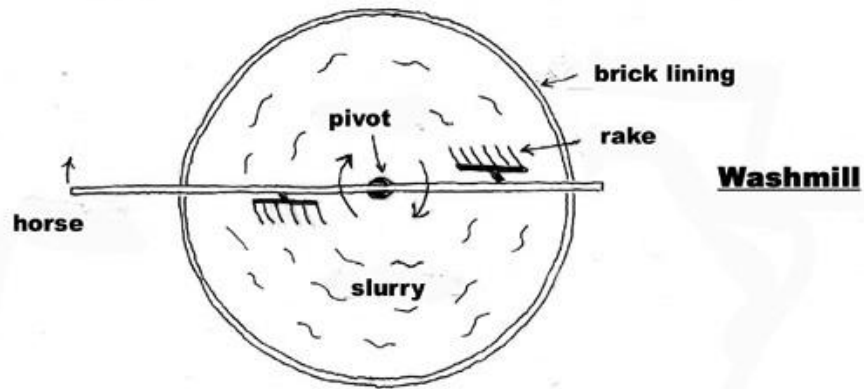
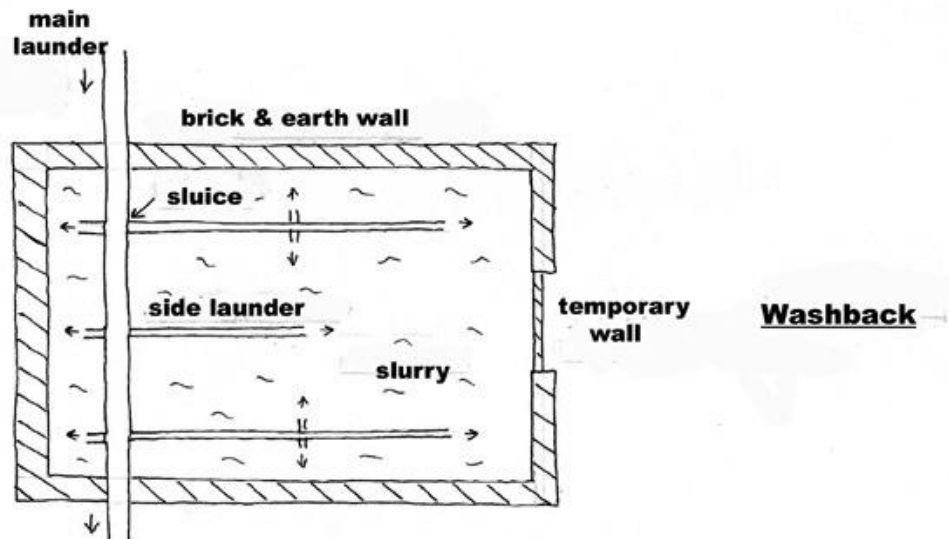
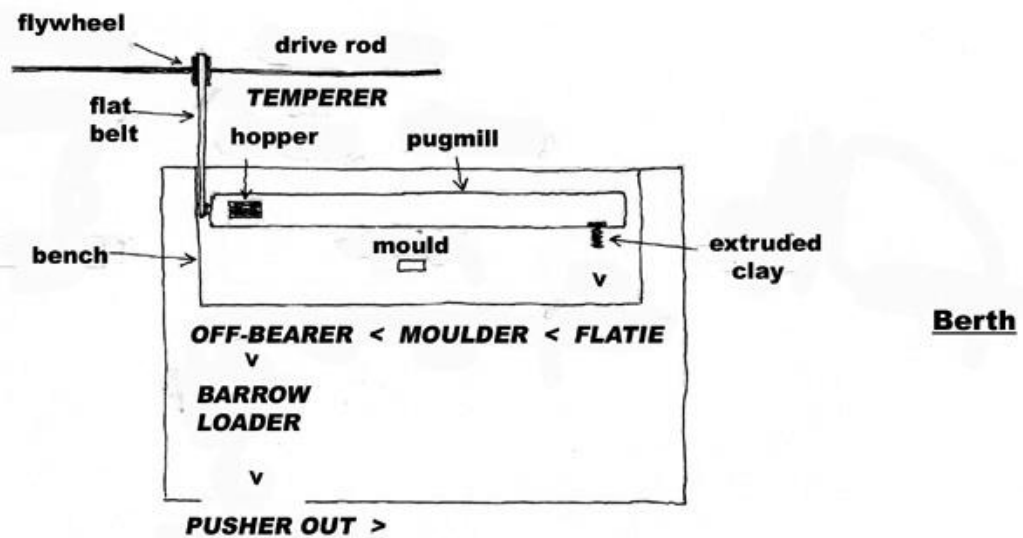
Fig.13 Brickfield Features

The slurry was then laundered to features called Washbacks, which were settling ponds (see Fig.13). These were square enclosures surrounded by brick walls up to 6ft high which were banked with soil on the outside to provide extra strength. There was a small gap left in the front wall which was boarded until the slurry had dried. A brickfield normally had at least 3 washbacks in line and an amount of slurry was placed into each in turn. About 2 days were allowed for the water to drain out before more slurry was added, this process being repeated until the washback was full. The mixture was then allowed to dry until it had reached the right consistency for brickmaking. Since many of the subsequent operations were carried out in the open, brickmaking was dependant on the weather and the season lasted from April to October. Men were laid off during the winter, apart from a few who were involved in clay digging.

The actual making of the bricks was done by gangs of persons who were often family units including women and children as labourers. Each gang operated from a "berth", which was sited in front of the washbacks (see Fig.13), the ratio normally being 2 berths for every 3 washbacks. Inside the berth was a bench, at the back of which was sited a "pugmill", which was a 6ft long narrow cylinder containing an Archimedes screw. Clay was placed in one end and the action of the screw carried it to the other end, in the process cutting it up and making it pliable. The berths were placed in line so that their pugmills could be operated from a flat belt off a mechanically—operated drive shaft. As soon as operations were ready to commence, the access to the washback was unboarded, exposing the clay mixture which was of a stiff consistency.

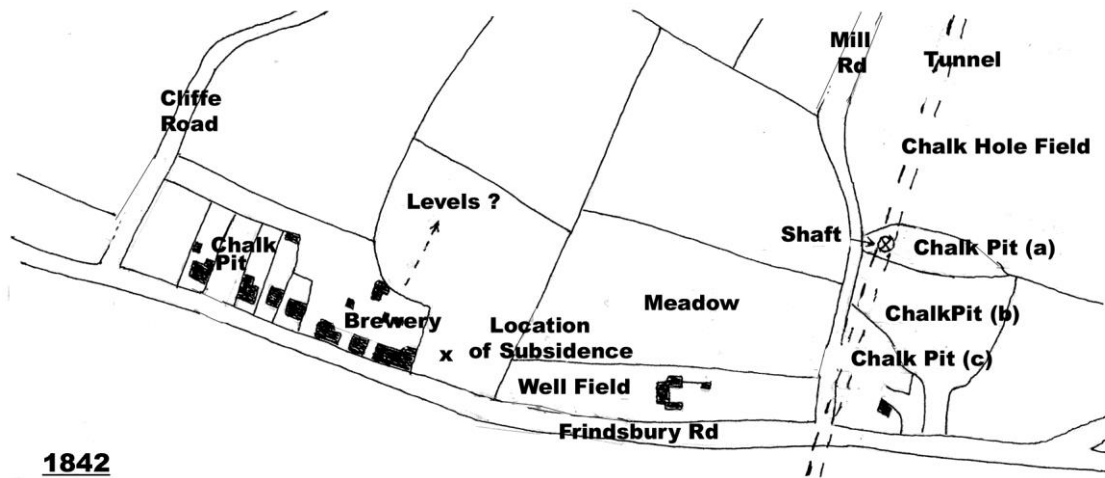
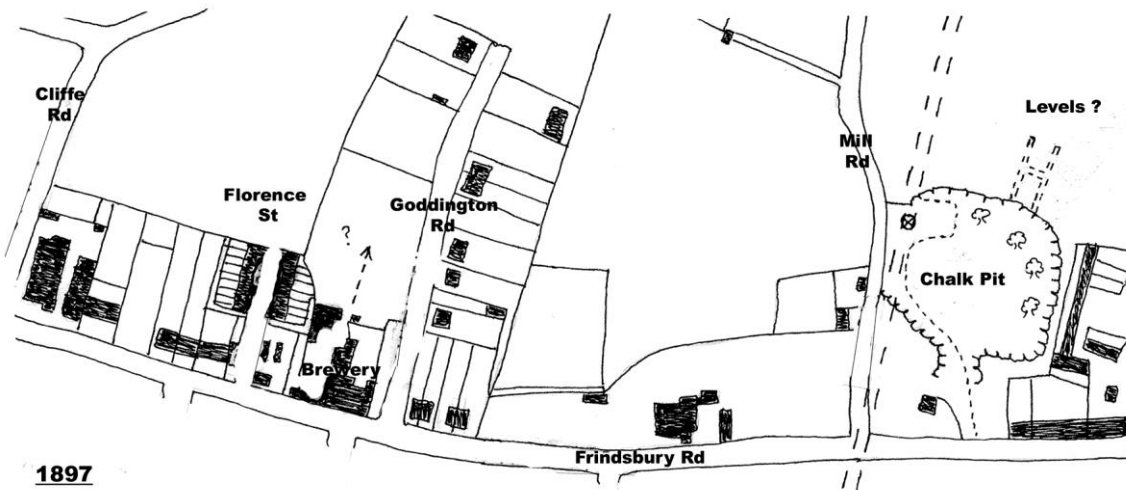
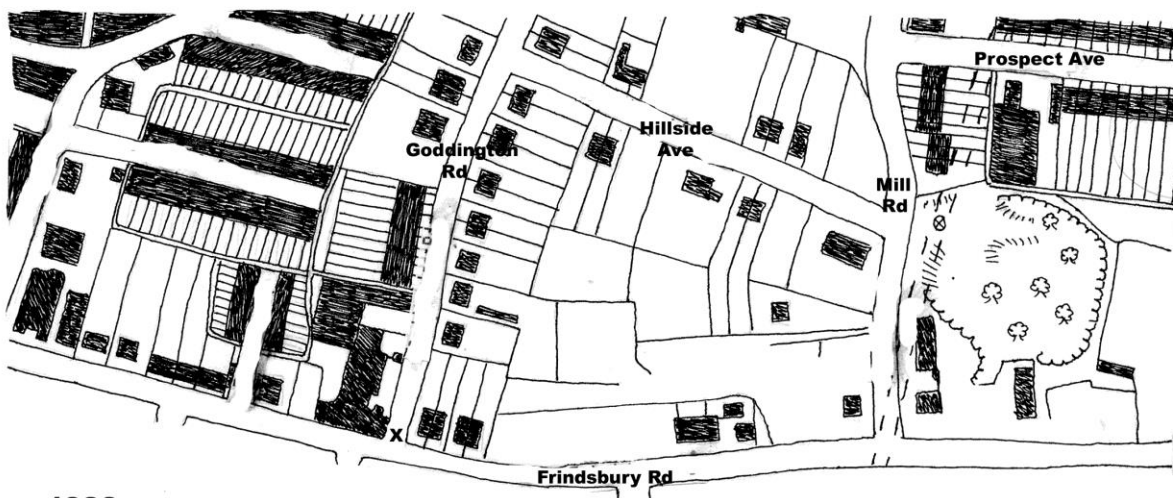
**Fig.17 Brewery Levels & Mill Road Chalkpit**

It has already been mentioned that a ventilation shaft down to the Higham-Strood tunnel was driven from the chalkpit at the junction of Hill Road and Frindsbury Road (see Fig.17). Unlike the other shafts, it is likely that the chalk pit here was already in existence when the tunnel was driven and the shaft was sunk from the floor of the pit. In 1842 the pit was divided into three parts of which (a) and (b) were leased by a farmer called John Sedgwick. The section marked (a) was where the shaft was sunk

The purpose of the levels was obviously to extract further chalk when the surface pit had reached the limits of its boundary. They can perhaps be dated between 1862-97 since the ramp leading down to them from Hill Road only appears on the O.S. map of the latter date. Mr Chinery only remembers them as a child so the measurements are only approximate and it could be that they ended at a collapse rather than a working face. We can only speculate on their direction but the position of the ramp and the cliff face on old maps indicates a likelihood of them trending north towards Prospect Road and Ravenswood Avenue. Coincidentally, there have been instances of subsidences on Ravenswood Avenue on the projected line of the passages.

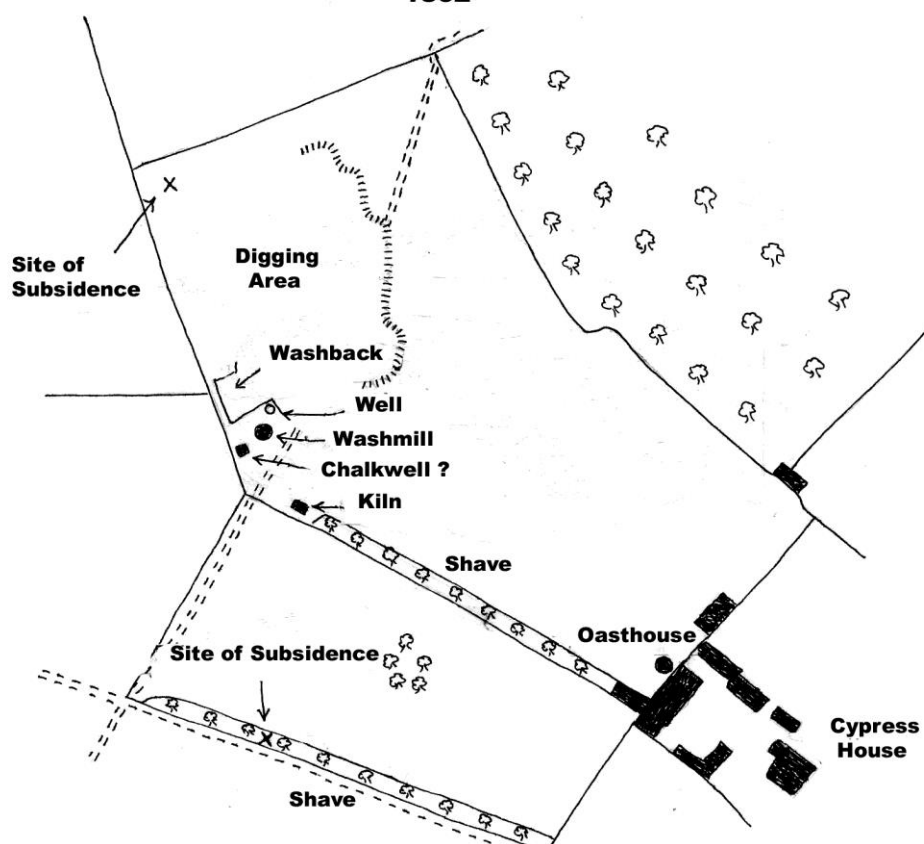
**Fig.21 Wickenden's Brickfield**  
1862

statistics of 1 million bricks as there would have been insufficient material on site. In addition, there is a probability that Hart was digging clay from Four Elms Hill and it would be too much trouble to bring it here just to make bricks on site. The most logical conclusion is that Hart was operating on two separate sites. At Four Elms Hill he could dig clay and use clamps to make stock bricks, obtaining the necessary chalk from this chalk pit. In the disused part of the chalk pit he could operate a small kiln to manufacture tiles and drainpipes from the Thanet Sand deposits obtained on site. Once the surface chalk deposits had been removed, the only option for further supplies would have been to drive short adits from the chalk face and to sink the chalkwell. The Gates family used the site for the various sides of their business and there are local rumours that coffins were stored in holes in the chalk face. This would tie in with the adit behind the present workshop since it would be cooler in summer and could act as a temporary morgue! Albert Walter remembers that, earlier this century, the firm used to cut their own trees and bring them to the yard on a wheeled trestle pulled by three horses, who were stabled in the yard. Local children stripped off the bark and the trunks were placed in the river at Strood Pier to season for a few years. By the 1930s there was a large complex of buildings at the yard which presumably acted as the joinery works. A long building along the right hand side could have been for sawing wood and it is in line with the recess in the rear wall. This may have been for the flywheel of an engine sited on the raised bank which could have operated the machinery via flatbelts.

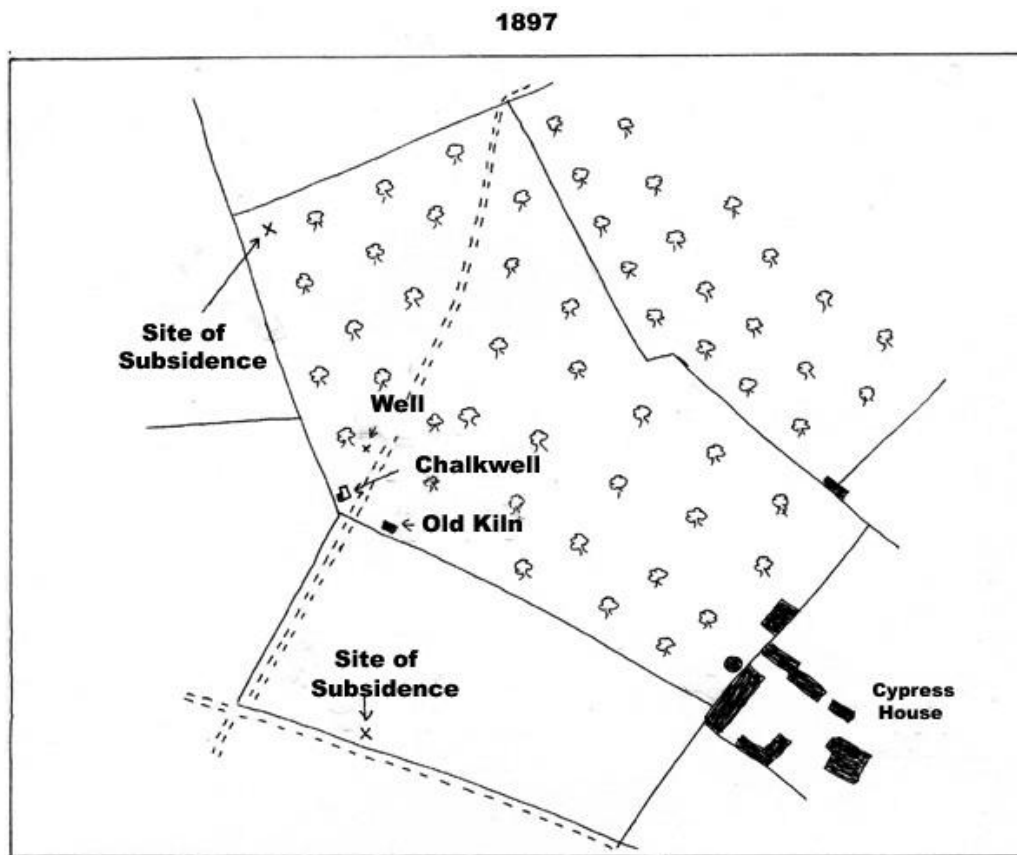
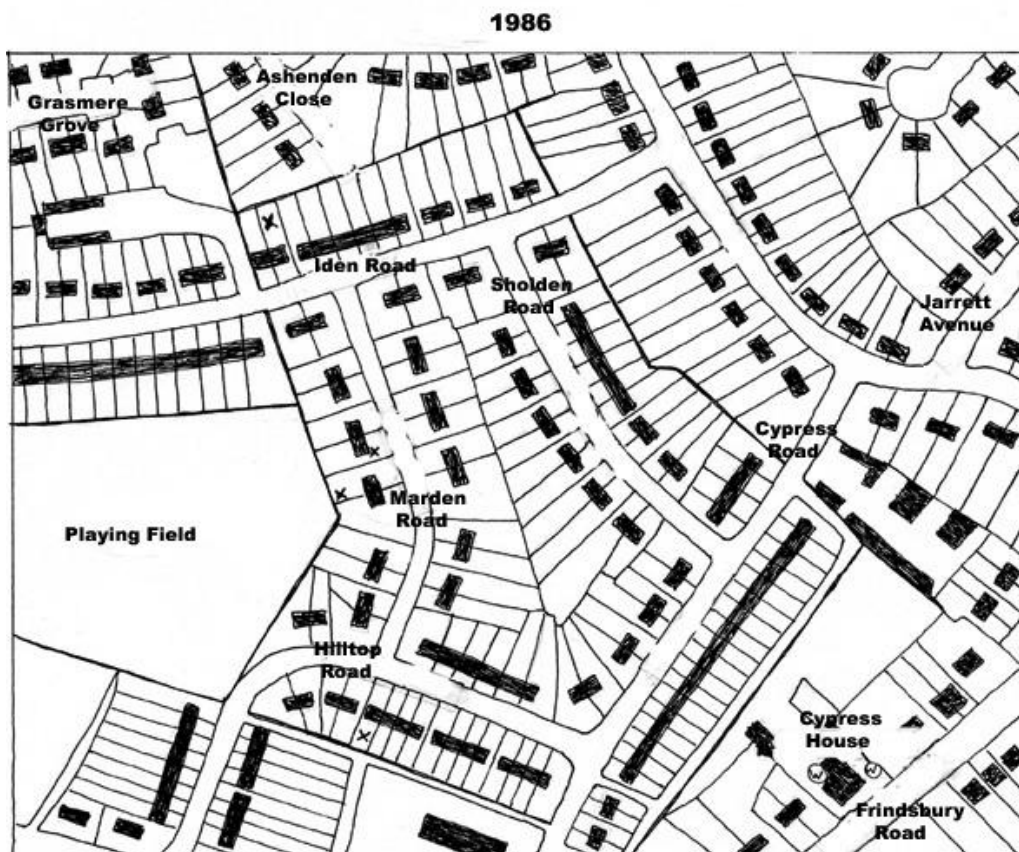
**Fig.22 Wickenden's Brickfield**

concrete, surrounded by a barbed wire fence. It was located next to the hedge to the left of the stile and corresponds to the square structure already mentioned. Fred was actually told that this was a capped shaft and the barbed wire fence points to the feature being regarded as dangerous. Similar brick beehives exist elsewhere in Kent as caps to disused chalkwells and there is a possibility that this was also a chalkwell. The shaft would have been round but it is always possible that a wooden hut was erected over it which would explain the shape on the map.

33. Said to have been associated with Bishop's greenhouses in 1950s. Located near flats on Cypress Road (see Fig.32).
34. Next to back door of Cypress House on Frindsbury Road covered over with slabs (see Fig.22) .
35. Noted in 1950s on north side of Cypress House on Frindsbury Road (see Fig.22). about 3 ft in diameter and covered with slabs. Probably connected to pump next to house.
36. At rear of old wooden houses opposite Sans Pareil PH on Home Street, about 4 ft in diameter. Couldn't be filled, despite attempts, so capped in 1950s with 15ft square 1" iron plate and 3 ft of concrete.

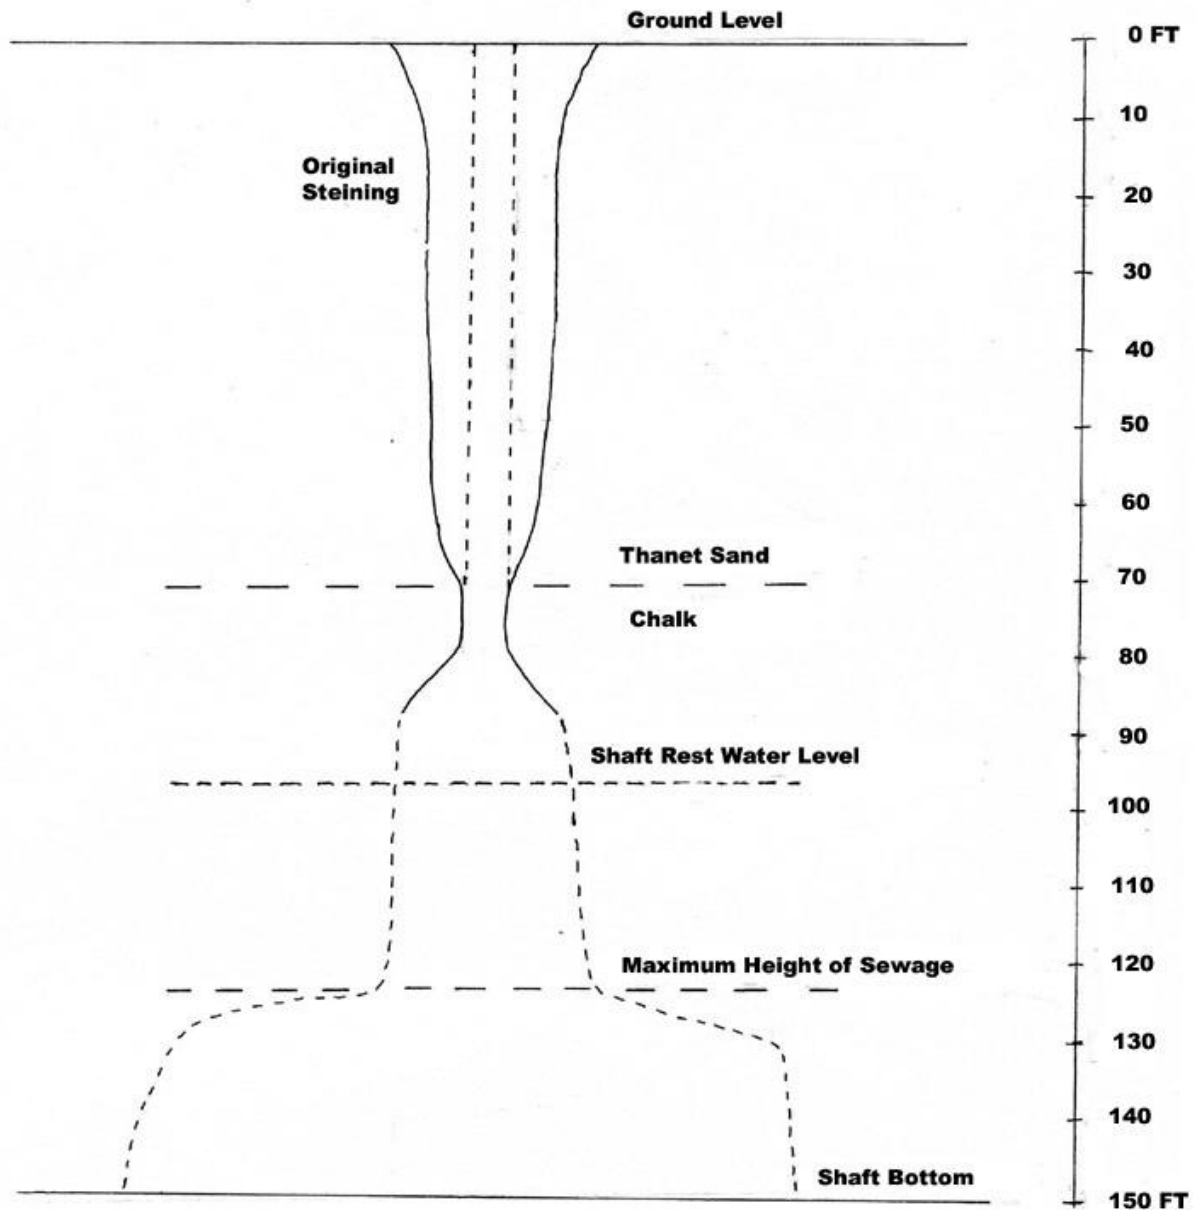
**Fig.26 West Street Shaft – Projected Structure**

**Ground Level = 173ft O.D.**  
**Volume of infill = 26,352 cu ft**  
**Volume of collapsed steining & shaft sides = 9,415 cu ft**  
**Volume of sewage = 20,000 cu ft**  
**Total volume of original structure = approx 55,000 cu ft**  
**Volume of unknown shape below 123ft = 29,000 cu ft**

Whatever the original nature of the shaft, it had been capped over with a concrete slab and converted into a cesspit for use by the local houses. At the time of the accident, it was still being used for this purpose and 8 sewer pipes plus 1 road drain emptied into the shaft top. The erosive effect of this outflow had, over the years, loosened the brick lining and caused most of it to fall away. This in turn exposed the looser strata underneath which had also started to collapse into the shaft and, in so doing, undermined the concrete slab which had fallen away. Locals claimed to have

Thus what has happened in this case is that the deposition of sewage has gradually coated the shaft walls with an impervious layer. Since the shaft was capped over, nobody could get down to perform the unpleasant job of emptying it and chipping the walls to expose a fresh surface. Since it was so deep anyway, the original builders knew it would be a great many years before it filled up. It can be presumed that the semi-solid sewage level had reached the 96ft mark in the shaft and this represented an effective barrier to downward drainage. Liquid waste would collect on top of this but rapidly drain out laterally. A rather macabre calculation based on the estimated period of use gives a likely total sewage volume of approximately 20,000 cubic feet. Allowing for the additional volume from the collapsed lining and shaft walls, calculated at some 9,415 cubic feet, together with the 26,352 cubic feet of infill used, this gives an underground structure consisting of over 55,000 cubic ft. Thus, collating all this information gives a projected structure as follows (see Fig.26). A 5ft diameter shaft lined in brick to a depth of 70ft where it continues in solid chalk. Widening to 15ft diameter at a depth of about 75ft and rapidly widening further to about 21ft, forming a bell-shaped chamber to the bottom at a depth of 150ft. Probably passages off at the bottom with maximum dimensions of 25ft in height and total length of 76ft. This of course is pure conjecture since access was impossible and the estimated 29,000 cubic feet of space below a depth of 123ft could take many shapes.

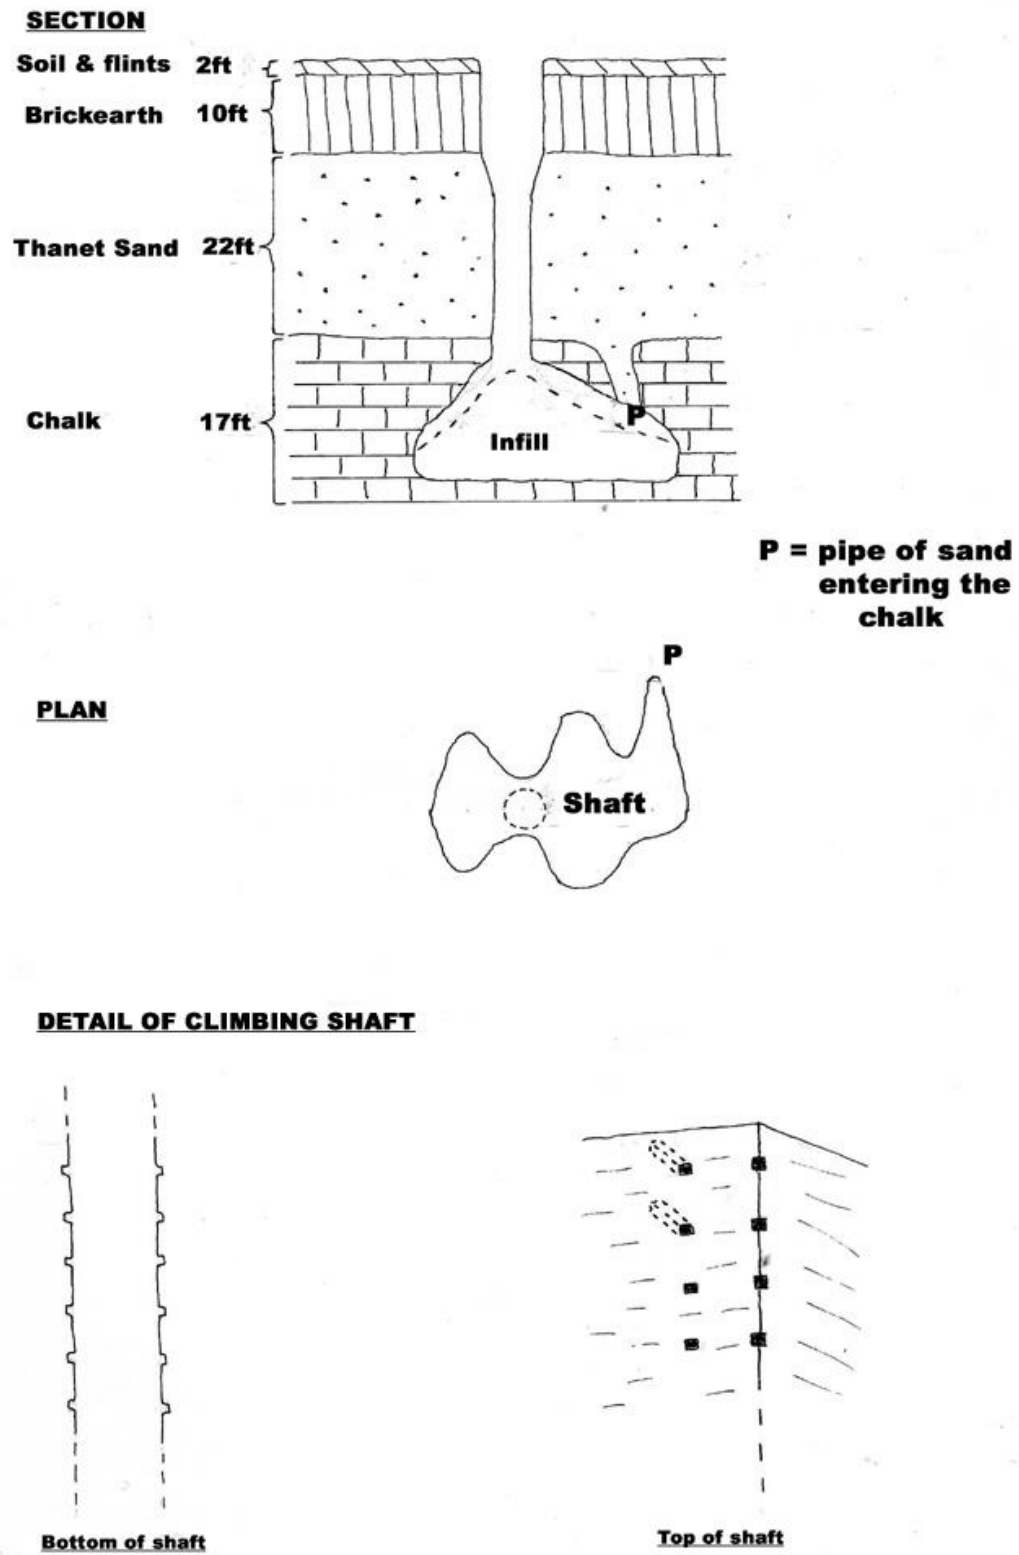
**Fig.29 Denehole in Frindsbury Brickfield**

*The footholes in the lower part were placed as usual and were of the usual depth; as the shaft got too wide the holes were placed, one row in an angle and another about the width of a man's chest on the left of the angle in the broad face. At this part the holes were very deep, as deep as the whole extent of a man's arm. In ascending, therefore, when the widening began the climber had to throw himself over to one side only and pass his arm up to the shoulder, hugging the rock to his body whilst shifting his leg and other arm, which in its turn hugged the rock.*

*The descent appeared to be much less agreeable where the critical change in attitude had to be made. The man who showed these old means of ascent and descent was singularly agile. To ordinary people the process would have been attended with great risk, which is not the case with the ordinary process. The original shaft was probably circular and regular from top to bottom. The splaying out above was clearly the result of a late alteration and appeared to be coincident with the irregular enlargement of one of the equal sized caverns below. In a pamphlet by Mr C. Bird called "Rochester Deneholes", this shaft is drawn in the figure as circular from top to bottom. This was not the case as is above described."*

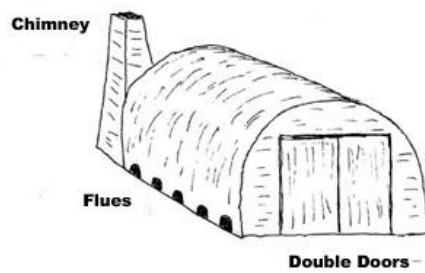
**Brick Kiln of Late 1920s**

As well as stock bricks, the company made a few red bricks and a kiln was used for firing these. This was a single kiln with a series of flues underneath, double doors at one end for access and a small chimney at the other end to draw off the fumes (see Fig.32). It was eventually demolished and the company reverted to the traditional clamps to make stock bricks only. The map of 1907 shows a large building which is described as a kiln (see Fig.31) but this is something of a puzzle since no other reference has been found to it. Its size is much greater than the one remembered from the 1920s and there appears to be a trackway linking it with three of the berths. Several possibilities have been considered and the most likely one is that this was a Hoffmann's Continuous Kiln which was part of the original investment on this side of the road. As part of an attempt at mechanisation to increase output, green bricks could be transported on flat wagons directly from the berths to hacks positioned around the kiln. Small turntables would allow the wagons to negotiate the sharp angles. Once dried, the bricks could be loaded straight into the separate kilns and this would cut down greatly on handling time. Whatever its true function, the larger building had been demolished by the 1920s and replaced by a smaller version.

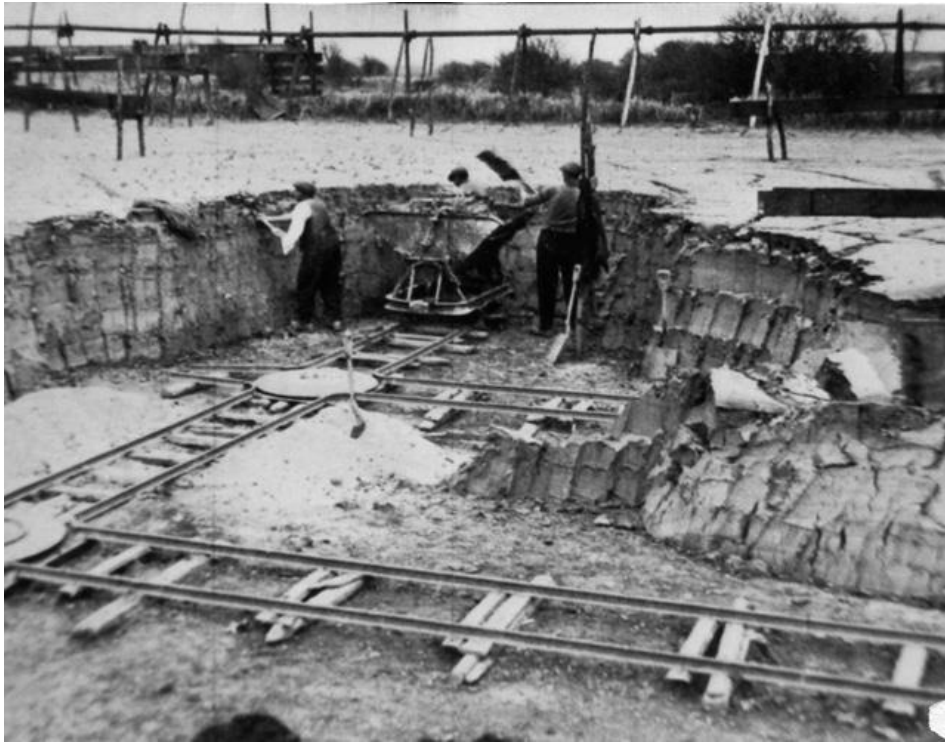
Excavating a washback in one of the larger Eastwood brickfields in the 1900s. The slurry launders can be seen in the background.

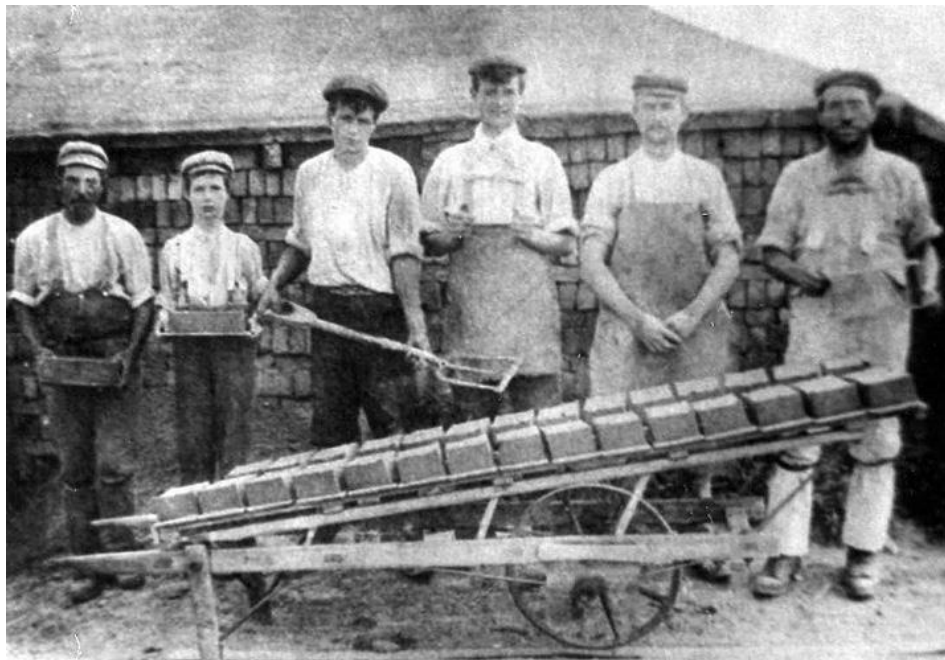
A brickmaking gang at Rainham in 1890 standing in front of a hack. Note the moulds, large cuckles and brick barrow.

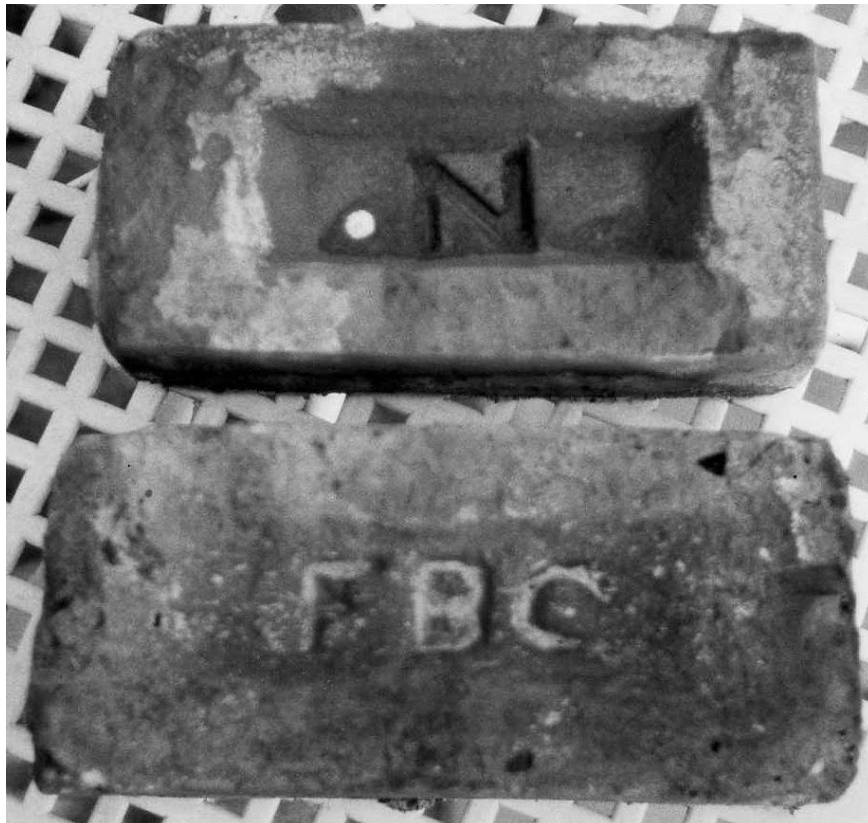
**The same brick compared to a red brick from Newington Brickworks. It can be seen that the latter is slightly smaller and more uniform since it was not hand-made. The Newington Brickworks were owned by the same Ivory who was a partner of Frindsbury Brickfield before it closed.**

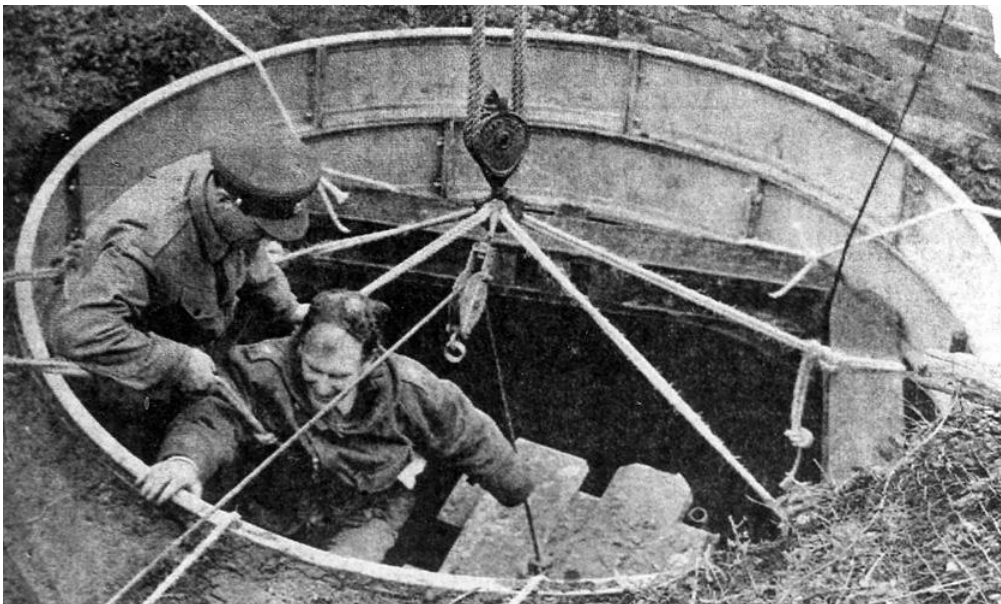
**The final attempt by Bomb Disposal personnel. Note that the shaft top had collapsed further and had to be supported.**

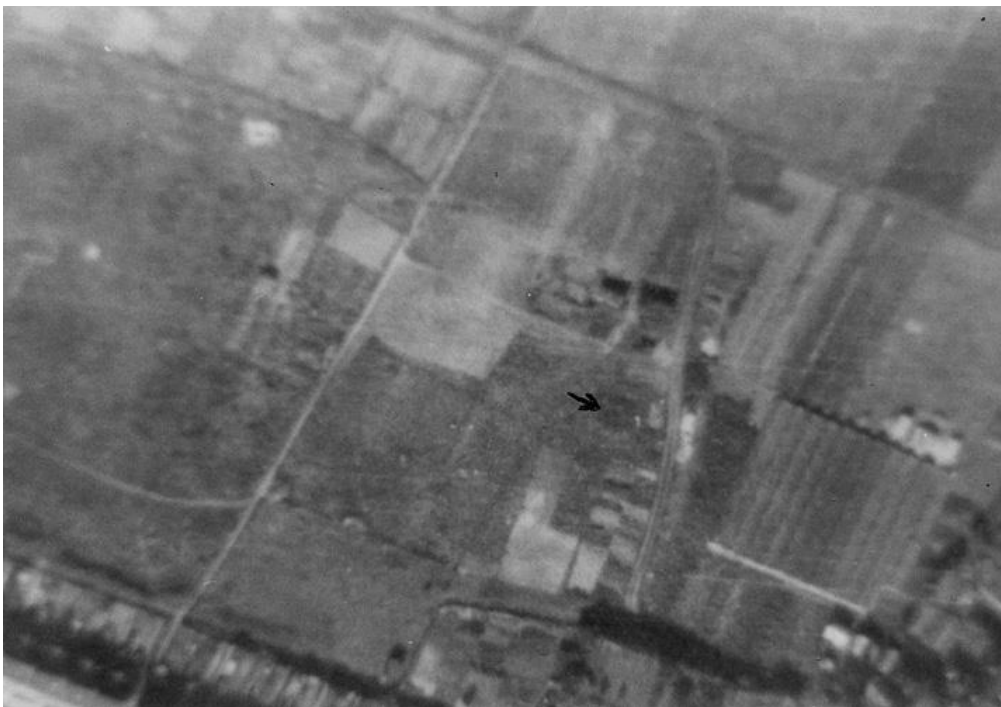
**Frindsbury Brickfield (East) – the mine shaft appears as a slightly darker patch just right of centre and the engine shed, etc is above this.**
