# **CHALK MINING**

and associated industries of

# **FRINDSBURY**

**Research Report 3**

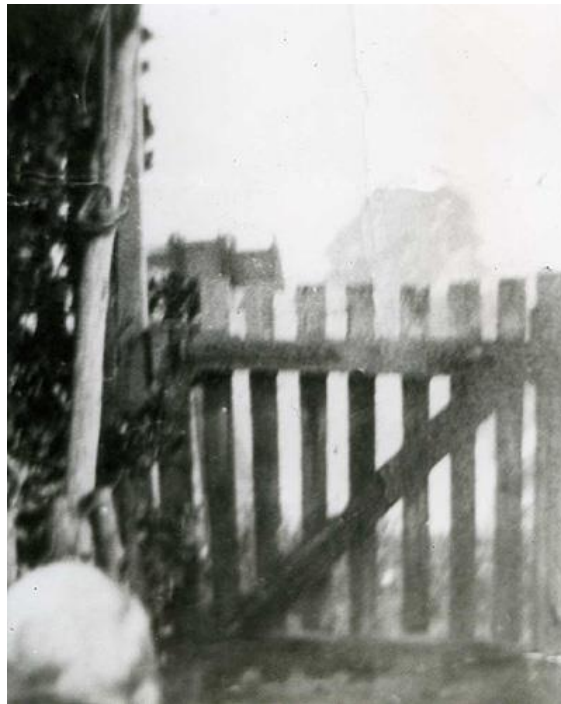
**Looking north across brickfield from rear of 6, Bingham Road.  
Two hacks can be seen in the background with their wooden caps.**

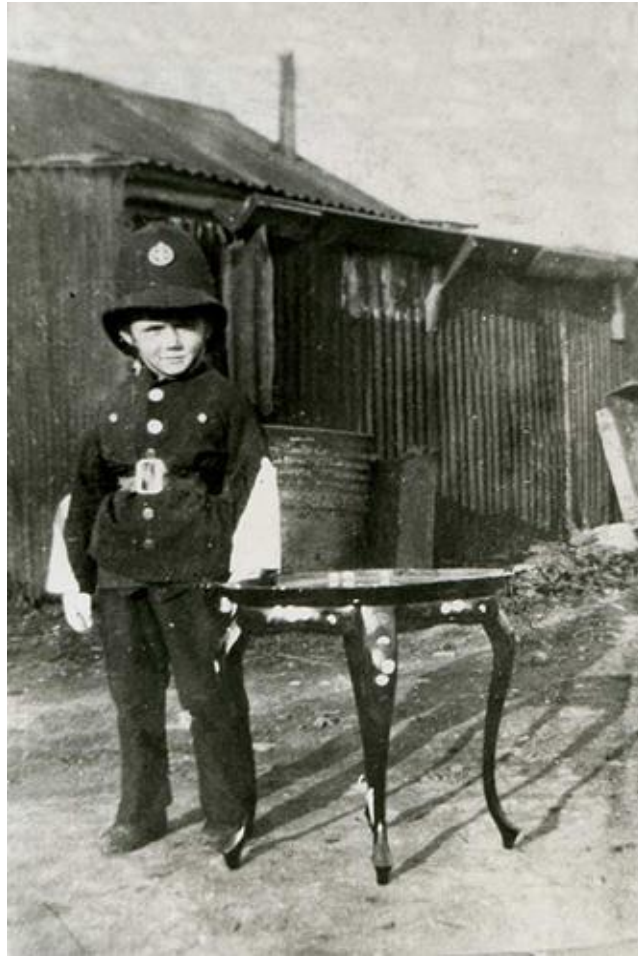
**Fred Denness in front of the engine shed. A clay sledge can be seen leaning up against the wall.**
