THE WESTERN HEIGHTS, DOVER, KENT

REPORT NO 3

THE DROP REDOUBT

A 19TH-CENTURY ARTILLERY FORTIFICATION

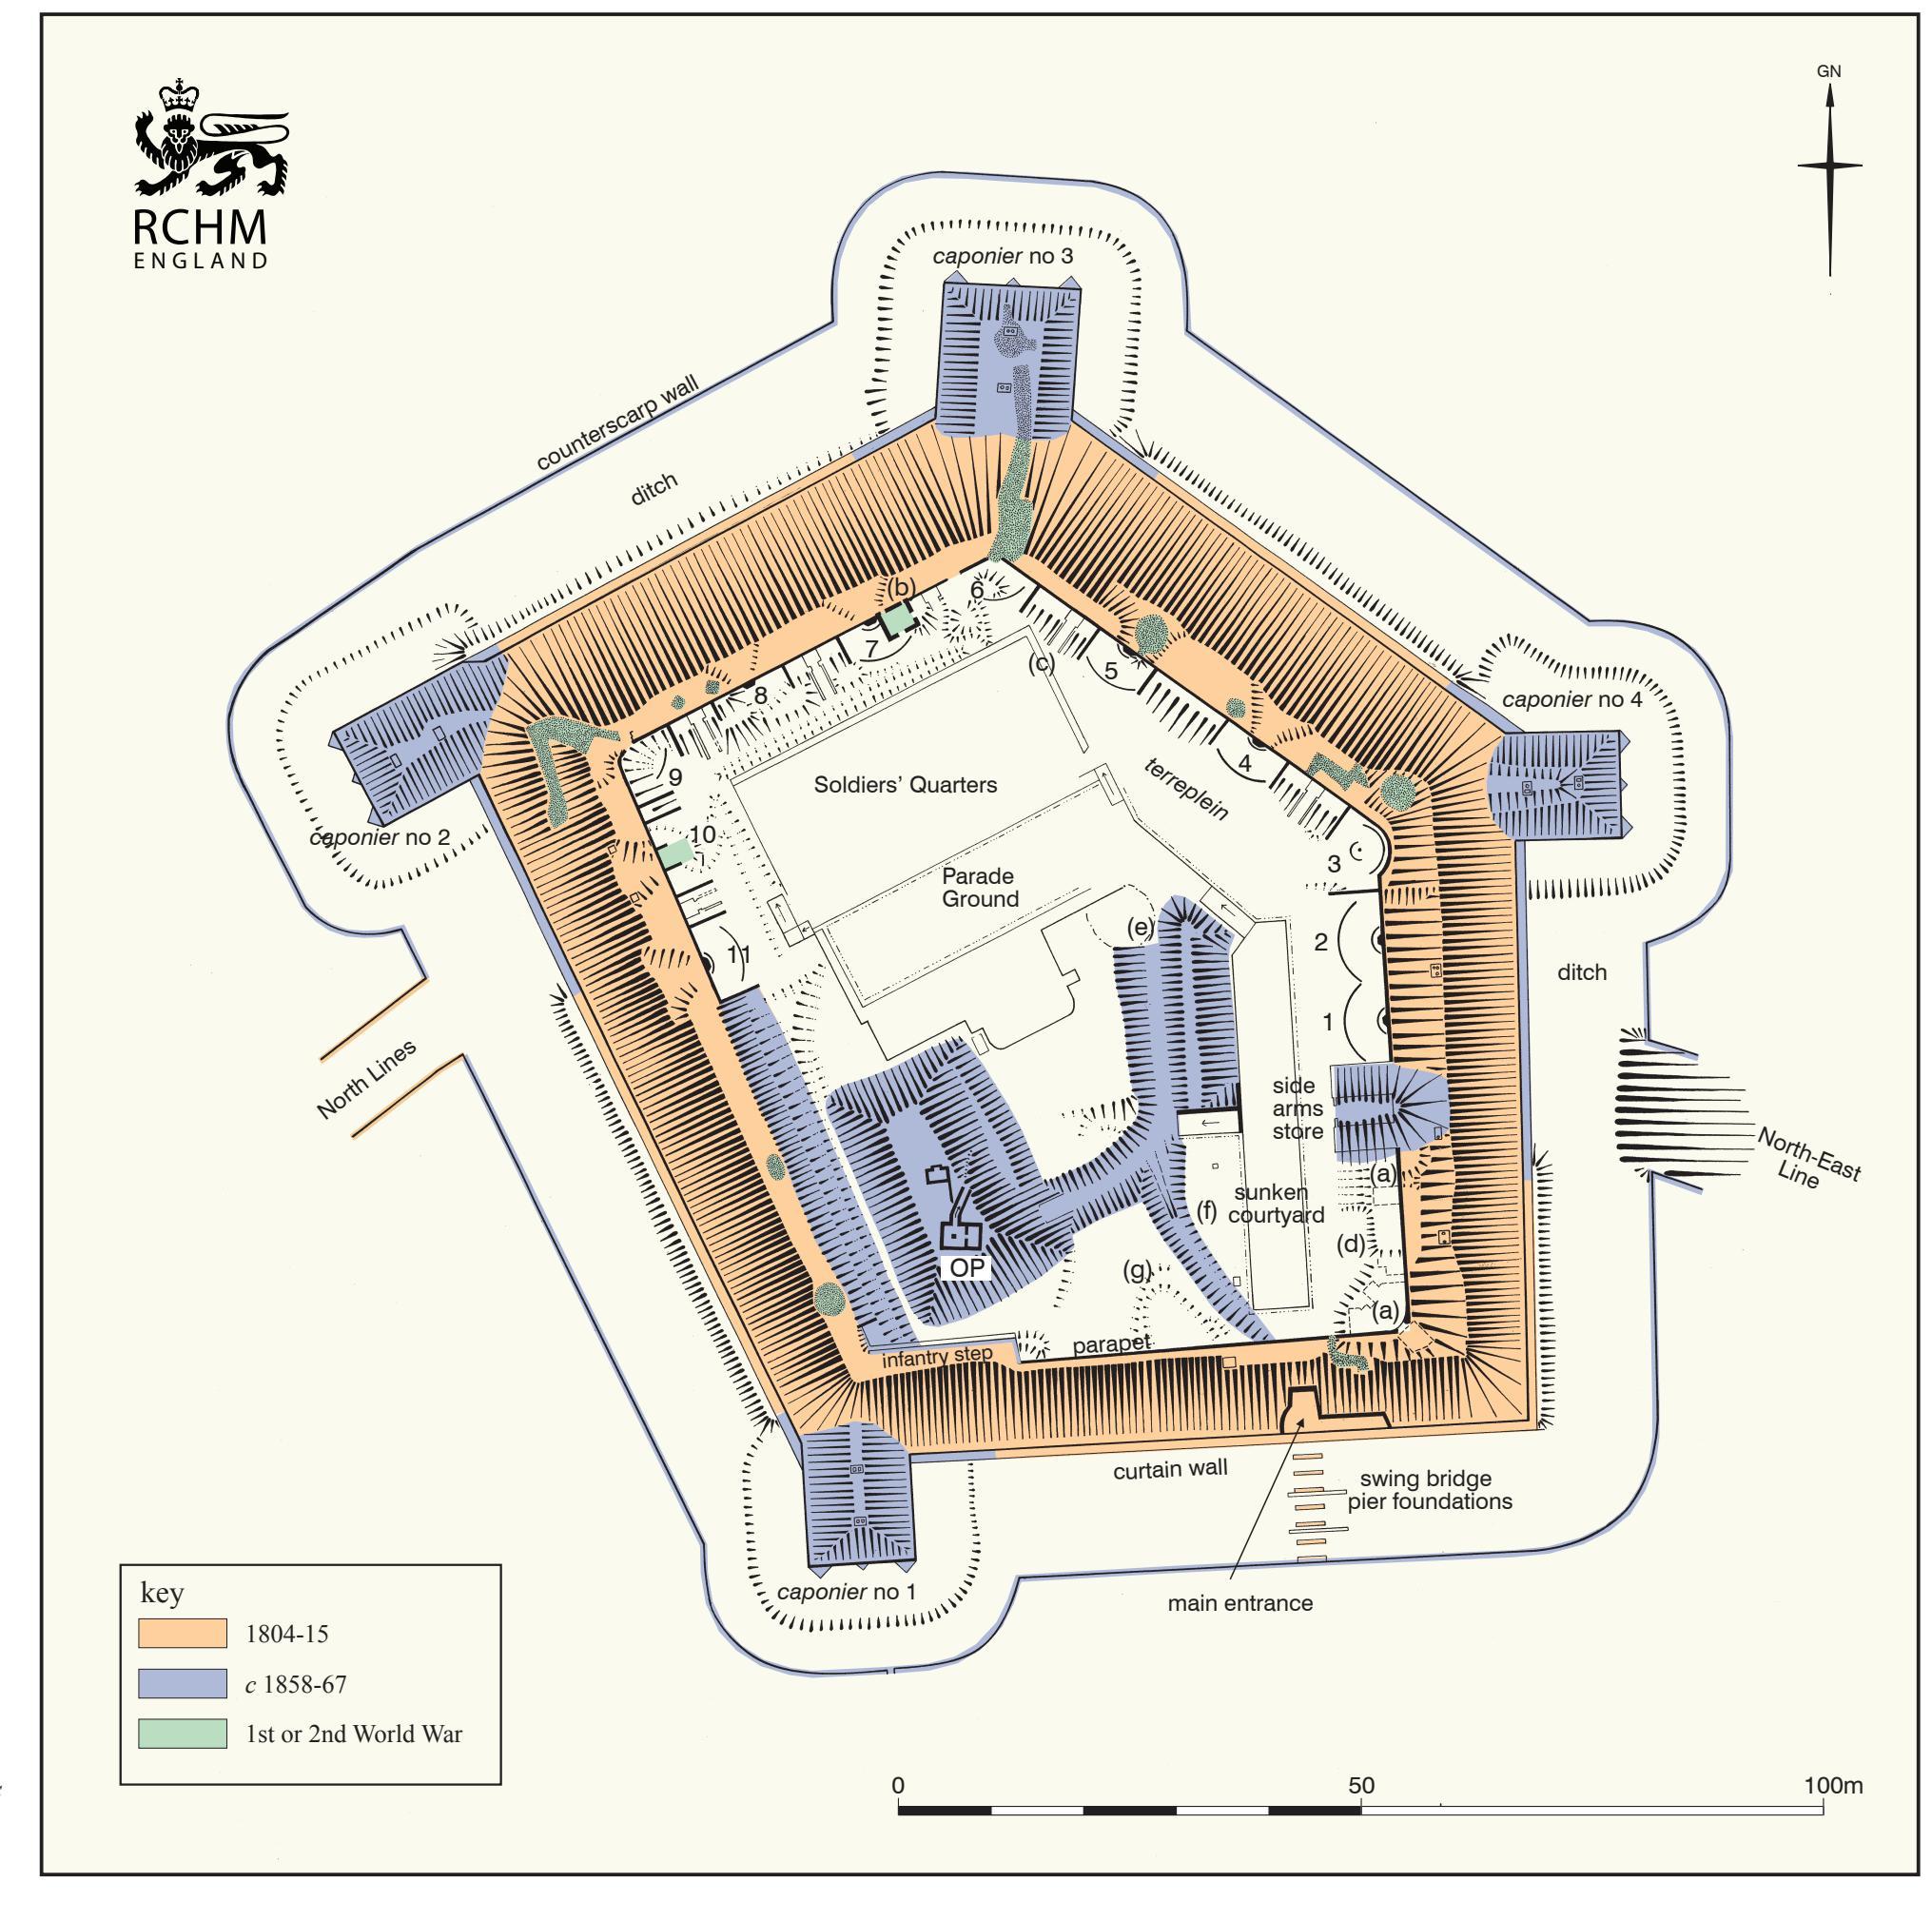
Fig 9 RCHME survey plan of the Drop Redoubt, showing major features (reduced from original at 1:500 scale)

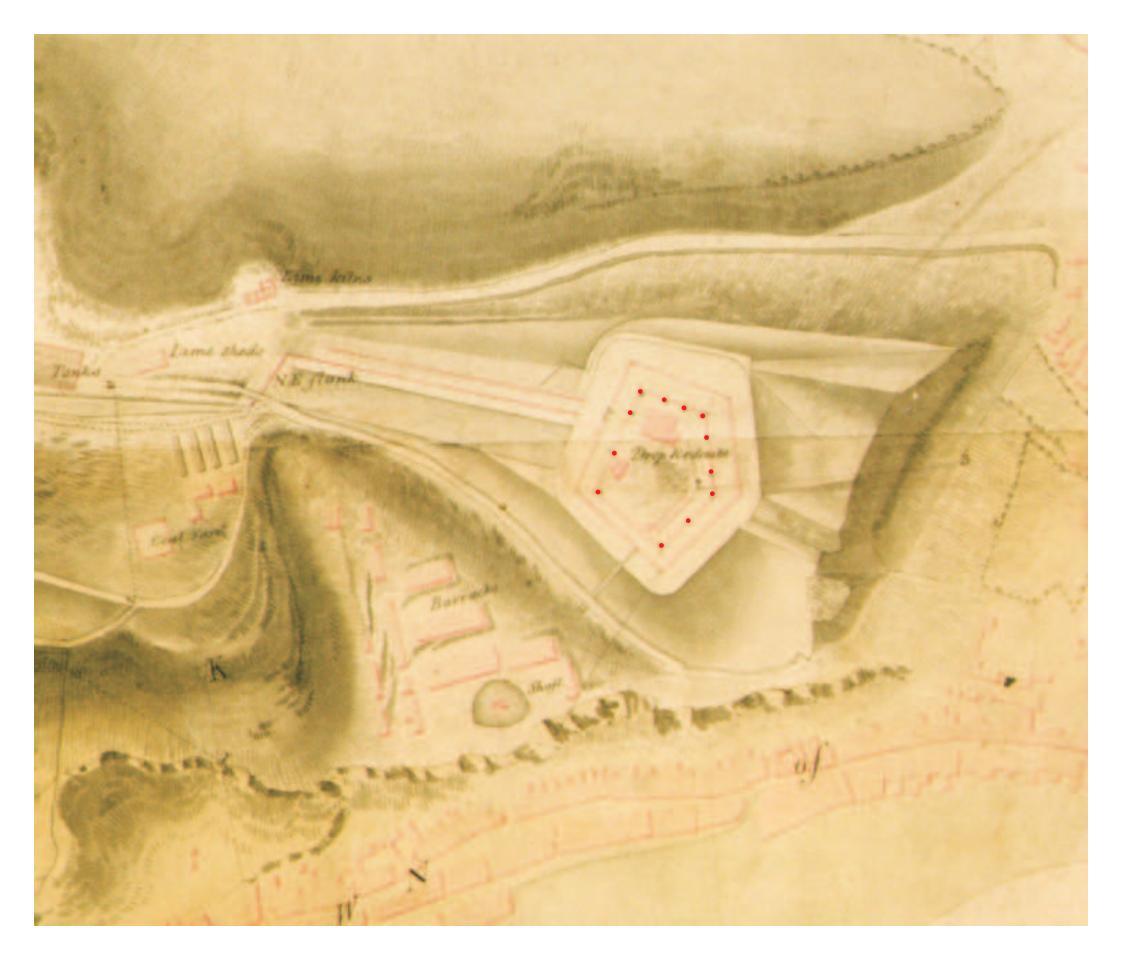
Figure 11 The Drop Redoubt in 1813, towards the end of the Napoleonic Wars. Note the gun positions, highlighted in red by the authors (extract from PRO: MR/1/1346)

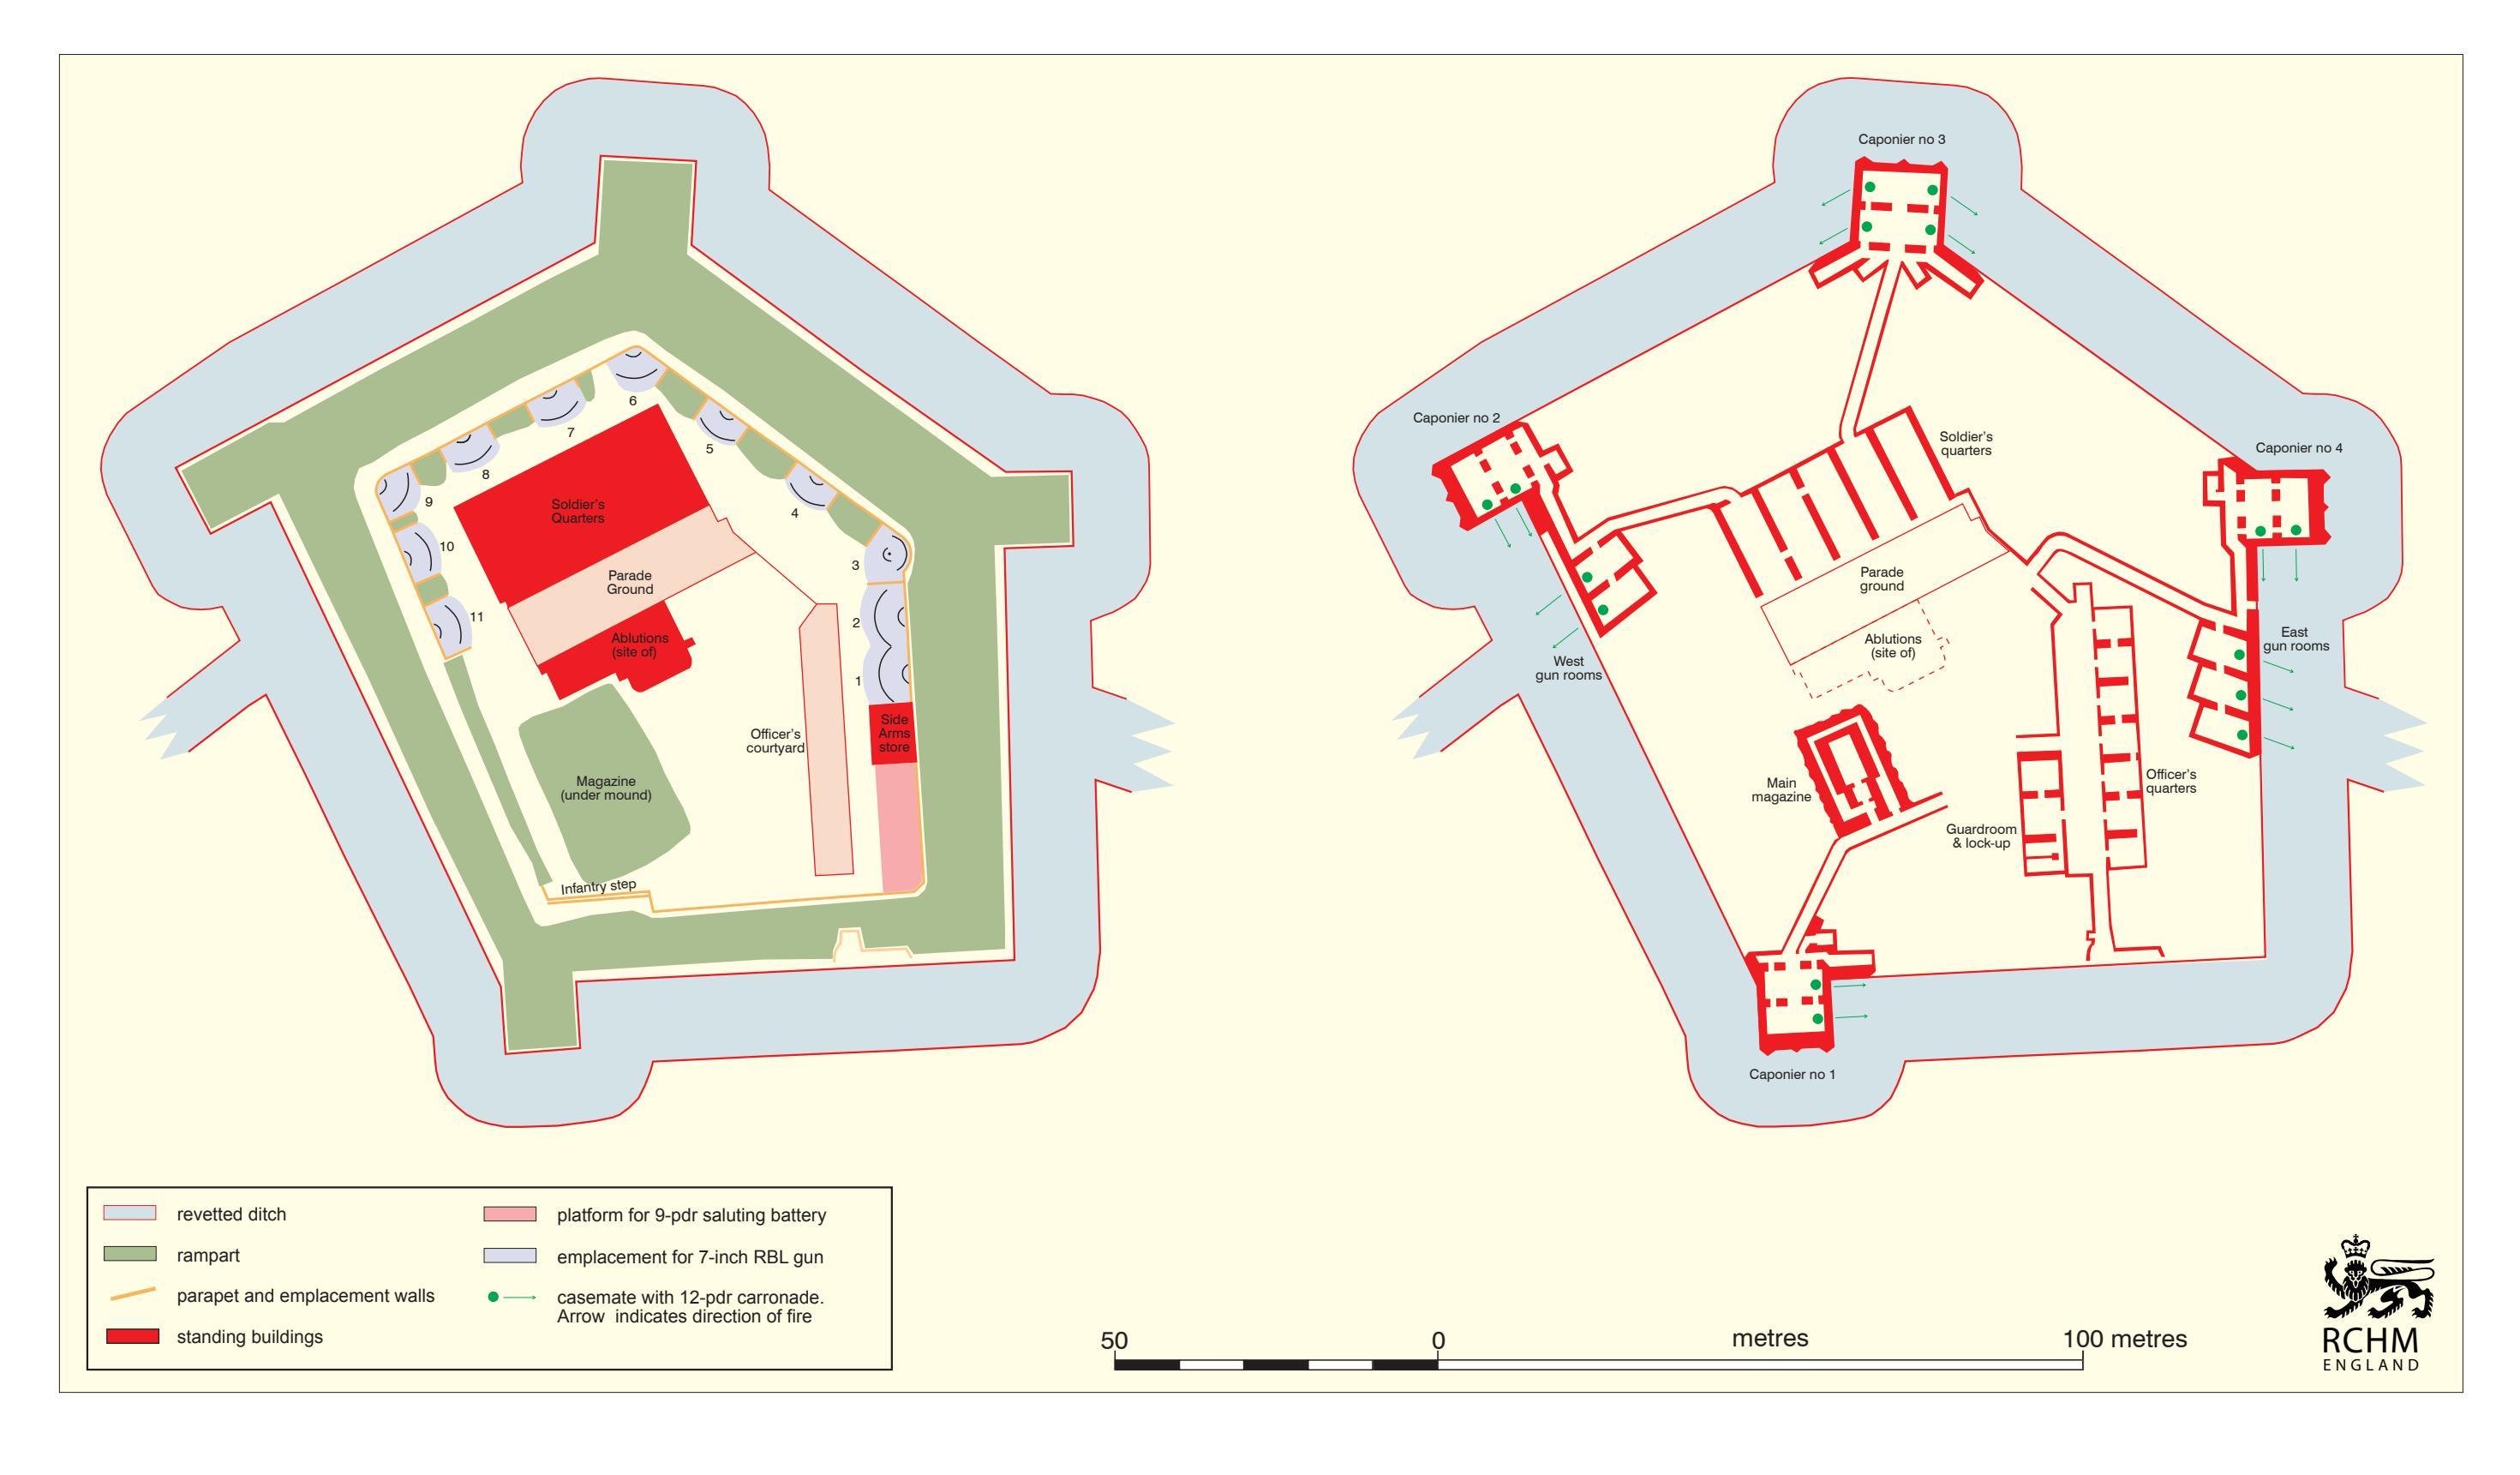
Fig 14c RCHME interpretation plans showing, at left, artillery positions on the terreplein and at right, carronade positions in the caponiers and gun rooms, between c1858 and 1893

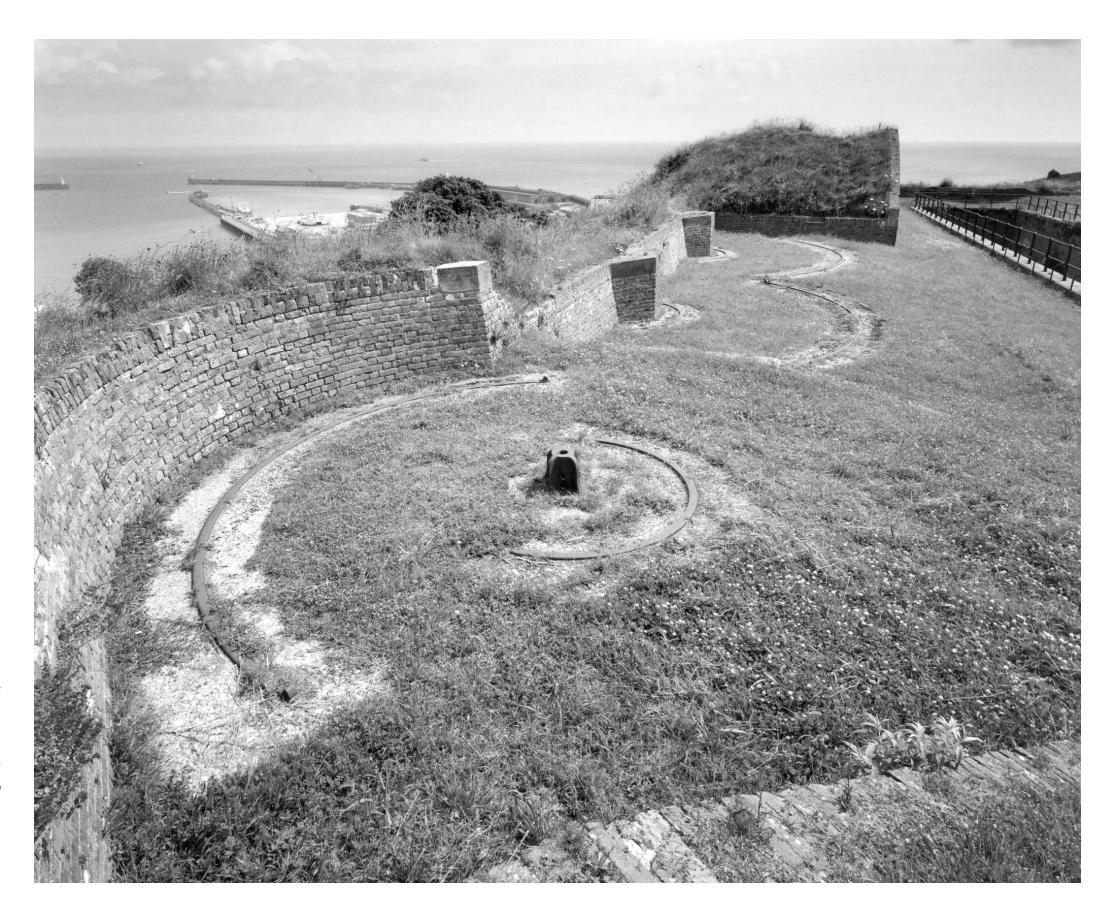
Figure 17 The east face of the terreplein, showing emplacement 3 with its 'C' pivot; emplacements 10 and 11 lie beyond (NMR: BB99/15924)

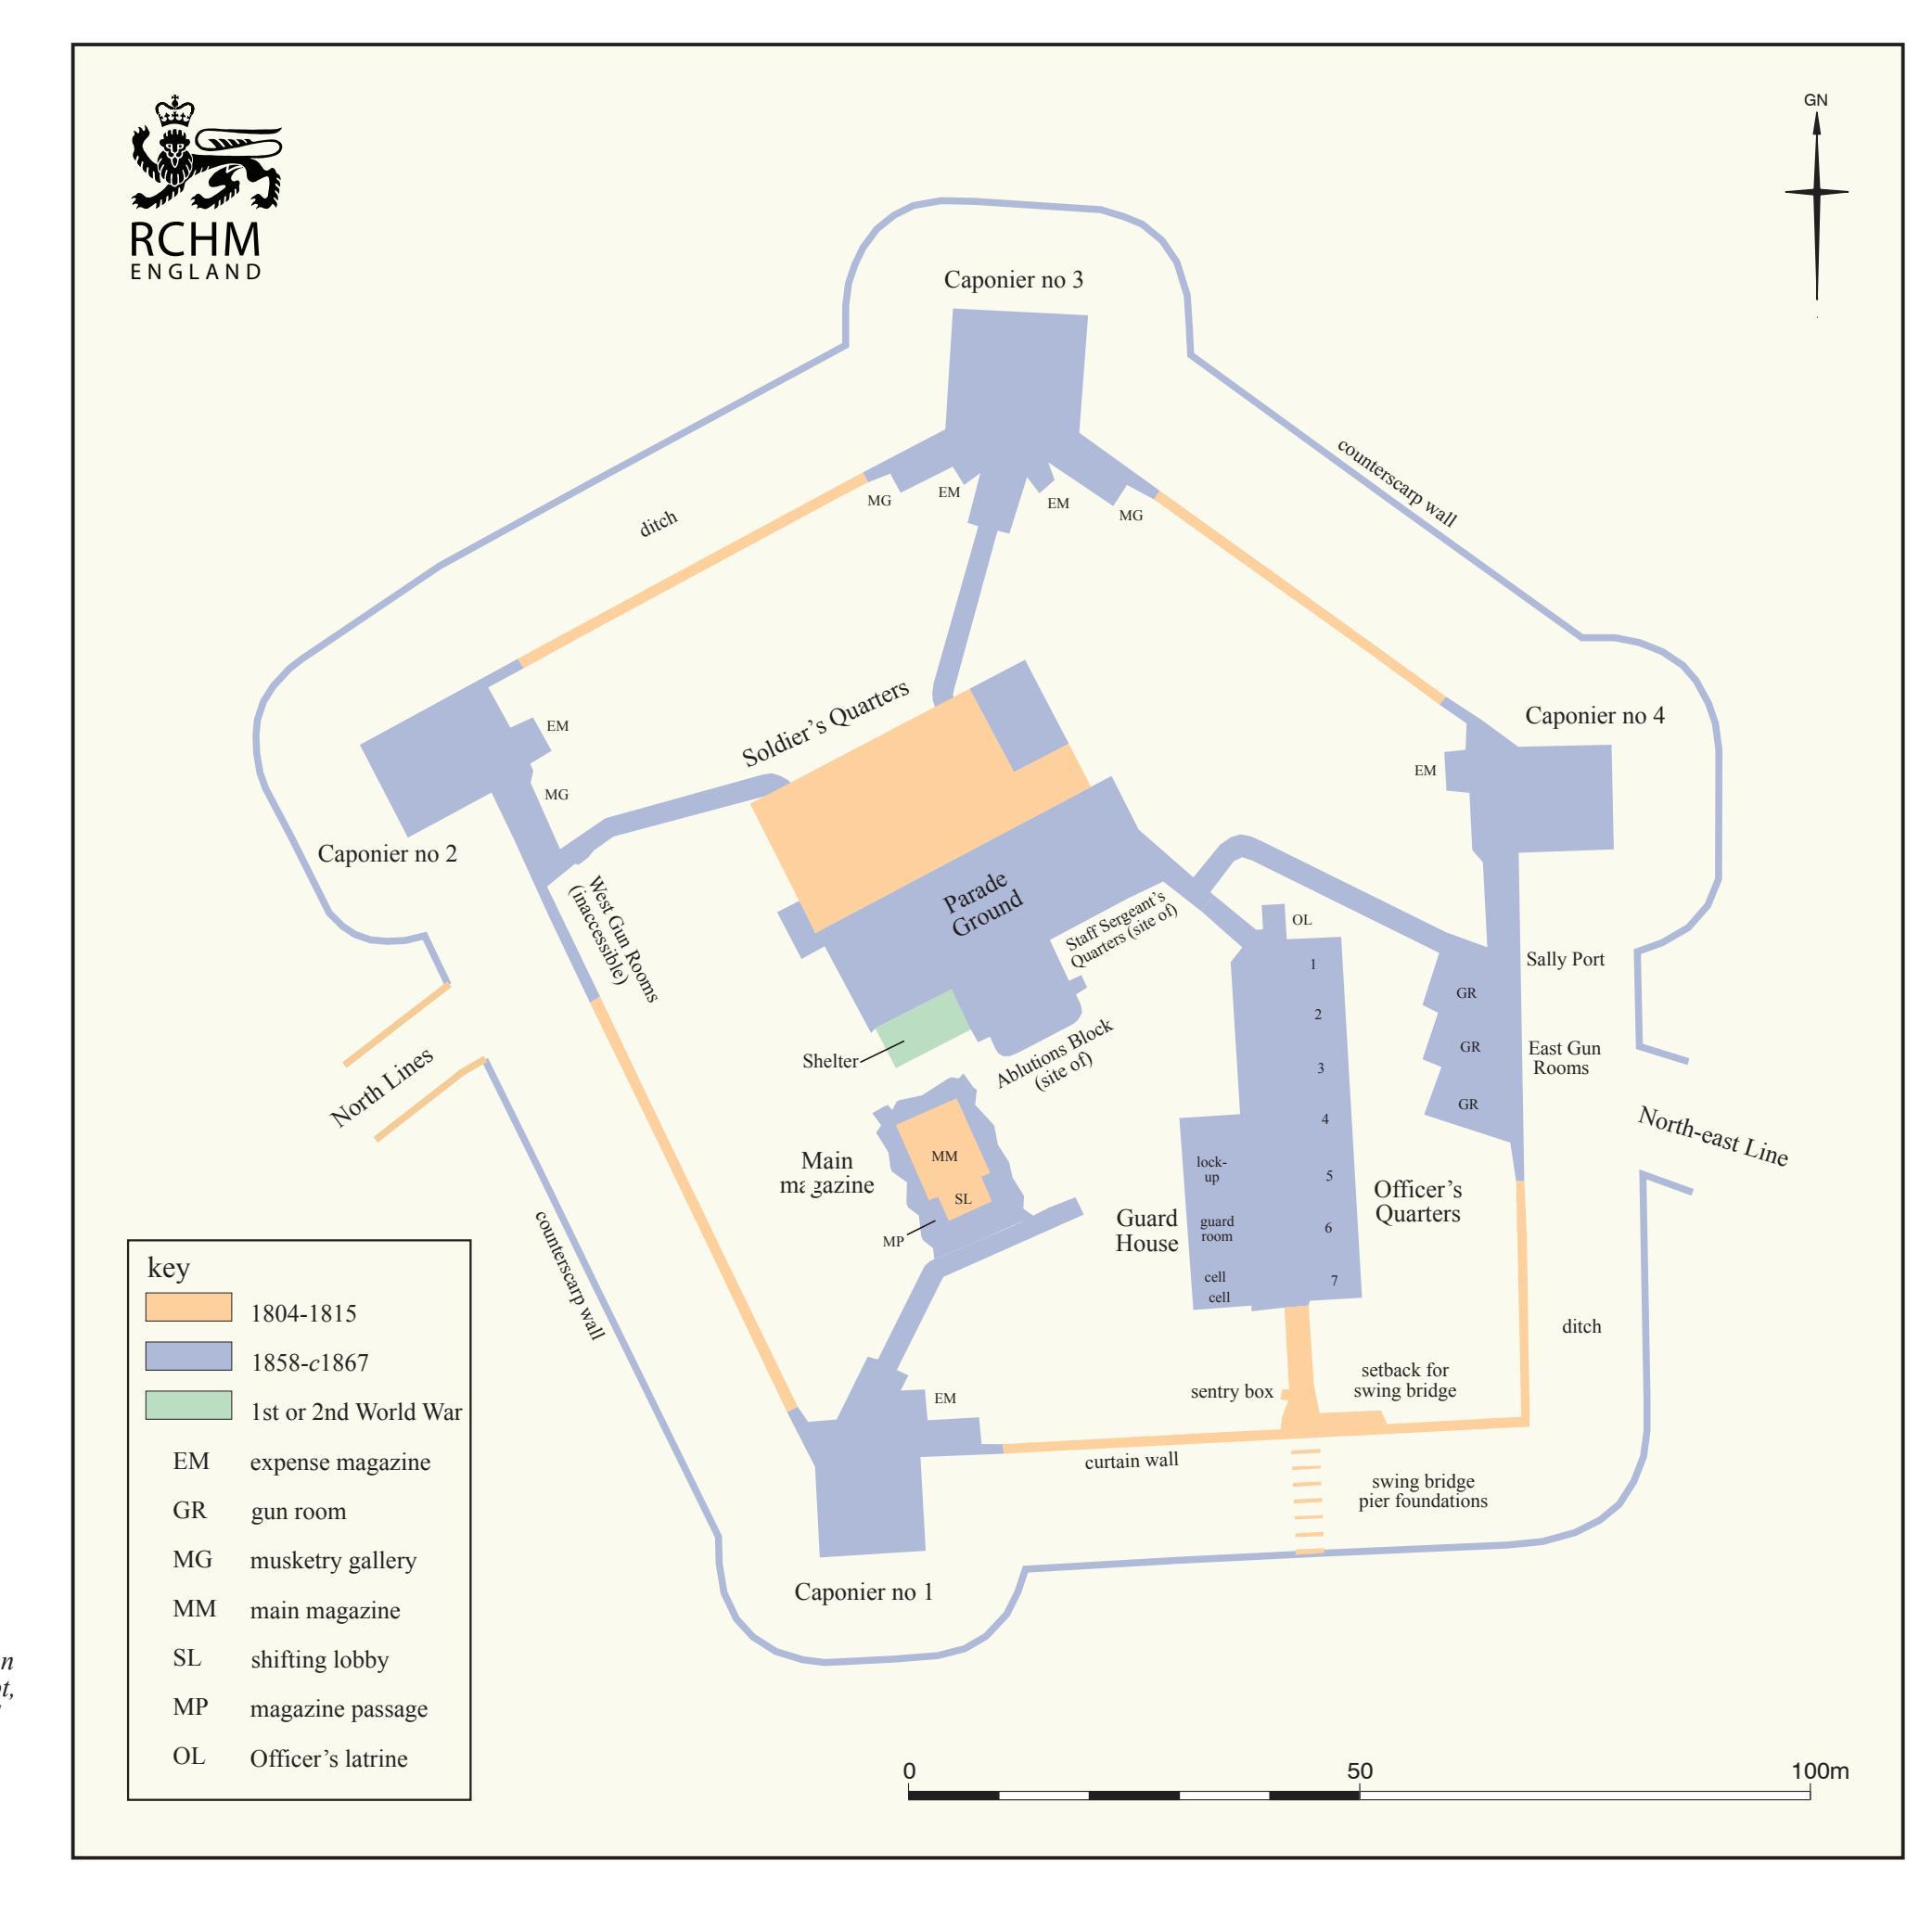
Fig 19 RCHME survey plan of the Drop Redoubt, showing casemated structures and caponiers (reduced from original at 1:500 scale)

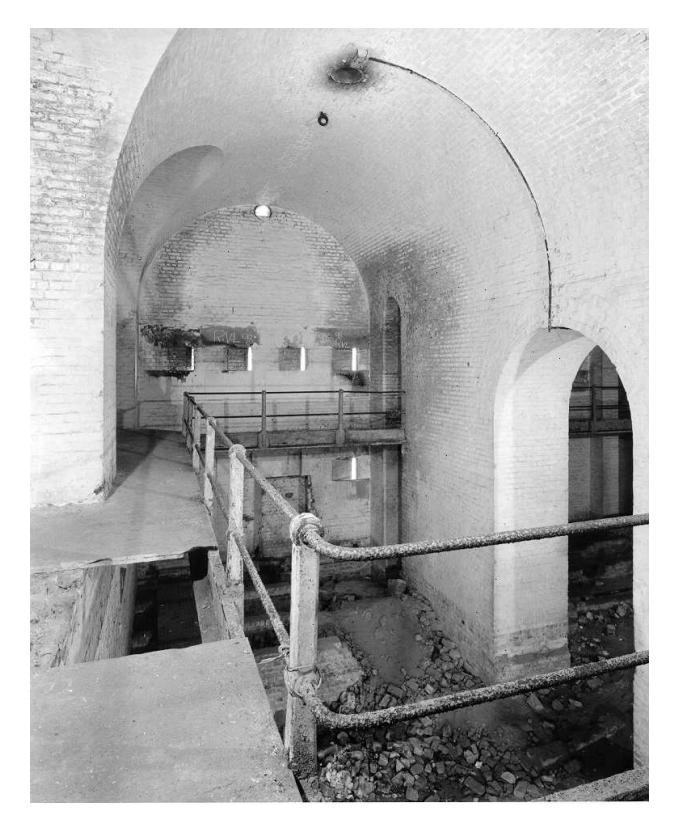
Figure 22 The interior of no 3 caponier, showing vaulting and first floor walkway (NMR: BB99/15904) arches allowing access between the casemates and the galleries (Fig 22). Fireplaces are in the spine wall, one per casemate.

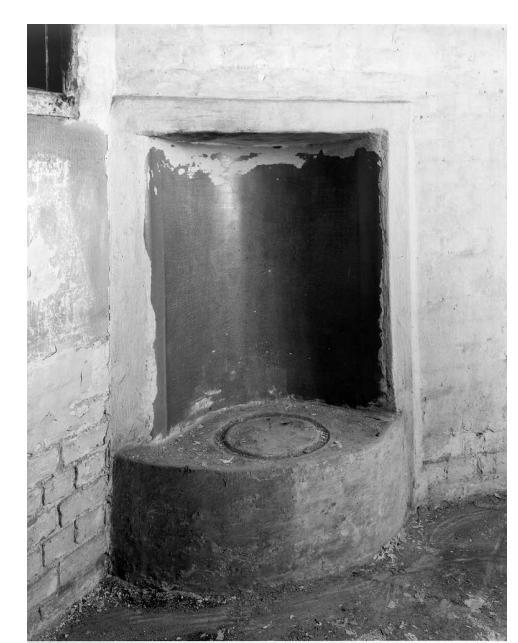
Figure 24 Ceramic splash-back for a bucket latrine in no 2 caponier (NMR: BB99/15900)

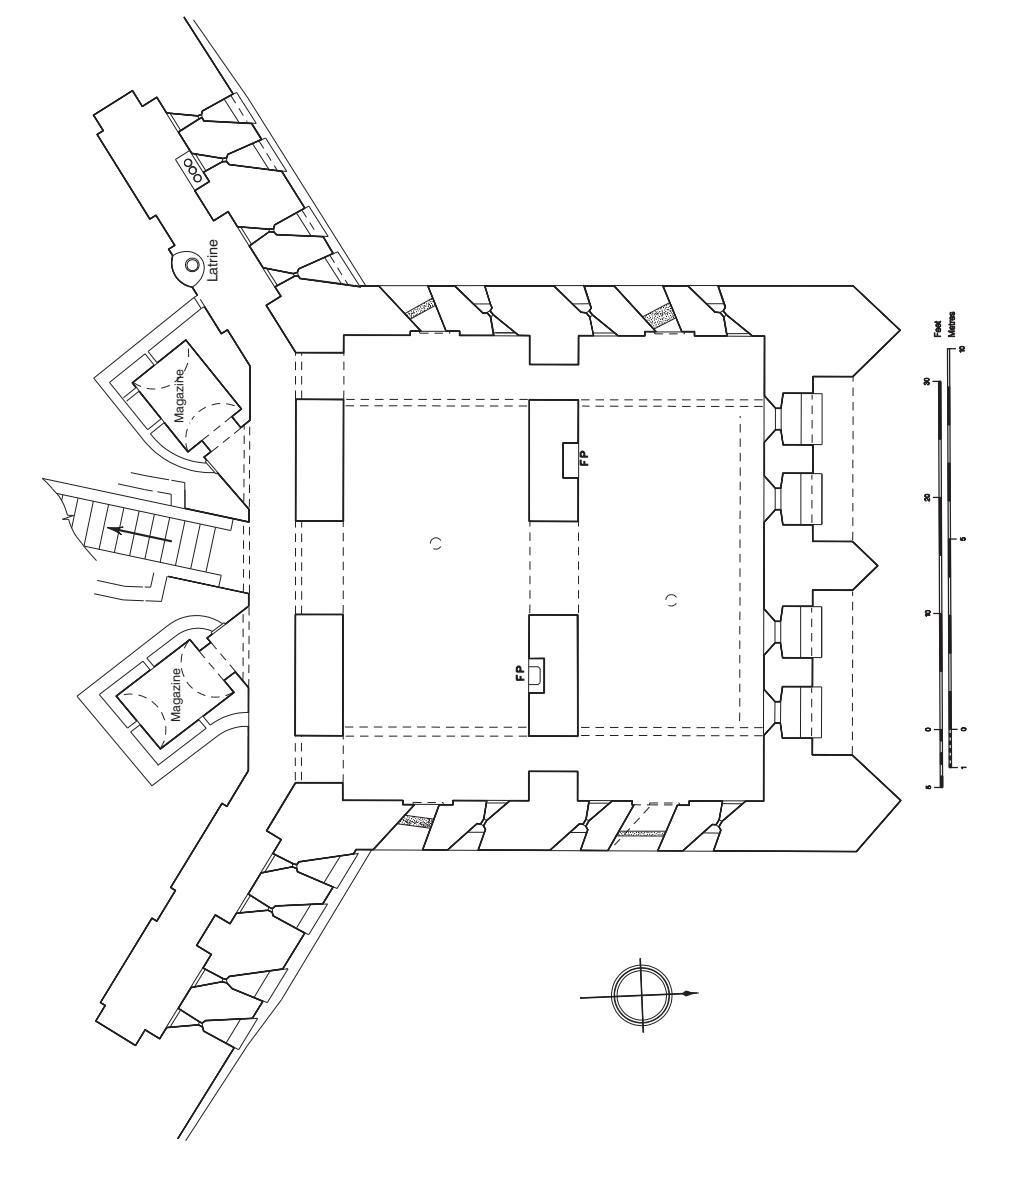
Figure 26 RCHME survey of no 3 caponier; ground floor plan at 1:200 scale

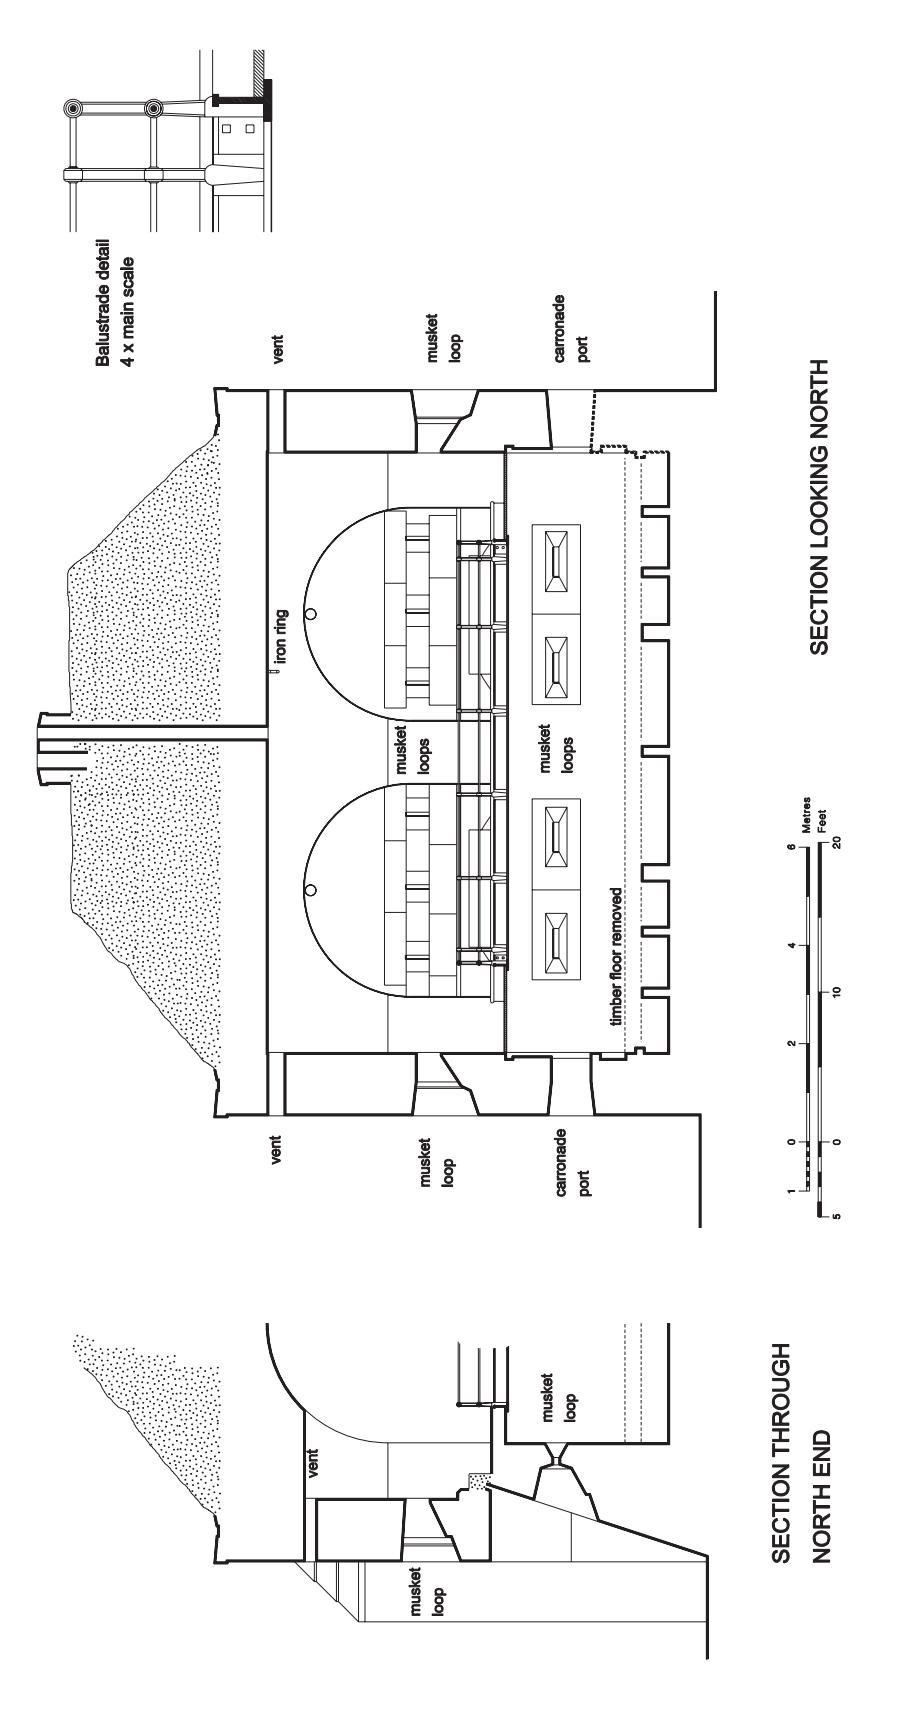
Figure 27 RCHME section through no 3 caponier

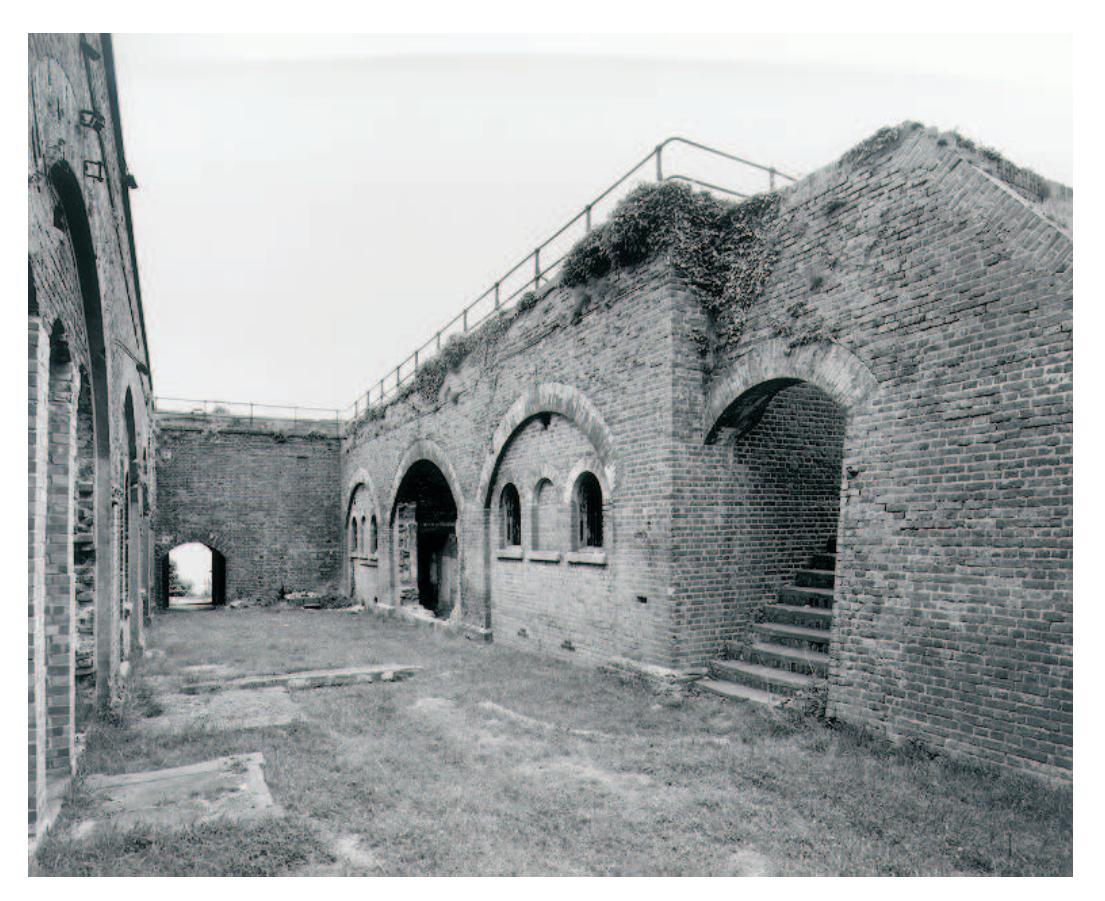
Figure 30 The Guard House range from the north-east (NMR: BB99/15911) The three casemates are constructed in English bond with the semicircular vaults picked out in buff brick, which is also used for door and window jambs. As there are no obvious changes in brickwork, colour or coursing and no apparent joints, it is reasonable to assume that they are of a single build. The inclusion of identical fittings like cast-iron flap ventilators in the front and rear walls of all the casemates lends support. Each casemate has three high-set small windows with sandstone sills; the central windows are blind and were probably always so, as the brickwork courses through. The central casemate has had the majority of its courtyard wall demolished but traces of jambs or their seatings suggest that it contained a door flanked by two windows. All the casemates contain set-backs and dwarf walls for suspended timber floors.

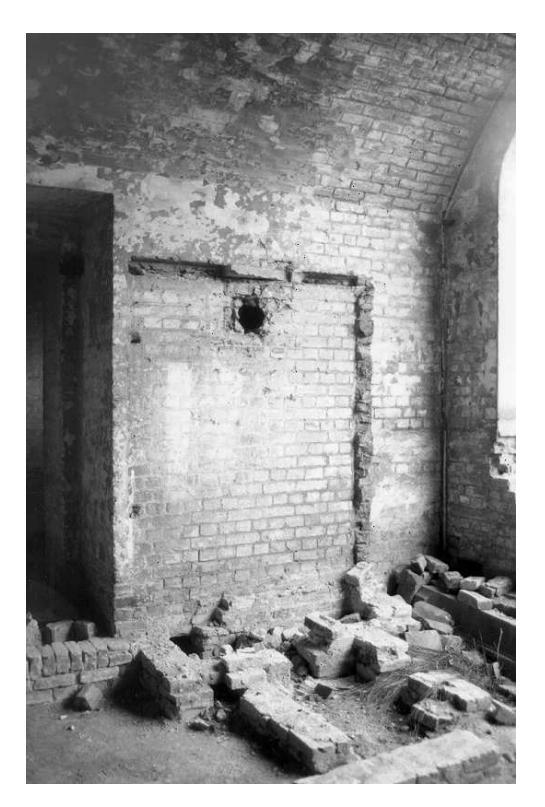
example of this type of closet in the North Entrance (NMR: WD/2306). This had a wrought-iron clothes horse which fitted into a separate heated compartment at the rear of the stack. Hot air passed into the Lock-up via an intramural vent and fine adjustable outlets set just below window-sill height.

Figure 31 Remains of the stove and hot air cupboard in the Guard Room (NMR: MF99/01348/16)

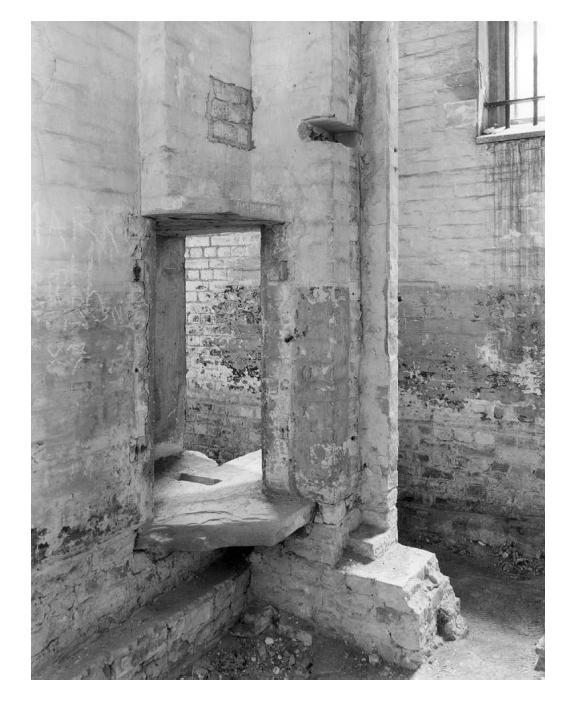
Figure 32 Setting for a rotating serving hatch built into the wall between the cells in the Guard House (NMR: BB99/15915) central pivot, set in a circular depression cut into the tooled stone sill. The only light for the cells came through barred fanlights over each cell door and ventilation was by cast-iron flap ventilators in the crown of the vault and the partition wall.

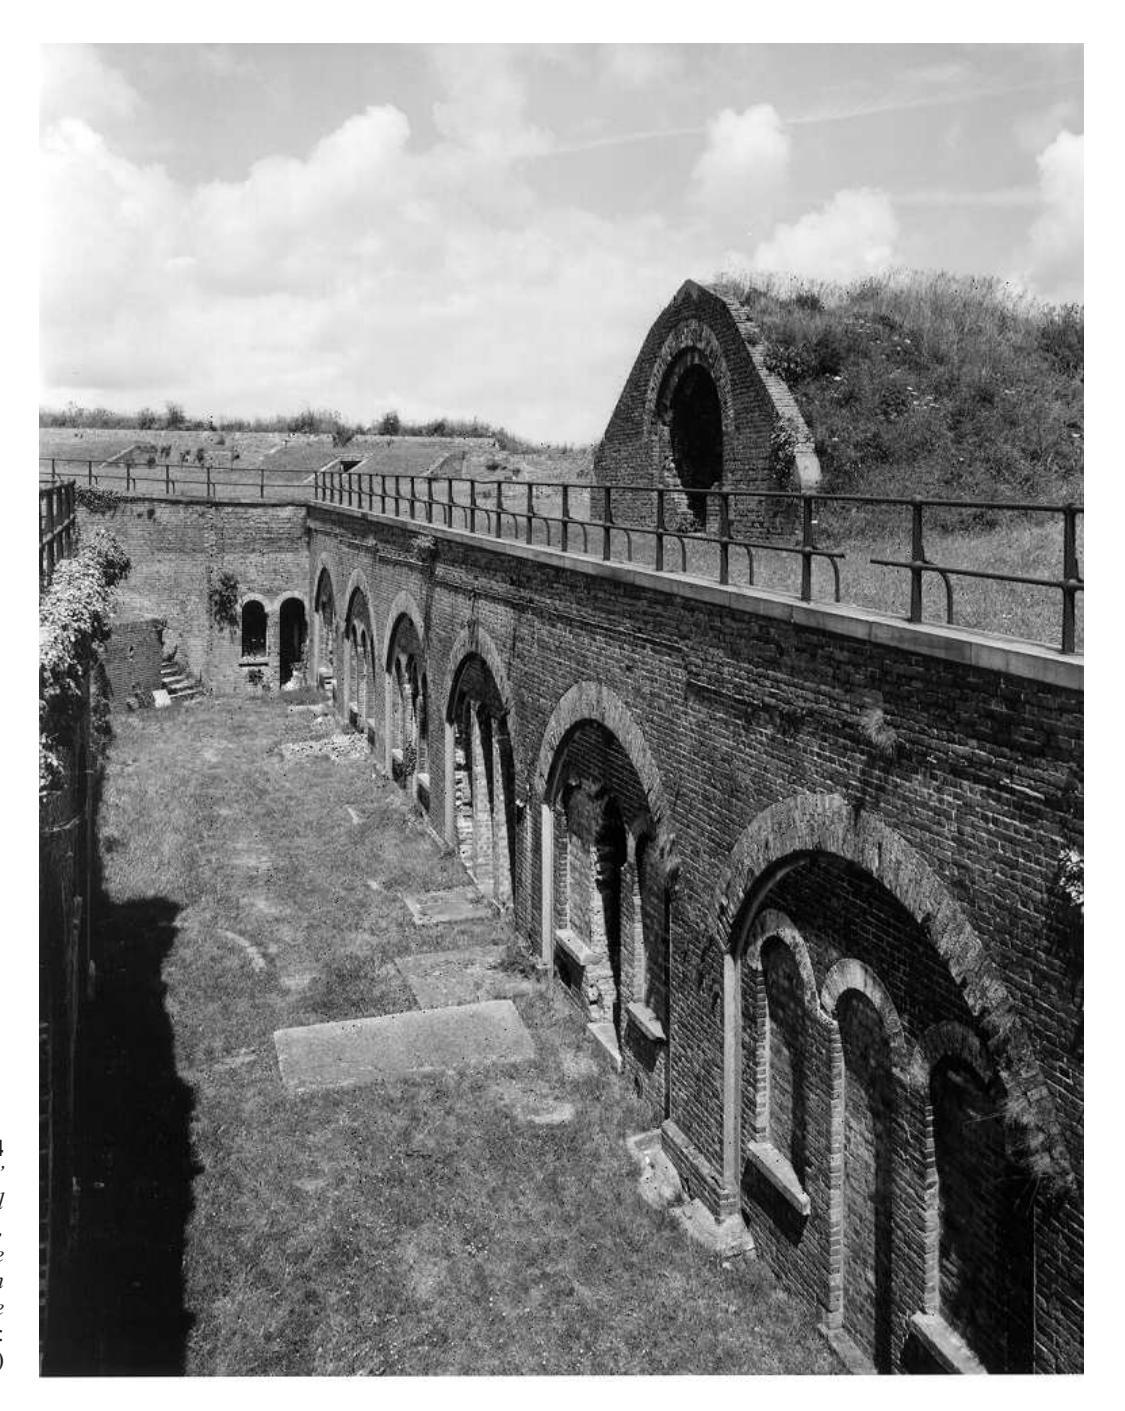
Figure 34 The Officers' Quarters: general view from the south, also showing the side arms store on the terreplein above (NMR: BB99/15918) 1810-13, nor one of shortly before 1860 (Figs 4, 5, 11 & 14b). However, close examination of another plan made around 1860 shows both that the range has been added in pencil and then inked over, and that the courtyard had not been built (Fig 6). Additionally, a flight of steps is shown in the position now occupied by the Officers' Latrine. These facts, together with the use of buff brick in the same manner as the Guard House, show that the Officers' Quarters were also part of the 1858-67 remodelling. The 1881 plan labels the Officers' Quarters 1 to 7 from north to south and this sequence is followed below.

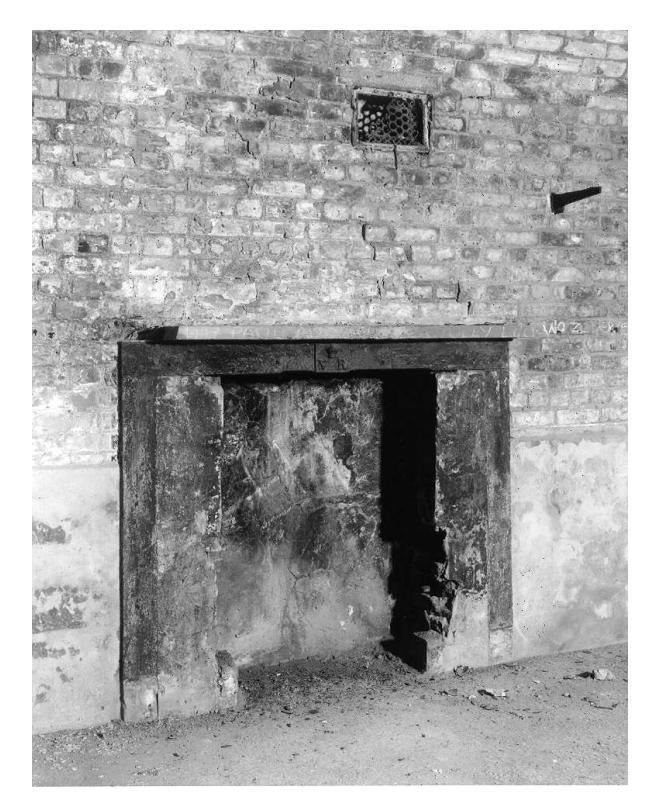
alternate crosswalls, while no 1 was served by a fireplace in the south wall. No 6 contains what appears to be the original form of cast-iron fireplace surround, with beaded edges and the royal initials (V R) cast in the lintel, above which there is a stone mantel shelf (Fig 35).

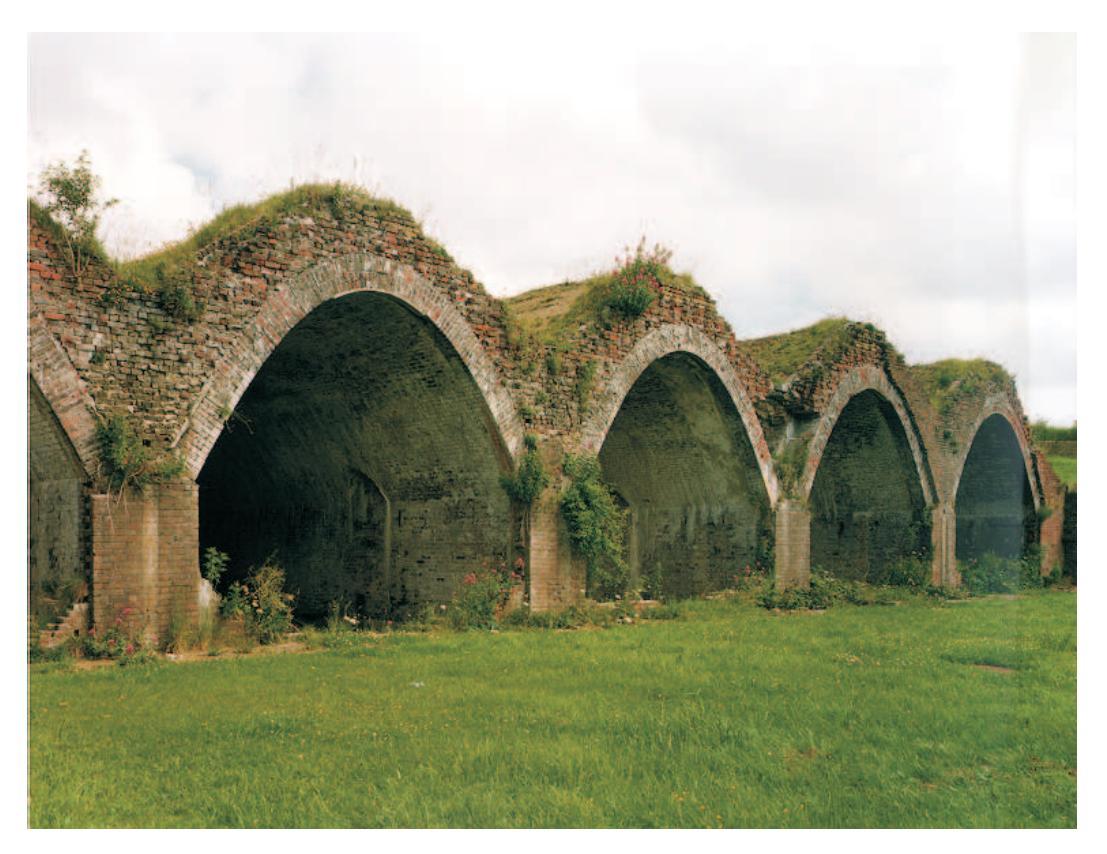
Figure 37 The Soldiers' Quarters: general view from the south (NMR: BB99/15930)
