THE WESTERN HEIGHTS, DOVER, KENT

REPORT NO 3

THE DROP REDOUBT

A 19TH-CENTURY ARTILLERY FORTIFICATION

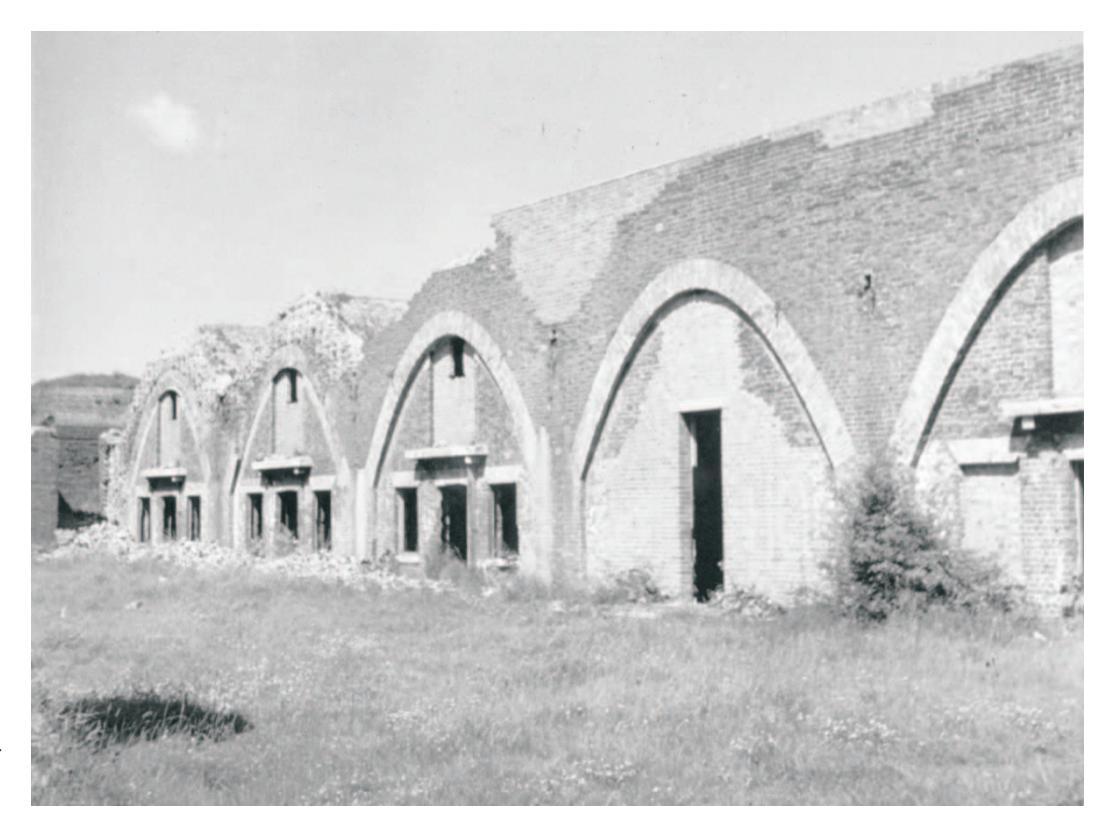
Figure 39 The Soldiers' Quarters prior to removal of the south elevation detail (Dover Museum: D07905; reproduced by kind permission of Dover Museum)

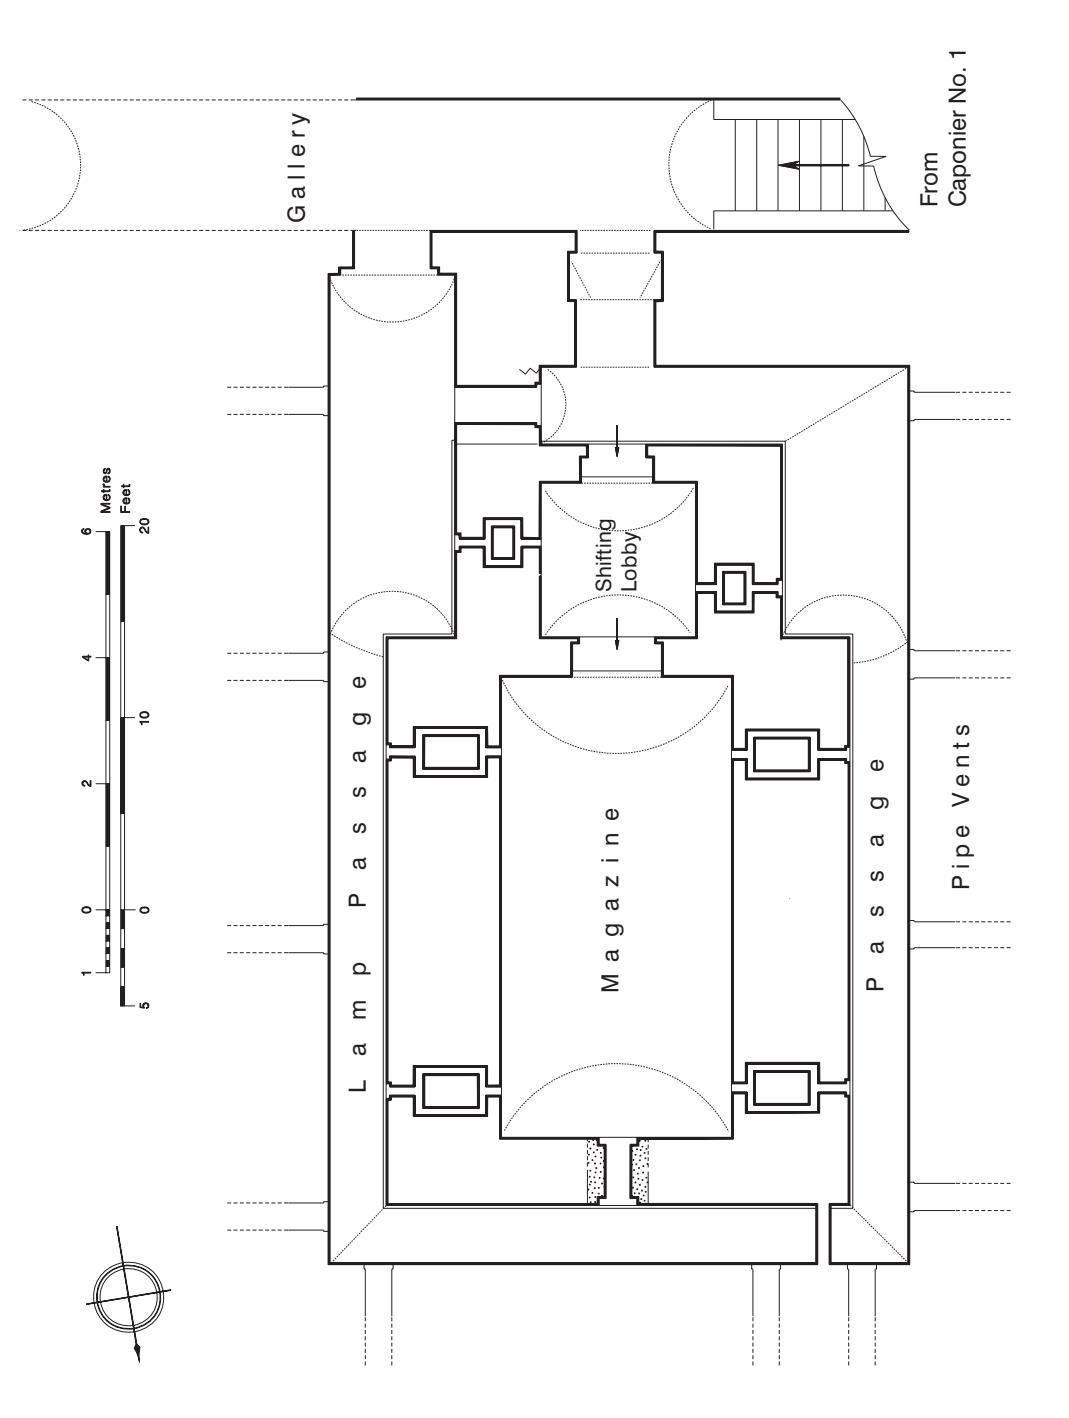
Figure 44 RCHME survey plan of the Main Magazine

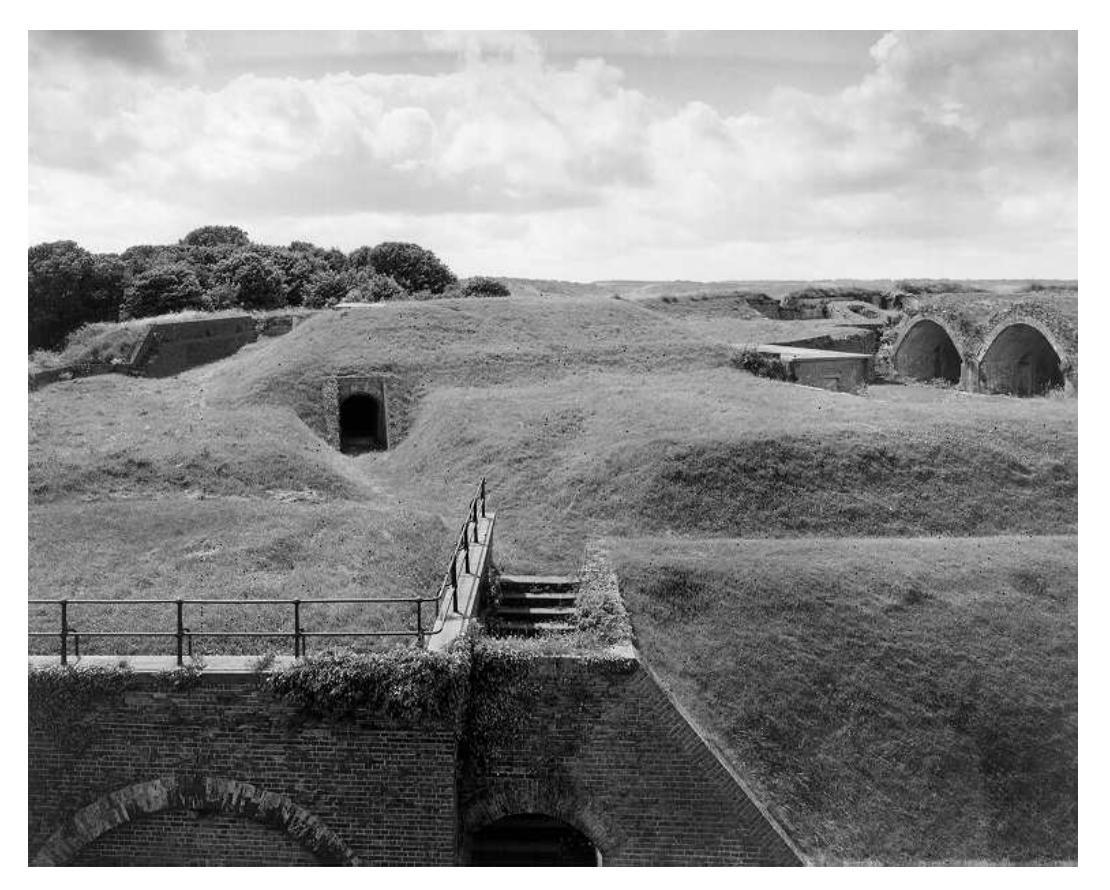
Figure 45 The Main Magazine mound and entrance, from the east (NMR: BB99/15934)

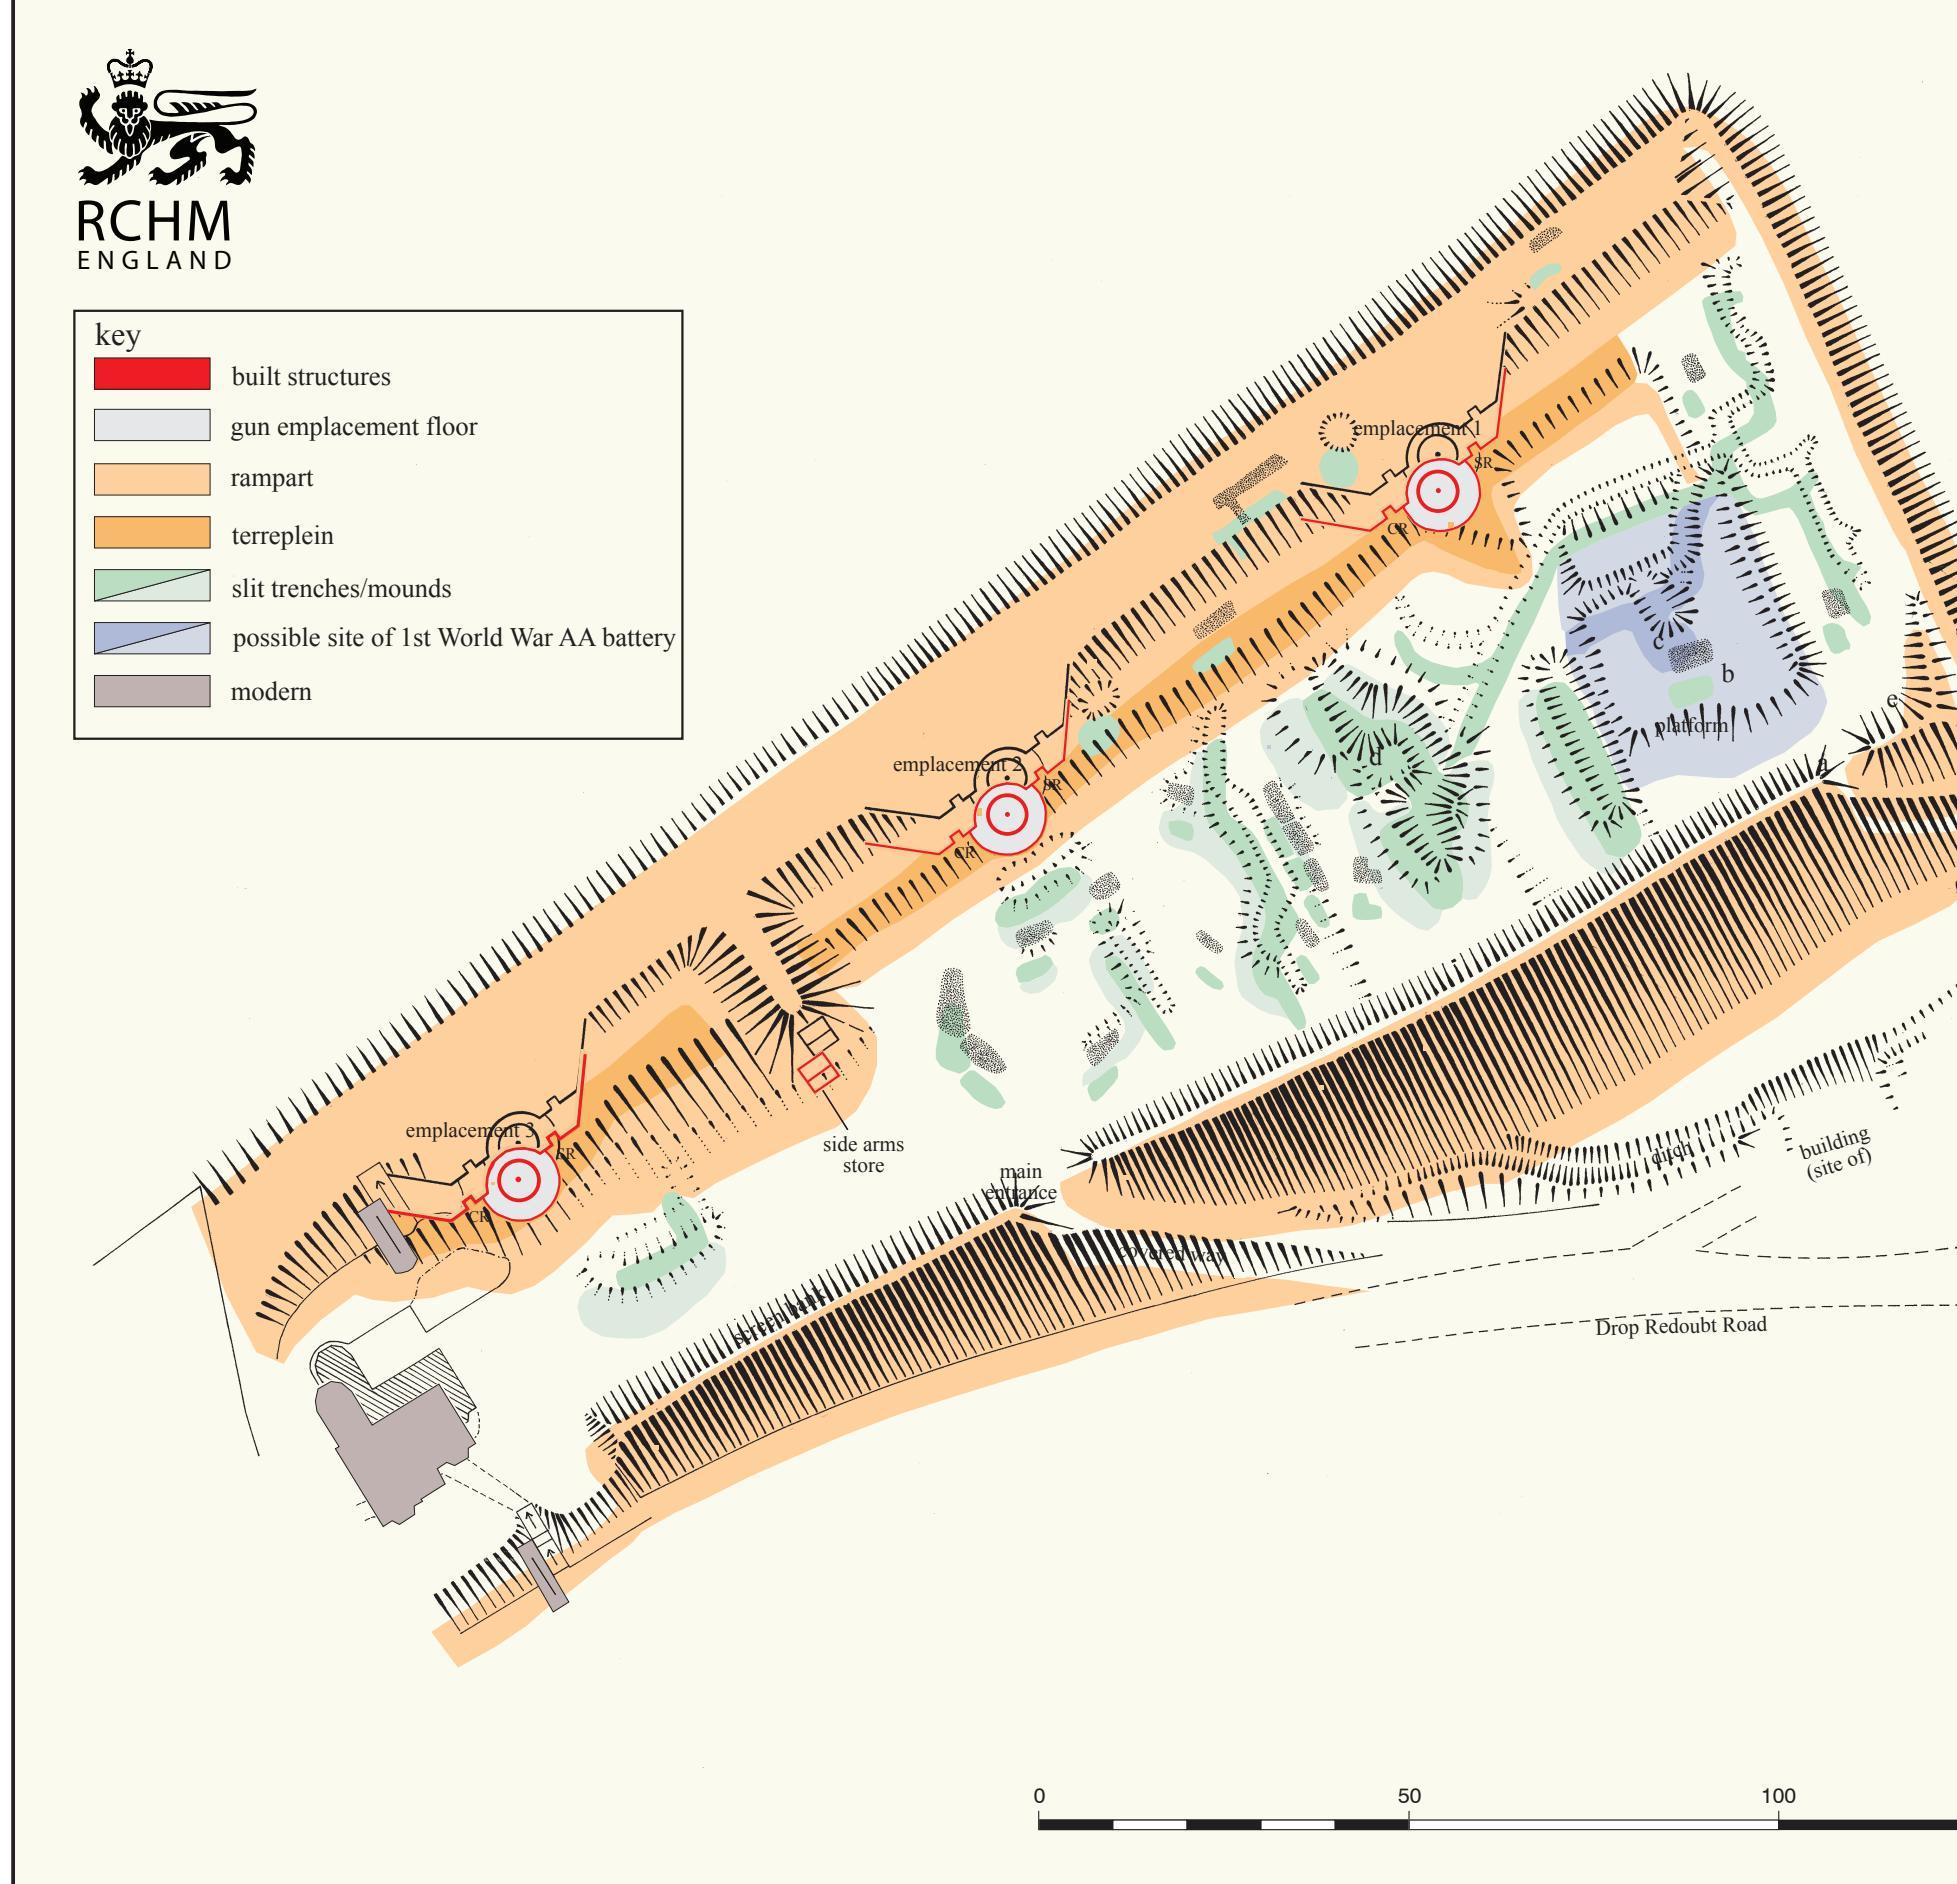
Fig 49 *RCHME survey and interpretation plan of the battery on the North Lines (reduced from original at 1:500 scale)*

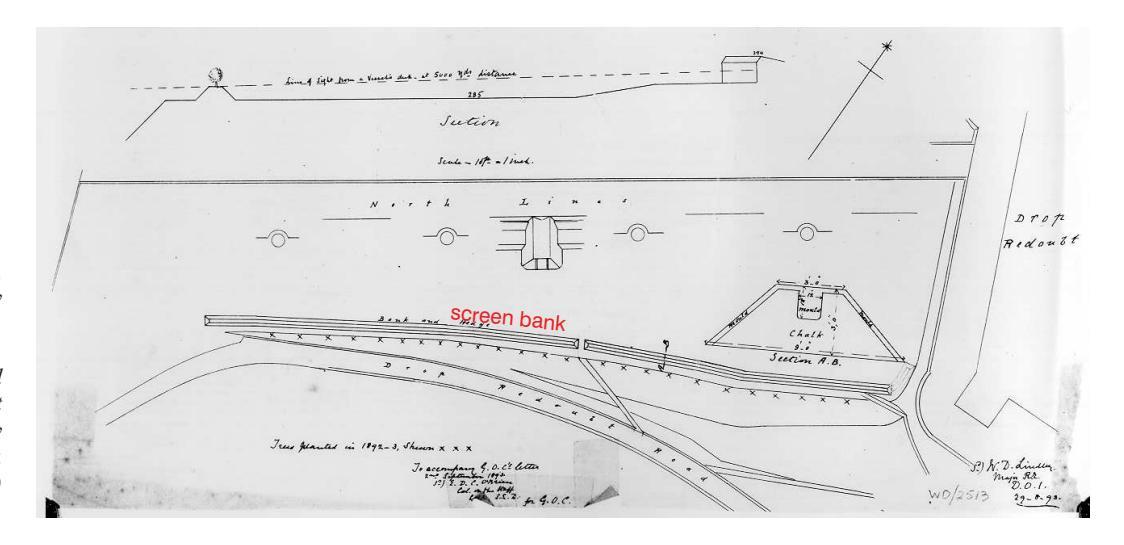
The ridge west of the Drop Redoubt is flattened into a broad top, along the north side of which four gun emplacements stood on a *terreplein* behind a **rampart**: three emplacements survive along with a **side arms store** towards the centre; a fourth emplacement and expense

Figure 51 Plan of the battery

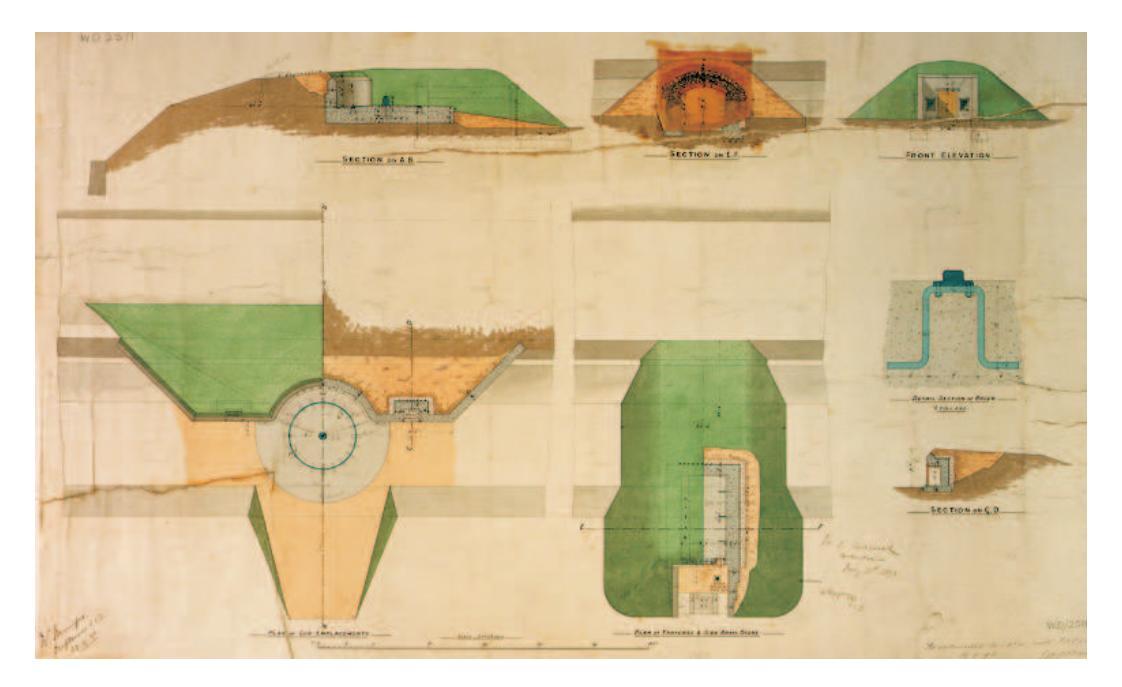
Figure 52 Proposal plans, elevations and sections of a gun emplacement and side arms store for North Lines Battery, dated 1892 (NMR: WD/2511) heavy RML guns to traverse on a central steel pivot. The gun floors were originally ramped down to the south and part of the ramp for no 3 gun survives; the others have been cut away.

The **side arms store**, located centrally to the original four emplacements, survives in good condition, much as shown on the 1892 plan (Fig 52). It is set slightly below ground level into a large earth mound, 34.0m long, 22.0m wide and 2.7m high, set across the *terreplein* at right angles to the rampart. The only visible elevation is that to the south: it is in concrete, with a central entrance flanked by windows. The door has a wooden frame for an outward-opening door, approached down a flight of four steps. On each side of the door is a small opening with a wooden frame for an inward-opening four-light window, originally glazed but replaced by two vertical steel bars (those of the eastern window are missing). Inside, the single chamber has a brick barrel vault above concrete walls, with no form of ventilation. It is whitewashed and has no obvious signs of shelving.
