CAERPHILLY CASTLE

Derek Renn CBE, PhD, FSA

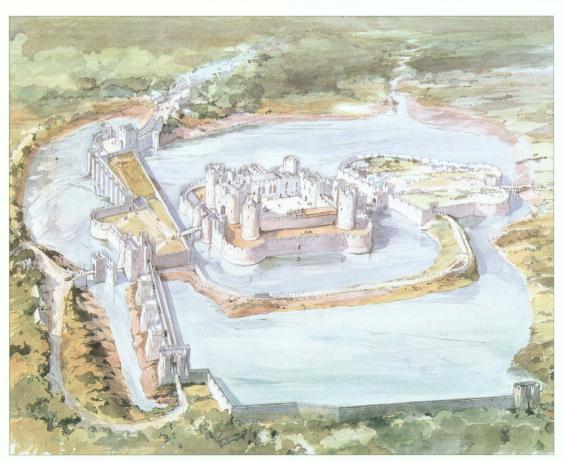
An artist's impression of Caerphilly Castle as it may have appeared on completion of the last phase of major building works in the mid 1320s. The size and strength of the stone defences, coupled with the scale of its two vast lakes, combine to make Caerphilly one of the largest castles in the British Isles (Illustration by Terry Ball, 1989).

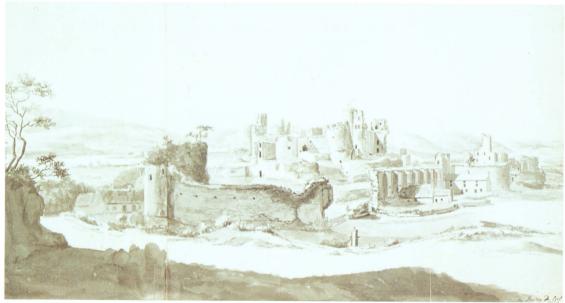
During the later Middle Ages, Caerphilly Castle appears to have been allowed to fall into gradual decay. By the time Henry de Cort (1742–1810) produced this watercolour in 1793, the front of the east gatehouse had already collapsed, the south-east tower was leaning, and there was a large breach in the south dam (By courtesy of the National Library of Wales).

Much of the damage to castle defences, however, may not have been the result of military action at all. Indeed, the dilapidation could simply have been the result of stone removal by the owners after 1583. Once the sluicegates were neglected, the lakes would have been drained and the embanked islands on which the castle stood would have dried out and 'heaved' or slumped. This was clearly the case on the north dam wall (p. 29), where the curtain wall itself has parted company from the towers along its entire length.

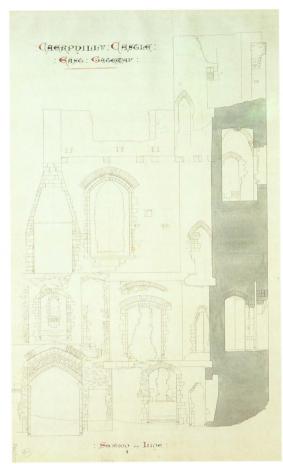
The third marquess of Bute had Caerphilly Castle carefully recorded in a series of detailed plans and elevations. The drawings were the work of William Frame (d. 1906), an architect who worked on other Cardiff projects for the marquess. This illustration is one of Frame's sections of the east gatehouse, and now forms part of the site archive.

The restoration of the castle began a century later when John Patrick Crichton Stuart (1847–1900), the third marquess, reroofed the great hall during the 1870s, and later had the ruins fully recorded in measured drawings. The third marquess of Bute was undoubtedly enthralled by the medieval past, and had both Cardiff Castle and the enchanting Castell Coch rebuilt by his remarkable architect, William Burges (1827–81).

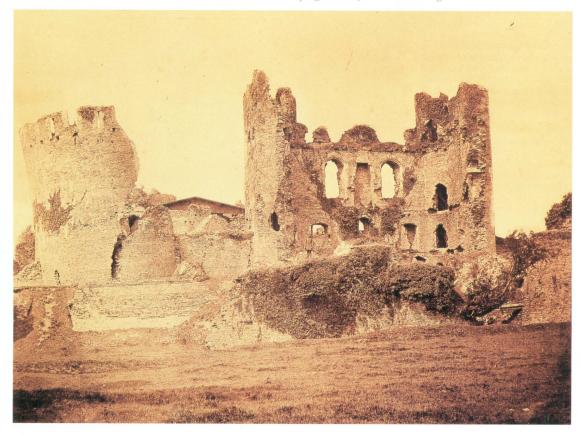
Above: The painstaking restoration of Caerphilly was the work of John, fourth marquess of Bute (d. 1947), and was undertaken from 1928 to 1939. One of the major pieces of rebuilding was the front of the great east gatehouse, along with the smaller gate towers at its front.

Below: This early photograph shows the east gate prior to the programme of restoration. The gate was rebuilt in 1931–33.

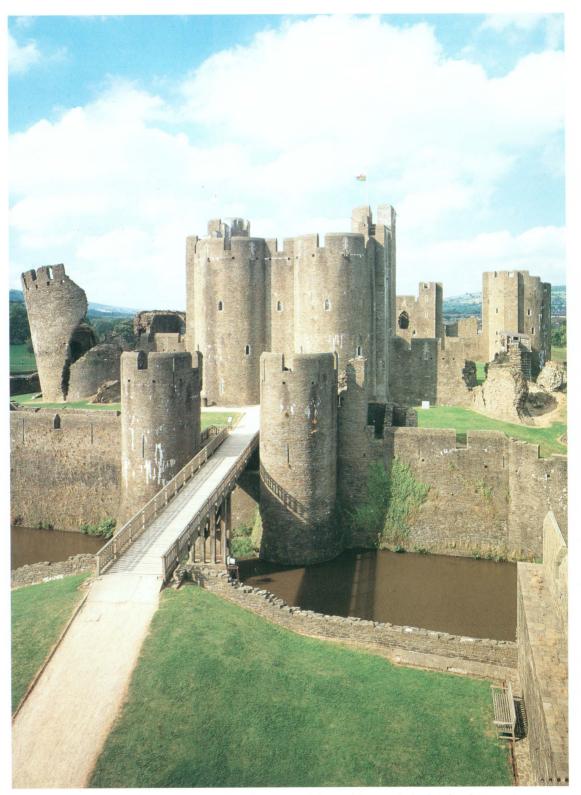
Viewed from any direction, the concentric — walls within walls — defences of the central island are hugely impressive. This view is from the top of the main outer gatehouse.

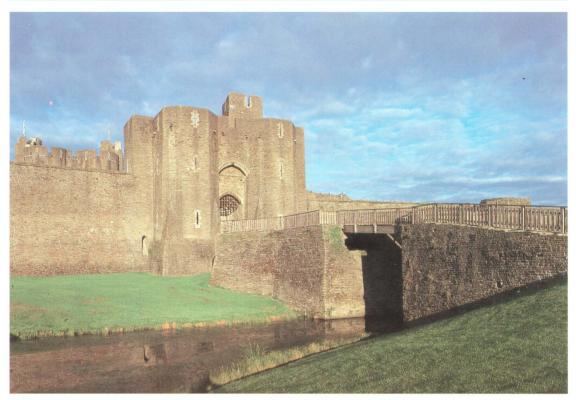
The main outer gatehouse and the remains of the bridging arrangements across the outer moat. The intact survival of the gatehouse is probably due to its long use as a prison for the district.

The main outer gatehouse, through which you will have entered the castle, survives remarkably intact, probably due to its long use as a prison for the district. It was this gateway, and the chamber above, which were almost certainly repaired for Earl Richard of Warwick in 1428–29. A new gate of oak was hung in the passage, and the roof, doors and windows were all replaced. It was the outer gatehouse, too,

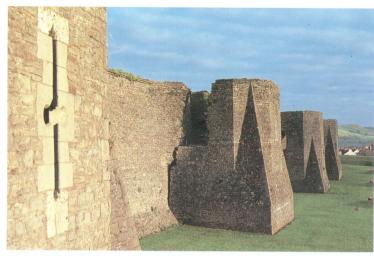
The north dam, showing the angular towers which have been pulled away from the wall face as a result of ground settlement. Note that the lower stages of the towers were not built into the wall and have therefore parted clean.

To the right lies the slightly later extension, a second fortified dam holding back the waters of the north lake. Close inspection of the stonework reveals that this wall — at least in its lower courses — is contemporary with the main gatehouse itself. There is a similar gateway closing off the far end of the platform. The dam is fronted by three angular towers, with spurred bases, and which have been

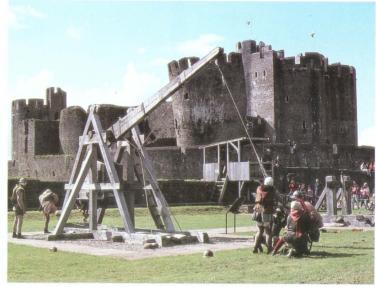
Four full-scale reconstructions of medieval siege engines are located on the south dam platform. Here the trébuchet is shown as it is prepared for firing,

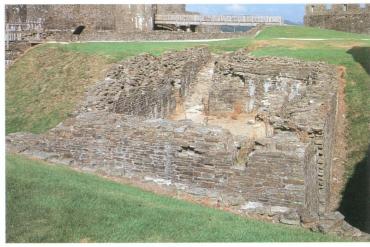
The cornmill on the south dam platform was in operation from the thirteenth to the seventeenth centuries, and it is a rare survival.

A cutaway reconstruction of the castle mill, showing the arrangements by which its overshot wheel was driven (Illustration by Chris Jones-Jenkins, 1989; with modifications, 1997).

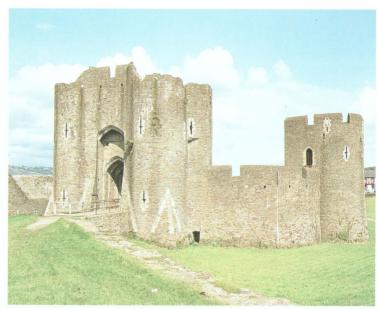
The south dam ends in a rounded salient, with a projecting round tower and a gatehouse facing the town. The gate was probably that attacked during the Llywelyn Bren uprising of 1316.

The dam ends in a rounded salient, with a projecting middle tower and a gateway to the right. The half-round tower may have had an open back in its earliest phase, and was situated where defenders could protect the most exposed part of the salient. The south gateway has twin towers which have been rebuilt at various times. To the right of the central passage, the gate is largely a modern reconstruction. The left-hand tower retains much original work, with the more recent additions marked off by rows of red tiles. The exterior of the gate towers retain spurred bases, and in the passage there are the same unusual slots for the drawbridge pivots seen in the main gatehouse (pp. 29-30).

It was probably this southern gateway towards the town which lay most exposed to the Welsh assault during the Llywelyn Bren uprising of 1316 (p. 16). It seems very likely that the 'turning bridge' destroyed by fire in the attack was the drawbridge in this gatehouse. The gate was afterwards repaired on the orders of the royal administrator, John Giffard (d. 1322), and subsequently it was to acquire the name 'Giffard's Tower'.

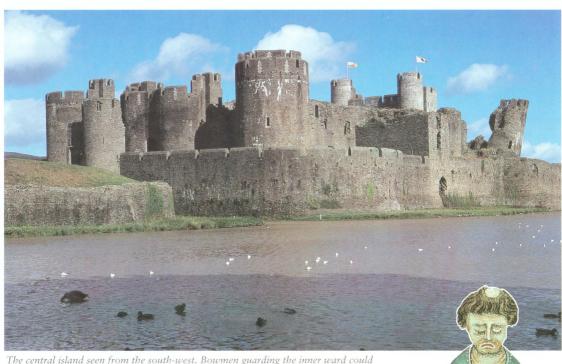
The central island seen from the south-west. Bowmen guarding the inner ward could easily fire over the tops of the lower outer walls.

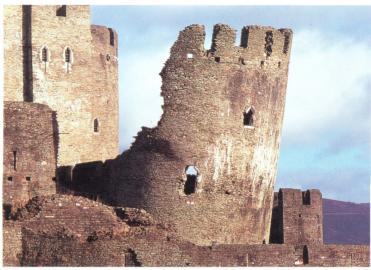
Caerphilly's most celebrated feature is perhaps its 'leaning tower', the south-east tower of the inner ward. It leans at an angle of 10 degrees, probably the result of ground subsidence.

The far corner is the best position to view what is in fact the south-east tower of the inner ward. The great three-storey tower has in effect split, perhaps due to ground subsidence, and now leans out at an angle of 10 degrees from vertical. Despite its precarious appearance, the outer face of the tower remains undamaged, and its features are entirely original. At ground level there are three arrowslits, whilst in the two upper floors there are trefoil-headed windows belonging

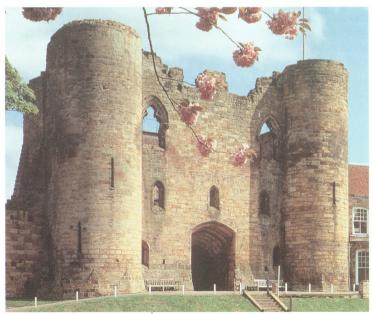
The gatehouse at Tonbridge Castle in Kent may have been raised just a few years before Caerphilly Castle. It was perhaps the work of Gilbert de Clare's father, Richard (d. 1262). As this view of the inner façade shows, it may have provided the model for the east gate at Caerphilly.

Gilbert de Clare's remarkably advanced gatehouse is almost identical in size and design to one which may have been built a few years earlier at Tonbridge Castle in Kent by his father, Richard.

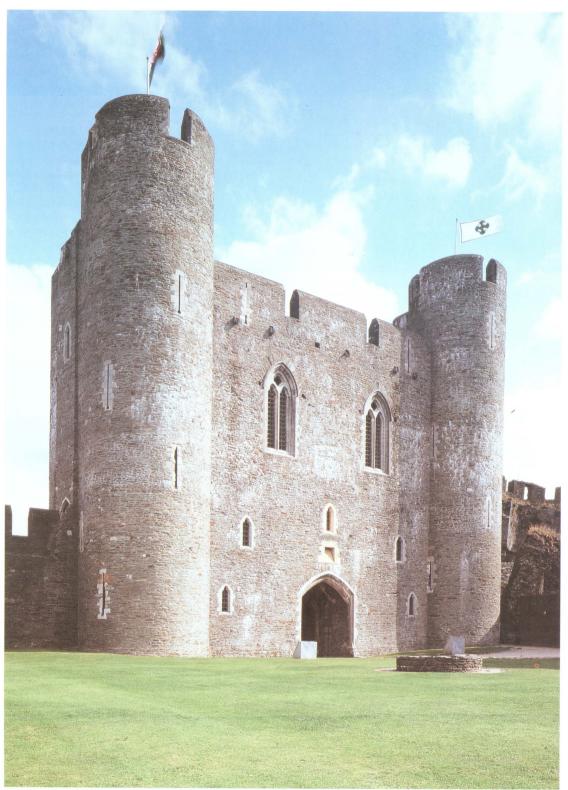
The great east gatehouse continues to dominate the entire castle. It probably housed the 'constable's hall', a name first recorded in 1373–74. The inner façade, seen here, is almost entirely original up to the level of the battlements.

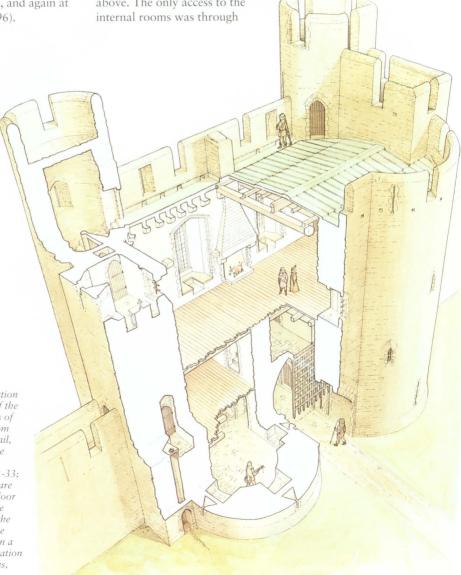
A cutaway reconstruction showing something of the internal arrangements of the east gatehouse from the south-east. In detail, the drawing shows the. gate much as it was reconstructed in 1931-33; other interpretations are possible. The upper floor probably served as the constable's hall, and the small room seen at the top left may have been a private chapel (Illustration by Chris Jones-Jenkins, 1997).

At the back of the gate, the circular corner turrets contain spiral stairs which link the three internal floors and the battlements. At ground-floor level, there is a small, trefoil-headed window in the room to either side of the passage.

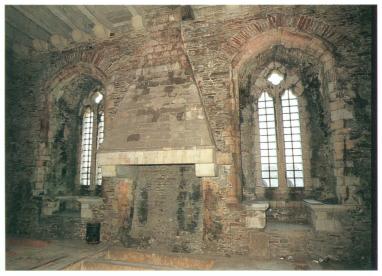
Everything in the chamber on the upper floor of the east gatehouse is of grand proportions. There is a large fireplace between the two windows overlooking the courtyard of the inner ward.

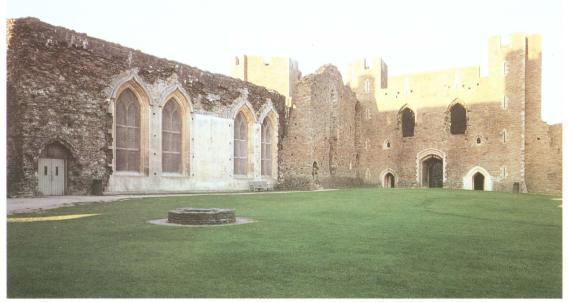
A general view looking south-west across the inner ward. To the left is the courtyard façade of the great hall, with the private apartments at the centre, and the inner west gatehouse to the right.

Now turn to face the opposite side of the courtyard, where you will see a range of buildings containing Caerphilly's main residential apartments. In the centre is the pale cream stonework of the great hall, and to the right of this the taller block was designed to provide high-quality lodgings for Earl Gilbert de Clare. To the left, the castle chapel was set over storerooms situated on the ground floor.

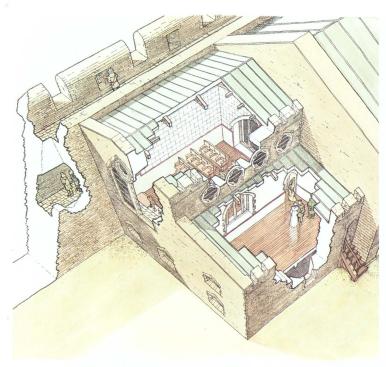
This cutaway illustration attempts to reconstruct the medieval arrangements at the east side of the great hall. On the upper floor there was a chapel, with its clerestory windows originally overlooking the courtyard. The rooms on the ground floor served as the buttery and pantry (Illustration by Chris Jones-Jenkins, 1989).

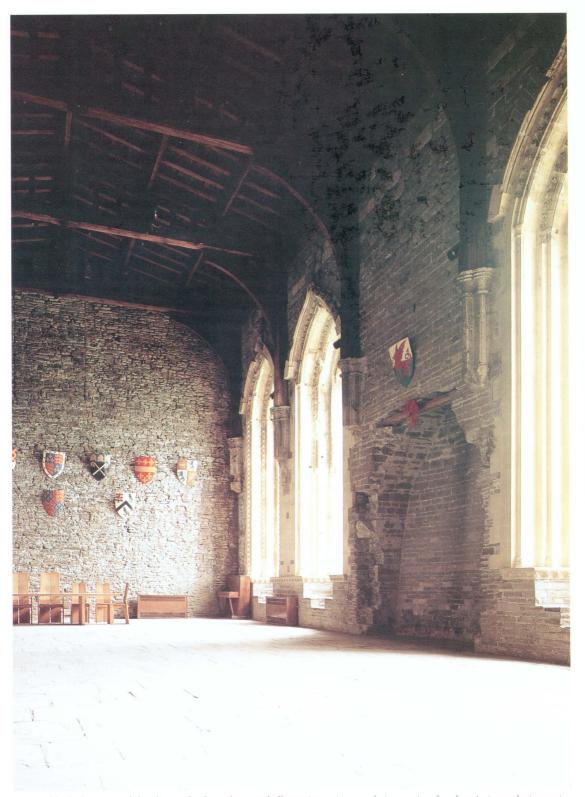
Even robbed of its original detailing and colour, the great hall remains an immensely impressive chamber. As it stands, it remains essentially a fourteenth-century construction and belongs to the time of Hugh Despenser the younger.

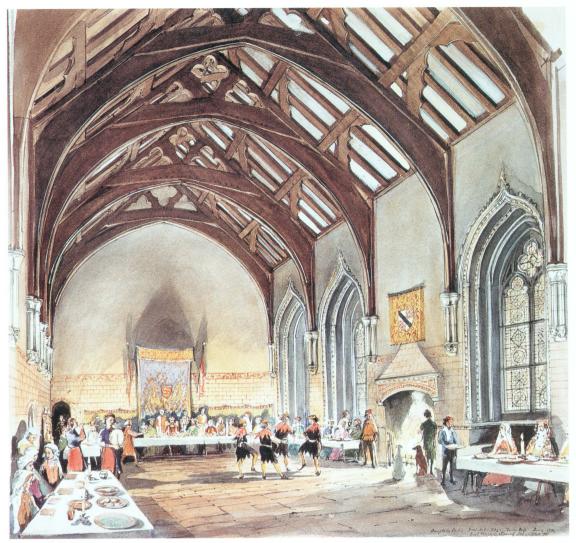
An artist's impression of the great hall as it may have appeared about 1326. We cannot be sure that Despenser's remodelling was fully complete by this date, nor can we be certain of the form of the great timber roof. Nevertheless, this colourful scene suggests a possible feast during King Edward's troubled stay with Despenser in the autumn of 1326 (Illustration by Terry Ball, 1989; with modifications, 1997).

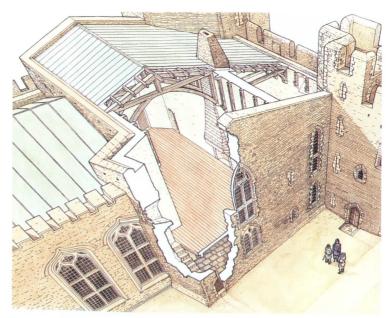
A cutaway reconstruction showing the private apartments on the west side of the great hall (Illustration by Chris Jones-Jenkins, 1989).

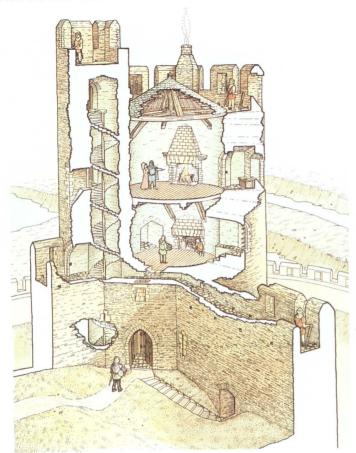
A cutaway drawing showing some of the features in the north-west tower. The floors were linked by a single spiral staircase. The wall-walk to the right is shown without the timber fighting platform now located in this area (Illustration by Chris Jones-Jenkins, 1989).

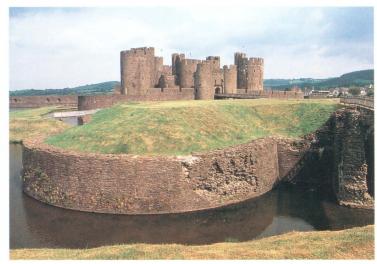
In the foreground of this view is one of the large curving salients on the western island. To the rear are the western gatehouses into the central stronghold.

The gravel areas to the east and west of the central island were now needed as solid approaches for the castle bridgeheads, and so these were also ditched around and revetted in stone. Each island was given large semicircular 'bulges' or salients at the outer corners. One of these salients on the eastern island was replaced
