**COASTAL ARTILLERY FORTIFICATIONS  
ON THE ISLE OF GRAIN,  
KENT**

**SURVEY REPORT**

ARCHAEOLOGICAL INVESTIGATION SERIES

**COASTAL ARTILLERY FORTIFICATIONS**  
**ISLE OF GRAIN**  
**KENT**

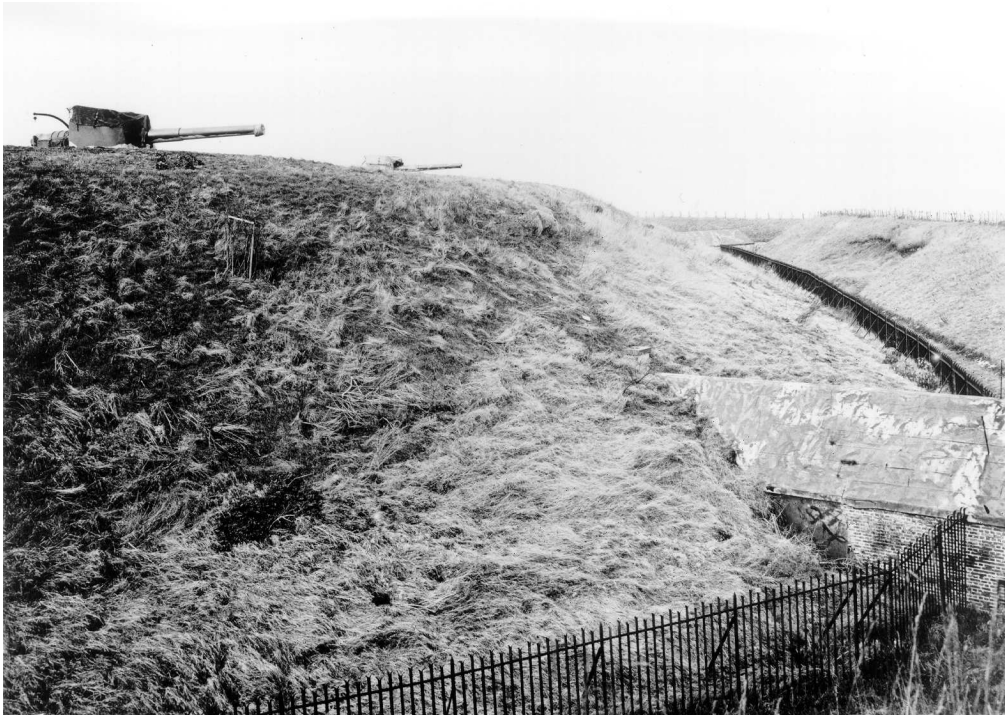
*Grain Fort during the First World War, with two 9.2-inch BL guns in place  
on the terreplein (reproduced courtesy of the Royal Engineers Library,  
Chatham: 779/940.3(42))*

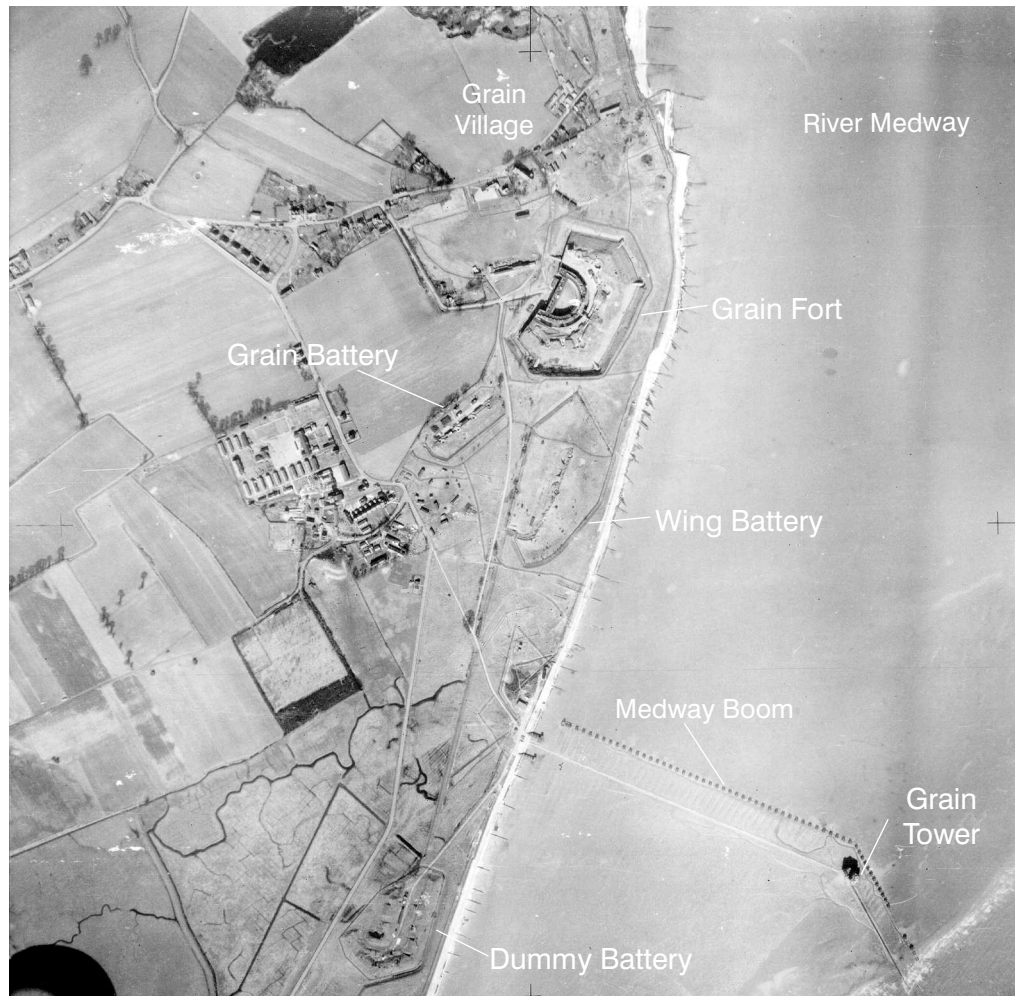
Figure 2  
Aerial photograph  
showing the coastal  
artillery batteries at  
Grain (NMR AP:  
58/RAF/ 1779/298  
(06/06/1955))

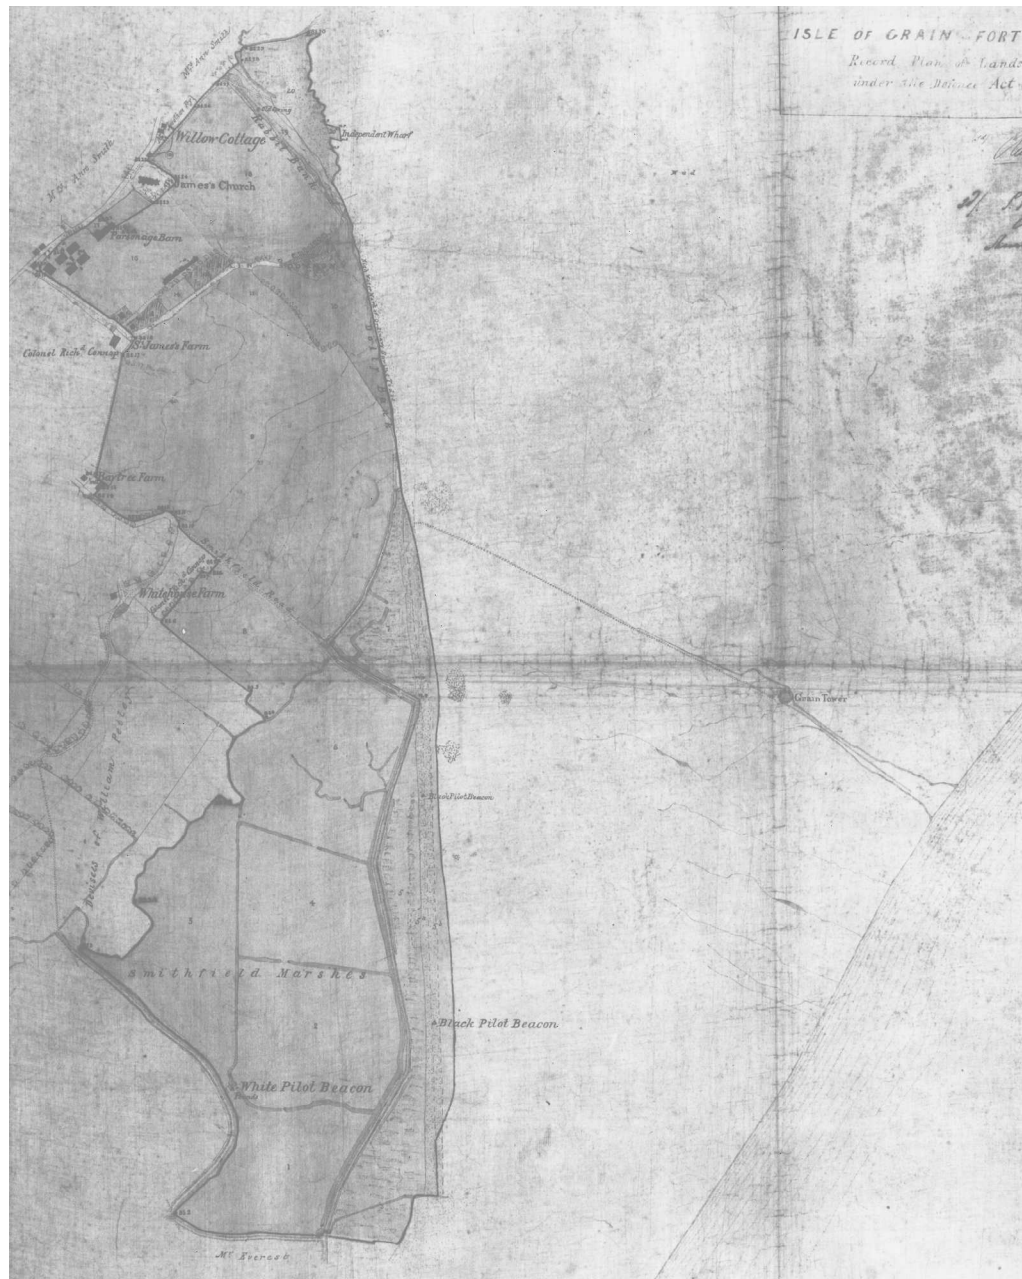
Figure 4  
Map dated 1864  
showing the land  
acquired for the  
new fortifications at  
Grain (acquisitions  
shaded darker grey)  
(PRO:  
WORKS/43/373)

With the exception of Grain Tower in the estuary, the defences were established on enclosed farmland, common land and coastal marsh, acquired under the Defence Act of 1860, by purchases between 1861 and 1863 (Figure 4). The northern half of this area occupies slightly higher, dry ground immediately south-east of the village of Grain, while to the south of Smithfield Road the remainder is taken up by Smithfield Marshes. Smithfield Road provided access to the jetties and causeway serving Grain Tower.

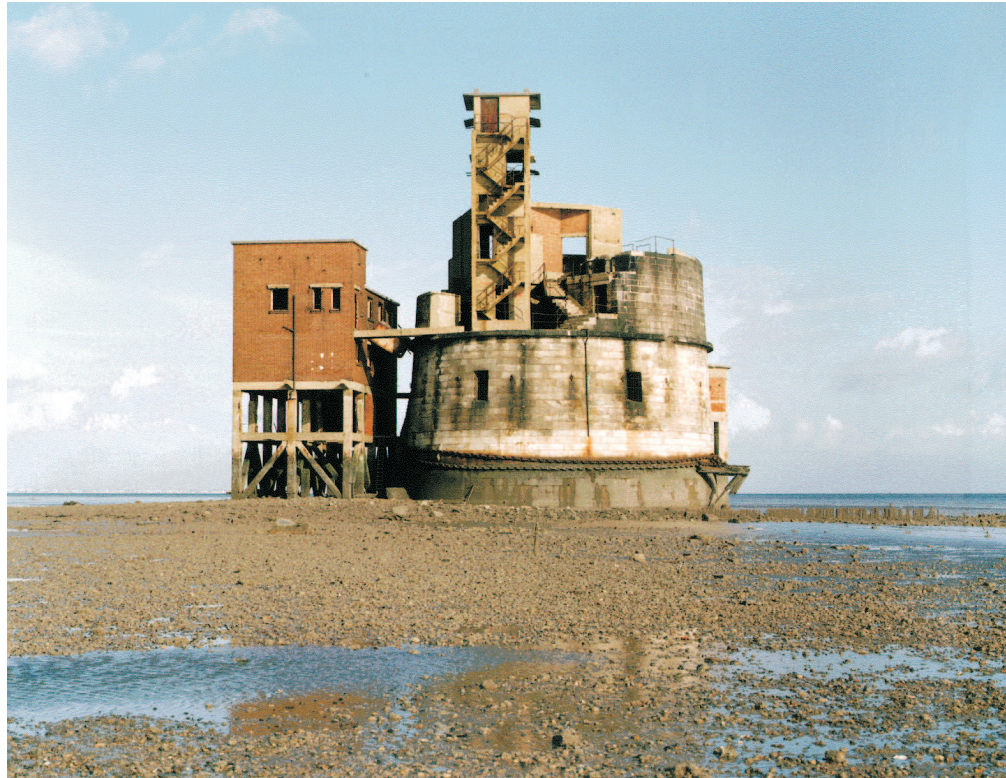
Figure 5  
*Grain Tower; view  
from the south-east  
across the mudflats*  
(NMR:  
AA98/07914)

The Tower (Figure 5) is reached at low tide by a causeway or hard, constructed from interlocking concrete blocks laid between timber edging. Large sections of the causeway, particularly at the exposed east end, have broken up under the action of the tides. In 1864, access to the tower was from a little further north via a track following an angled course, heading south-east from the shore: this is likely to have been the original arrangement (Figure 4). The causeway was moved to its present position sometime before 1889, though the structure which survives today may be a later rebuild, possibly dating to around 1915, the date of the boom to which the hard also provided access (PRO: WO/78/5115/2).

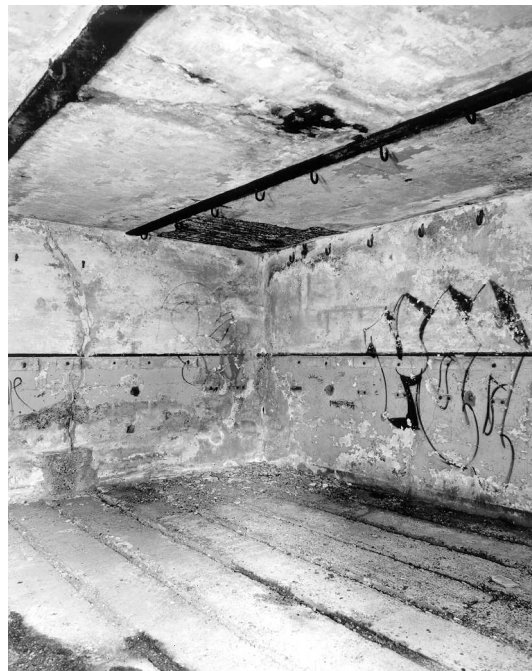
Figure 11  
*The interior of the  
Men's Shelter  
showing hammock  
hooks in the ceiling*  
(NMR:  
AA98/07906)

plain finish. They hold a series of large metal hooks set at regular intervals in their soffits; these are hammock hooks and there were corresponding hooks let into both side walls, forming interleaved spaces for sixteen hammocks, half the war complement of NCOs and men for the battery as noted on one of the 1914 plans (Figure 11). Another of these plans shows what could be central heating radiators running along the north wall and indeed some pipe fittings survive at the bottom of this wall. A stove is also shown with its flue emerging through or above the south window (Figure 10); a section of pipe remains in this position and could be the remains of this flue but there is no visible evidence of the stove. There is no evidence of plaster or skirting boards.

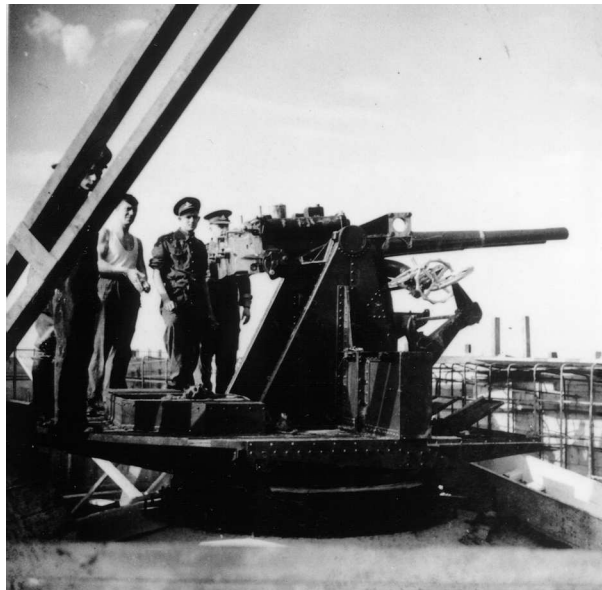
Figure 17  
Contemporary  
photograph  
showing the  
installation of the  
Twin 6-pounder  
gun in 1941 (PRO:  
WO/192/223)

Extensive remodelling took place on the Gun Floor and Upper Shelter Level around the northern 4.7-inch emplacement (no. II). From contemporary photographs of the Twin 6-pounder's installation it seems that the 4.7-inch emplacement was demolished along with the shelter, director platform and corresponding sections of walkway (Figure 17). The tower also supported two Hotchkiss 2-pounder QF guns for anti-aircraft use, mounted in the summer of 1939 and removed in October 1941 (PRO: WO/192/223).

The ammunition handling and shelter area at the rear of the gun is protected by a reinforced-concrete structure consisting of a cantilevered roof supported on posts with the whole assembly standing on a floor projecting beyond the front wall of the 1910-12 Officers' and Men's Shelters. The rear wall of the shelter is of Fletton brick between the supporting posts for the roof. The roof does not project over the gun pit as the Twin 6-pounder had an armoured shield around the gun.

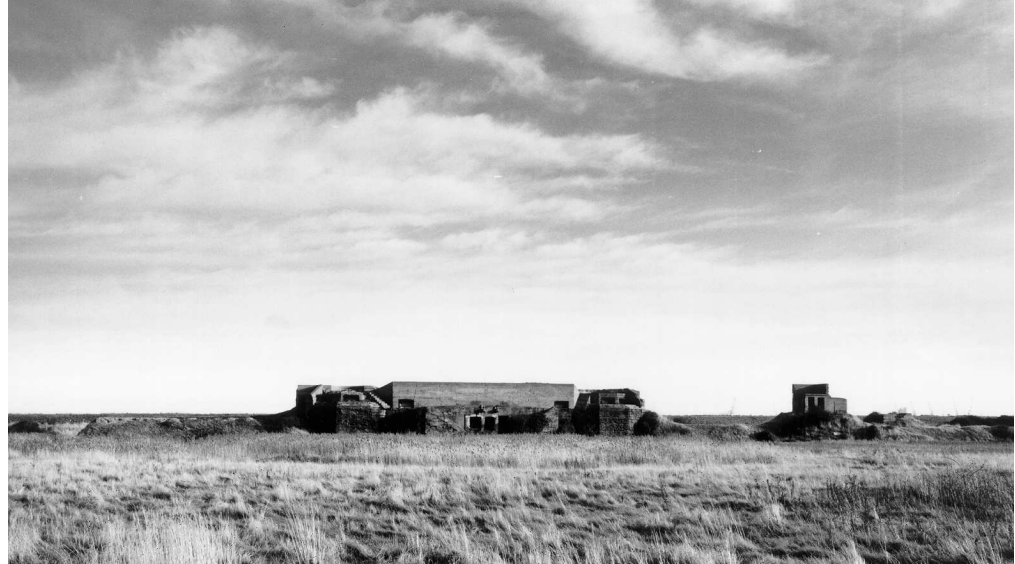
Figure 30  
*Dummy Battery*  
from the rear  
showing the two  
4.7-inch QF gun  
emplacements, the  
magazine between  
them, and the BC  
post to the right  
(NMR:  
AA98/07943)

The majority of the 1904-5 battery is constructed in mass concrete, though brick is used its magazine (Figure 30). The two gun emplacements were originally linked by a covered way with parapet for protection: this survives apart from short lengths at either end, such that it is no longer possible to walk between the two. The walkway is 0.92m (3ft) wide, its battered concrete parapet 2.43m (8ft) tall. Located centrally at eye level in the parapet face is an inserted concrete patch inscribed '1905', the battery's completion date. The edge of the walkway has a low plinth to the rear, formerly supporting a hand rail. From each end, a flight of 17 steps leads down to the magazine (Figure 31).

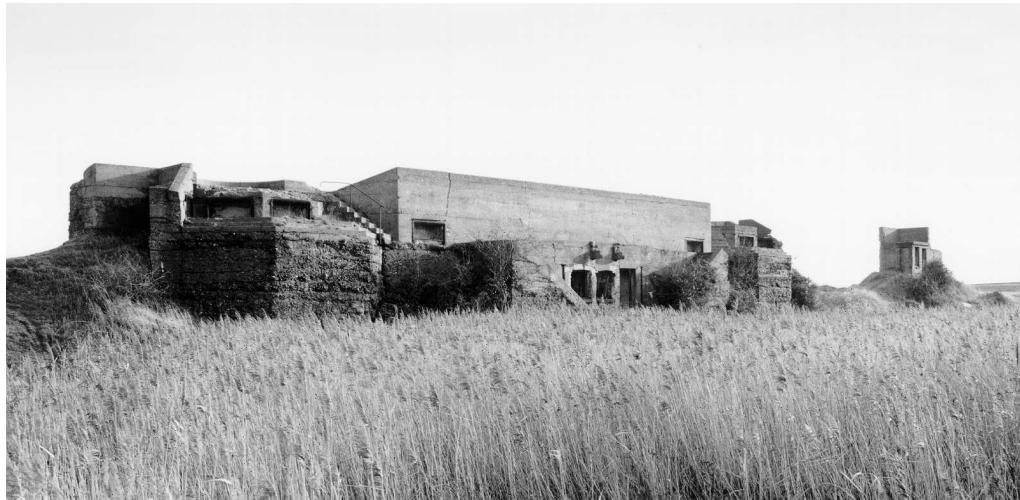
Figure 33  
*Dummy Battery  
showing the  
magazine entrance,  
steps to the gun  
emplacements and  
the BC post to the  
right (NMR:  
AA98/07945)*

The external elevation is smooth rendered, with a single door and two windows. Above these are fittings on the walls for two davits to lift ammunition up to the covered way above and the exit holes for two ventilators (Figure 33).

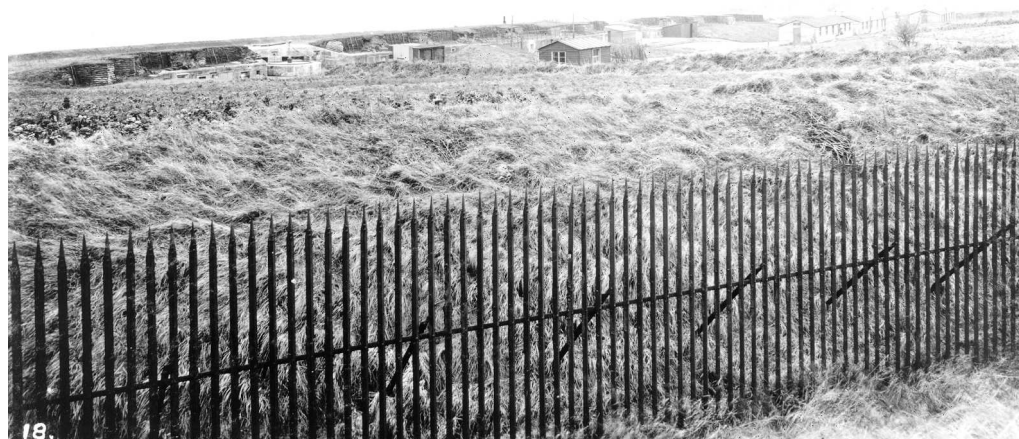
Figure 37  
*Photograph taken during the First World War showing the rear of Wing Battery and the buildings stationed there (reproduced courtesy of the Royal Engineers Library, Chatham: 779/940.3(42))*

A series of four buildings formerly stood in a line along the base of the hollow at its southern end: they are visible on photographs of First World War date held at the Royal Engineers Library at Chatham (Figure 37) and on an air photograph of similar date, when the battery was active (Figure 37; PRO: WO/192/223). The southernmost still stood until 1961 but was demolished shortly thereafter (NMR AP: 58/4646/333). These buildings probably comprised accommodation, stores, latrines etc for troops manning the defence lines along the coast here.

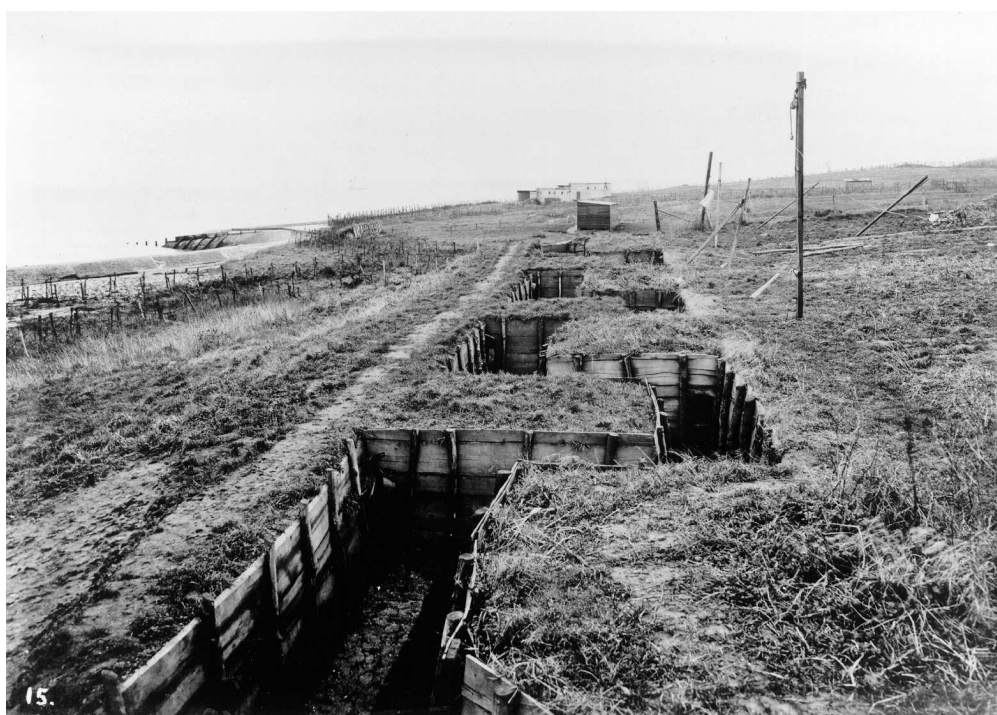
Figure 41  
First World War  
trenches north of  
Grain Fort, with the  
twin electric light  
emplacement for  
Grain Fort in the  
distance (the edge  
of Grain Fort can  
just be made out in  
the top right hand  
corner) (reproduced  
courtesy of the  
Royal Engineers  
Library, Chatham:  
779/940.3(42))

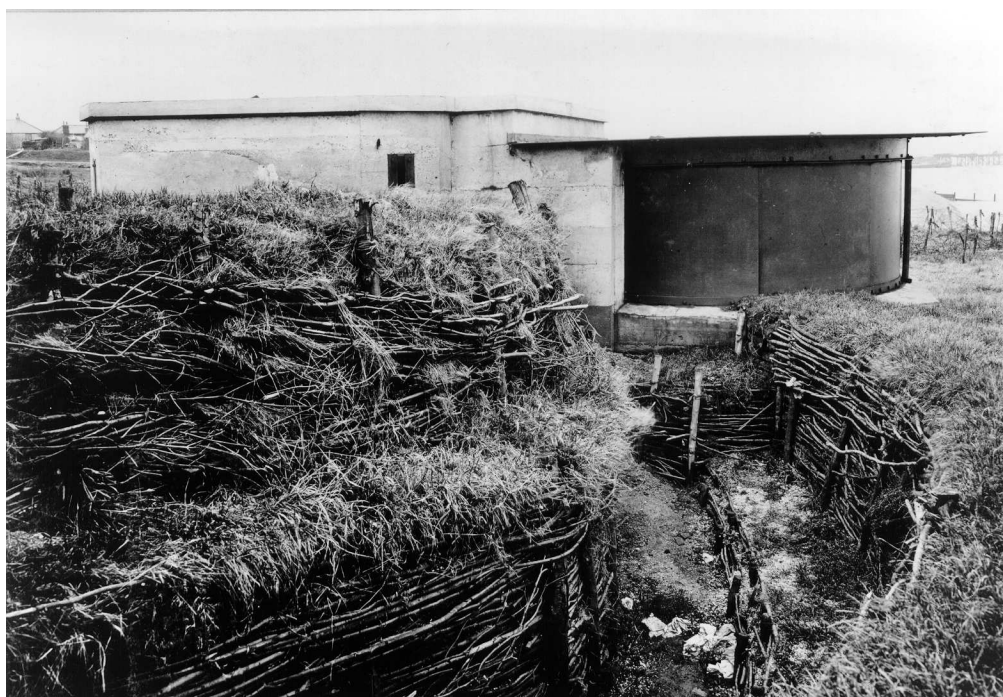
Figure 42  
Electric searchlight  
emplacement at  
Grain during the  
First World War,  
with part of the  
extensive trench  
system in the  
foreground. Note  
the apsidal end with  
its steel shutters  
guarding the lights  
(reproduced  
courtesy of the  
Royal Engineers  
Library, Chatham:  
779/940.3(42))

A twin searchlight emplacement, serving artillery in Grain Fort, formerly stood at **d**: it appears on First World War photographs and on aerial photographs of 1946 and 1961; thereafter it was demolished and cleared. A slight platform, **e**, is the sole remnant of an associated shelter or bunker a few metres to the south (Figure 42; NMR APs: 106G/UK/1444/4107-8; RAF/58/4646/332-3; OS/75/300/001). This twin emplacement, designated electric light nos. 13 and 14, was constructed by 1914 and served the guns on Grain Fort (PRO: WO/78/5124/10).

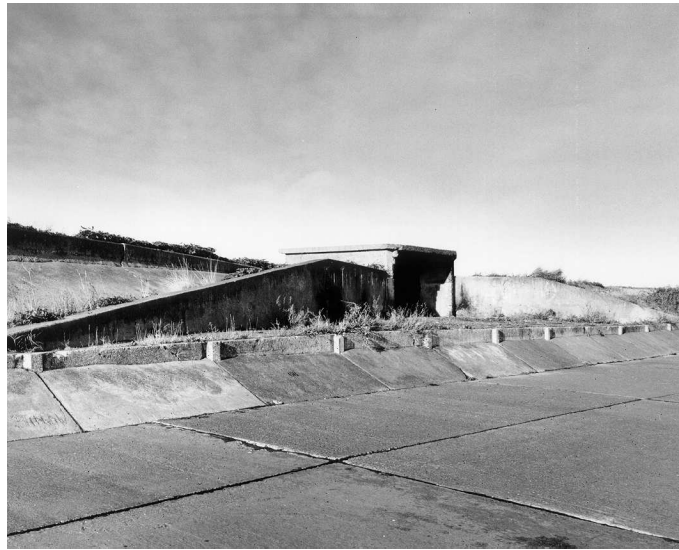
Figure 43  
*The electric  
 searchlight  
 emplacement east of  
 Grain Fort (NMR:  
 AA98/07927)*

An artillery searchlight, **f**, proposed in 1911 and probably built shortly afterwards, stands alone on the sea wall (Figure 43; PRO: WO/78/5124/12). It probably served the guns on both Wing and Grain batteries. It is set back into the slope which is revetted by a battered concrete wall up to 0.93m (3ft) high. The structure follows the standard pattern but is badly damaged so that the apsidal end, which formerly held the light cells, is largely broken out. Internally the rectangular room is just a concrete shell, approximately 3.32m by 2.87m (10ft 11in by 9ft 4in). The south wall contains a recess, 1.5m (5ft) long and 0.23m (9in) deep, and in the north-west corner the concrete has been chipped out for a stove; its flue pipe pierces the roof.

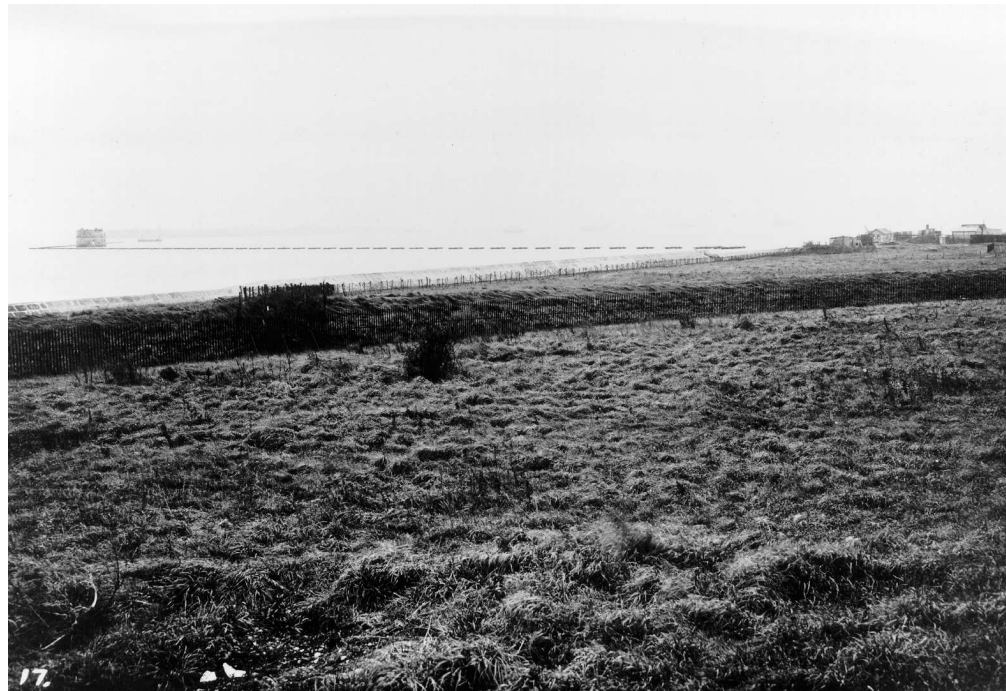
Figure 44  
*First World War  
 photograph across  
 Wing Battery,  
 showing the  
 building complex  
 at extreme right ,  
 and the Medway  
 Boom between the  
 shore and Grain  
 Tower (reproduced  
 courtesy of the  
 Royal Engineers  
 Library, Chatham:  
 779/940.3(42))*

There was a complex of buildings here in the First World War (Figure 44) and during the Second World War several structures stood within a roughly kite-shaped defended perimeter, probably defined by a fence, which is now gone. In its north-western corner aerial photographs record two square buildings in a small square enclosure: although the buildings have gone there is part of a concrete floor from one of them, and two sides of the enclosure are defined by a low scarp 0.4m (1ft 4in) high, incorporating irregular lumps of concrete which have metal inserts, presumably for uprights to support the perimeter fence. This enclosure and its two structures originally stood alone, approached via a track from Smithfield Road, and may date from the First World War: they appear on aerial photographs which, although undated, certainly pre-date 1931, and might be among the jumble of buildings on a ground photograph of definite First World War date (PRO: WO/192/83; OS 6-inch map Kent sheet 13NW; CREL b).
