THE WESTERN HEIGHTS DOVER, KENT

Report No 2: The Citadel

SURVEY REPORT

LAND-FRONT FORTRESS AND BARRACKS 1779-1950

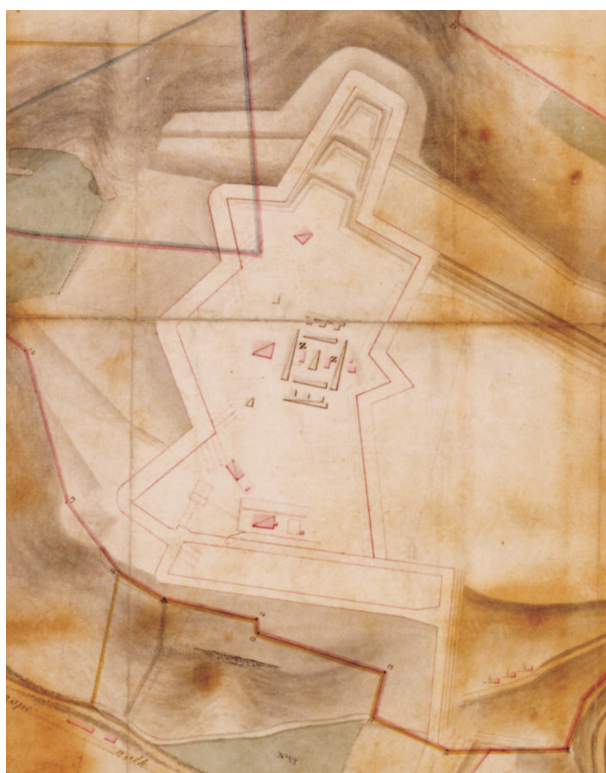
Figure 6
*The revised design
taking shape; the
Citadel in 1811 (extract
of PRO: MPH/1/506
© The Public Record
Office)*

Progress is recorded on a plan of 1810, with the north part of the gorge scarp, the inner ditch of the *tenaille* scarp and the counterscarp revetted. By 1811 the revetments to scarp and counterscarp were virtually completed for the whole trace (Fig 6; PRO: MR/1/1349).

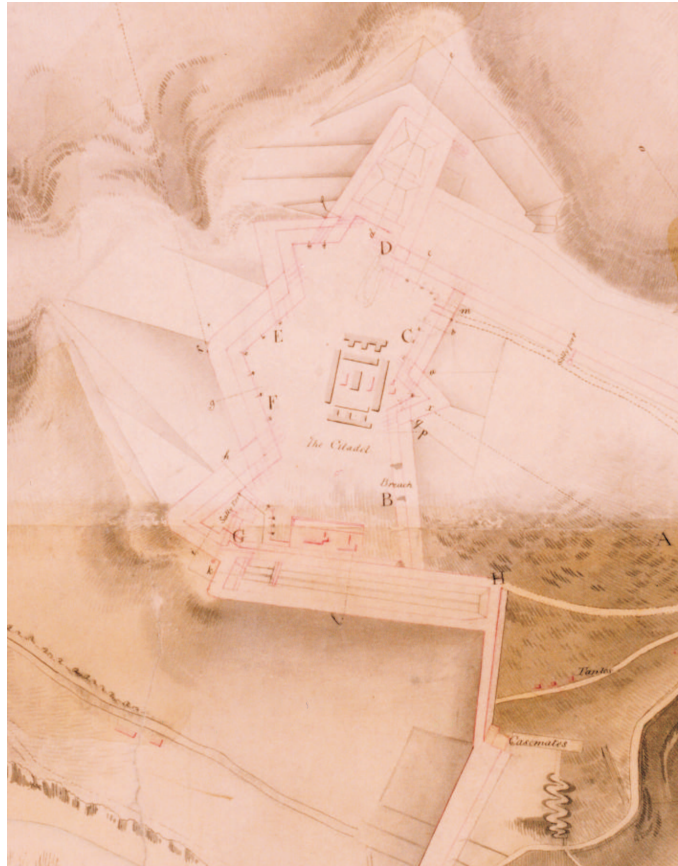
Figure 7
The Citadel in 1813
(extract of PRO:
MR/1/1346 © The
Public Record Office)

Work continued at a rapid pace until 1813, the last year of large expenditure on the Citadel, though smaller works continued until funding ceased in 1816 (Coad and Lewis 1982, 176-7). By this time, though the defences were in an advanced state, they were not finished. Completed buildings included some of the casemates, the brick guardhouses of the 1780s, temporary barracks built in 1804, a well house, and three structures of unknown function on the south (Figs 7 and 8).

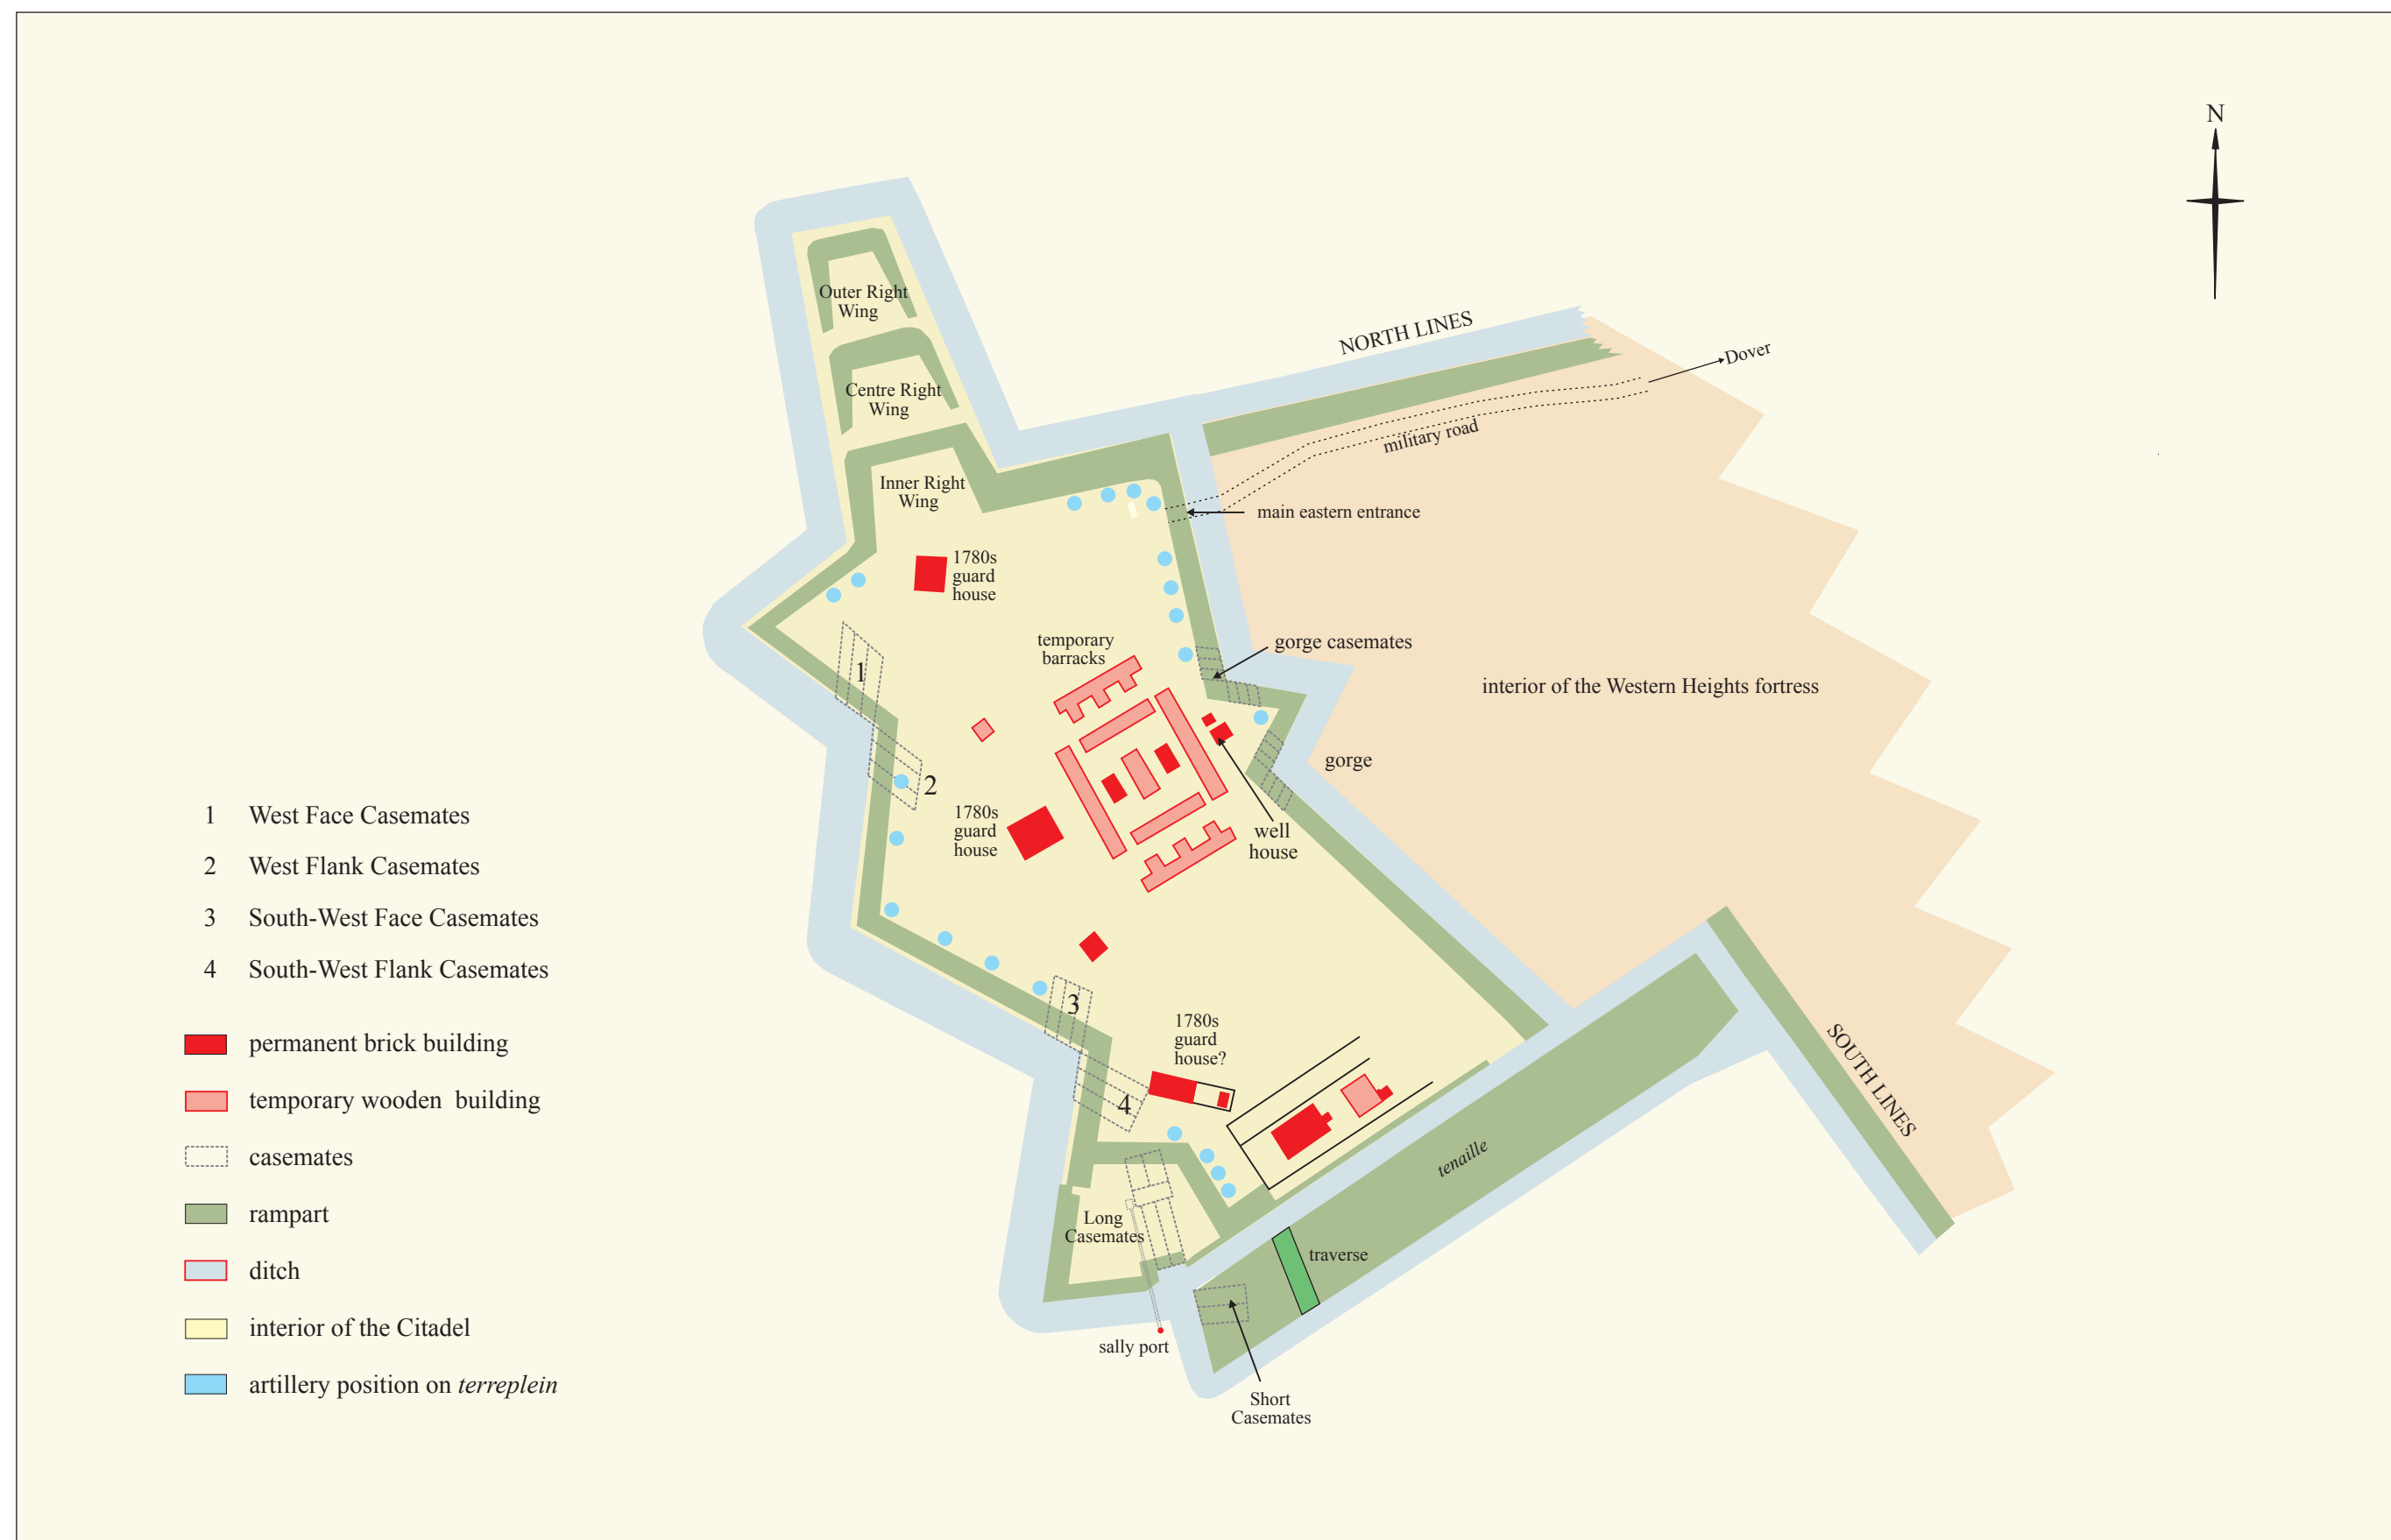
Figure 8 Plan showing the Citadel in 1815 (after PRO: MR/1/1346)

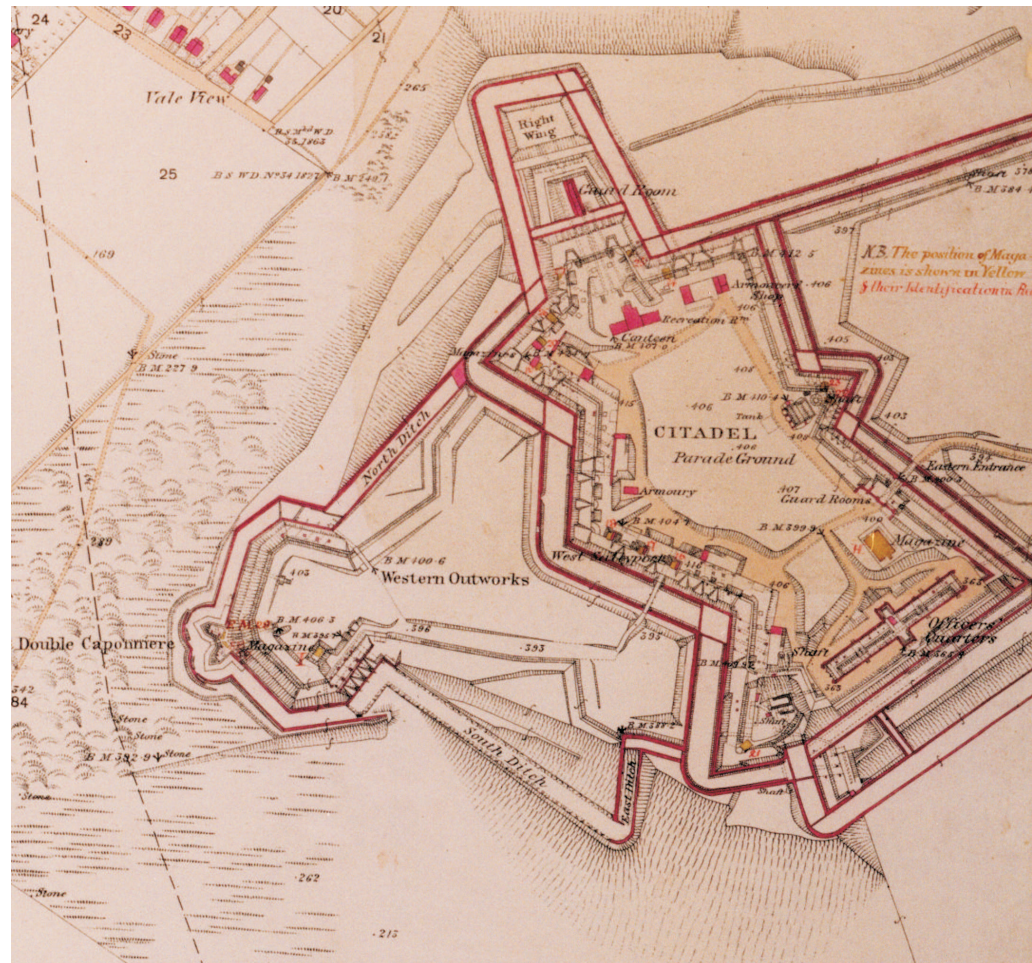
Figure 10
*The Citadel in 1871,
after completion of the
works recommended by
the Royal Commission
in 1860 (extract of
PRO: WO/78/2755/12
© The Public Record
Office)*

were largely finished by 1867 and completed the Western Heights as a land front fortress. At the Citadel, the new features are shown on a plan dated 1871 (Figs 10 and 11):

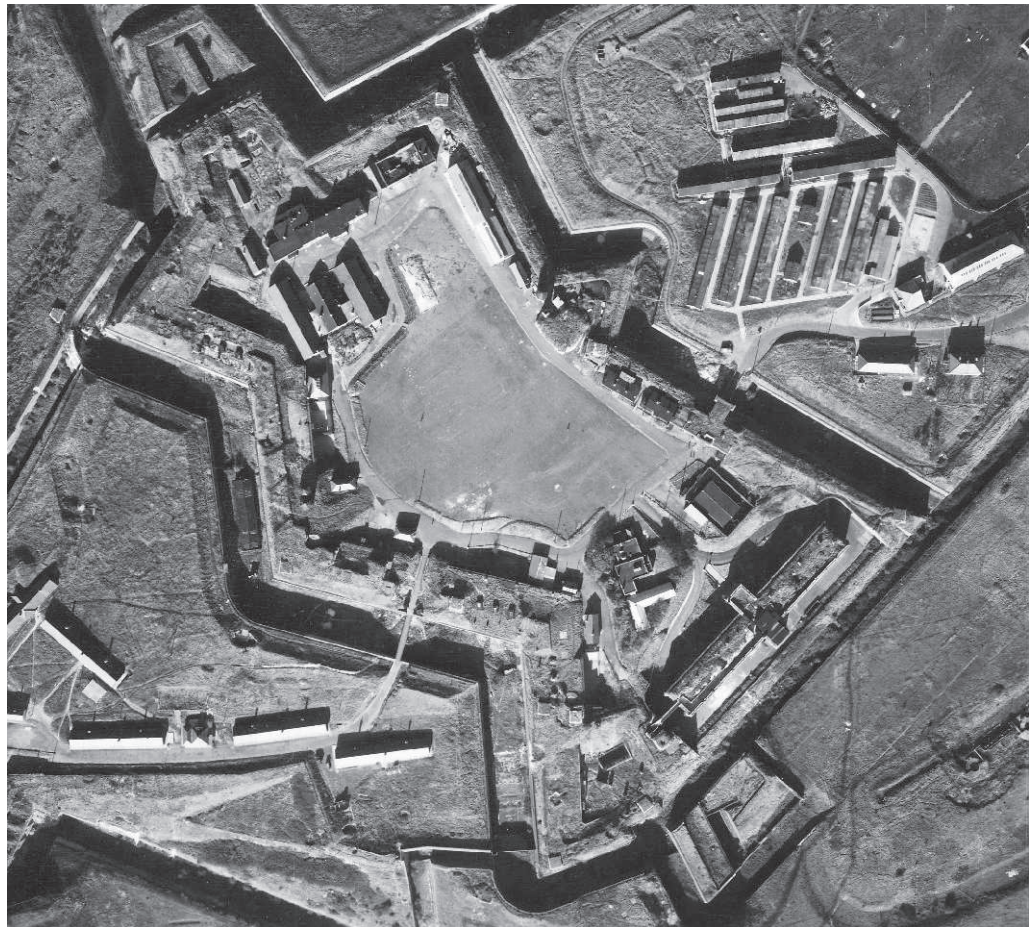
Figure 13
The Citadel from the air in 1945. Important additions include the hutment camp, built in 1939 (top right) (106G/UK944/6090-1 ©MOD)

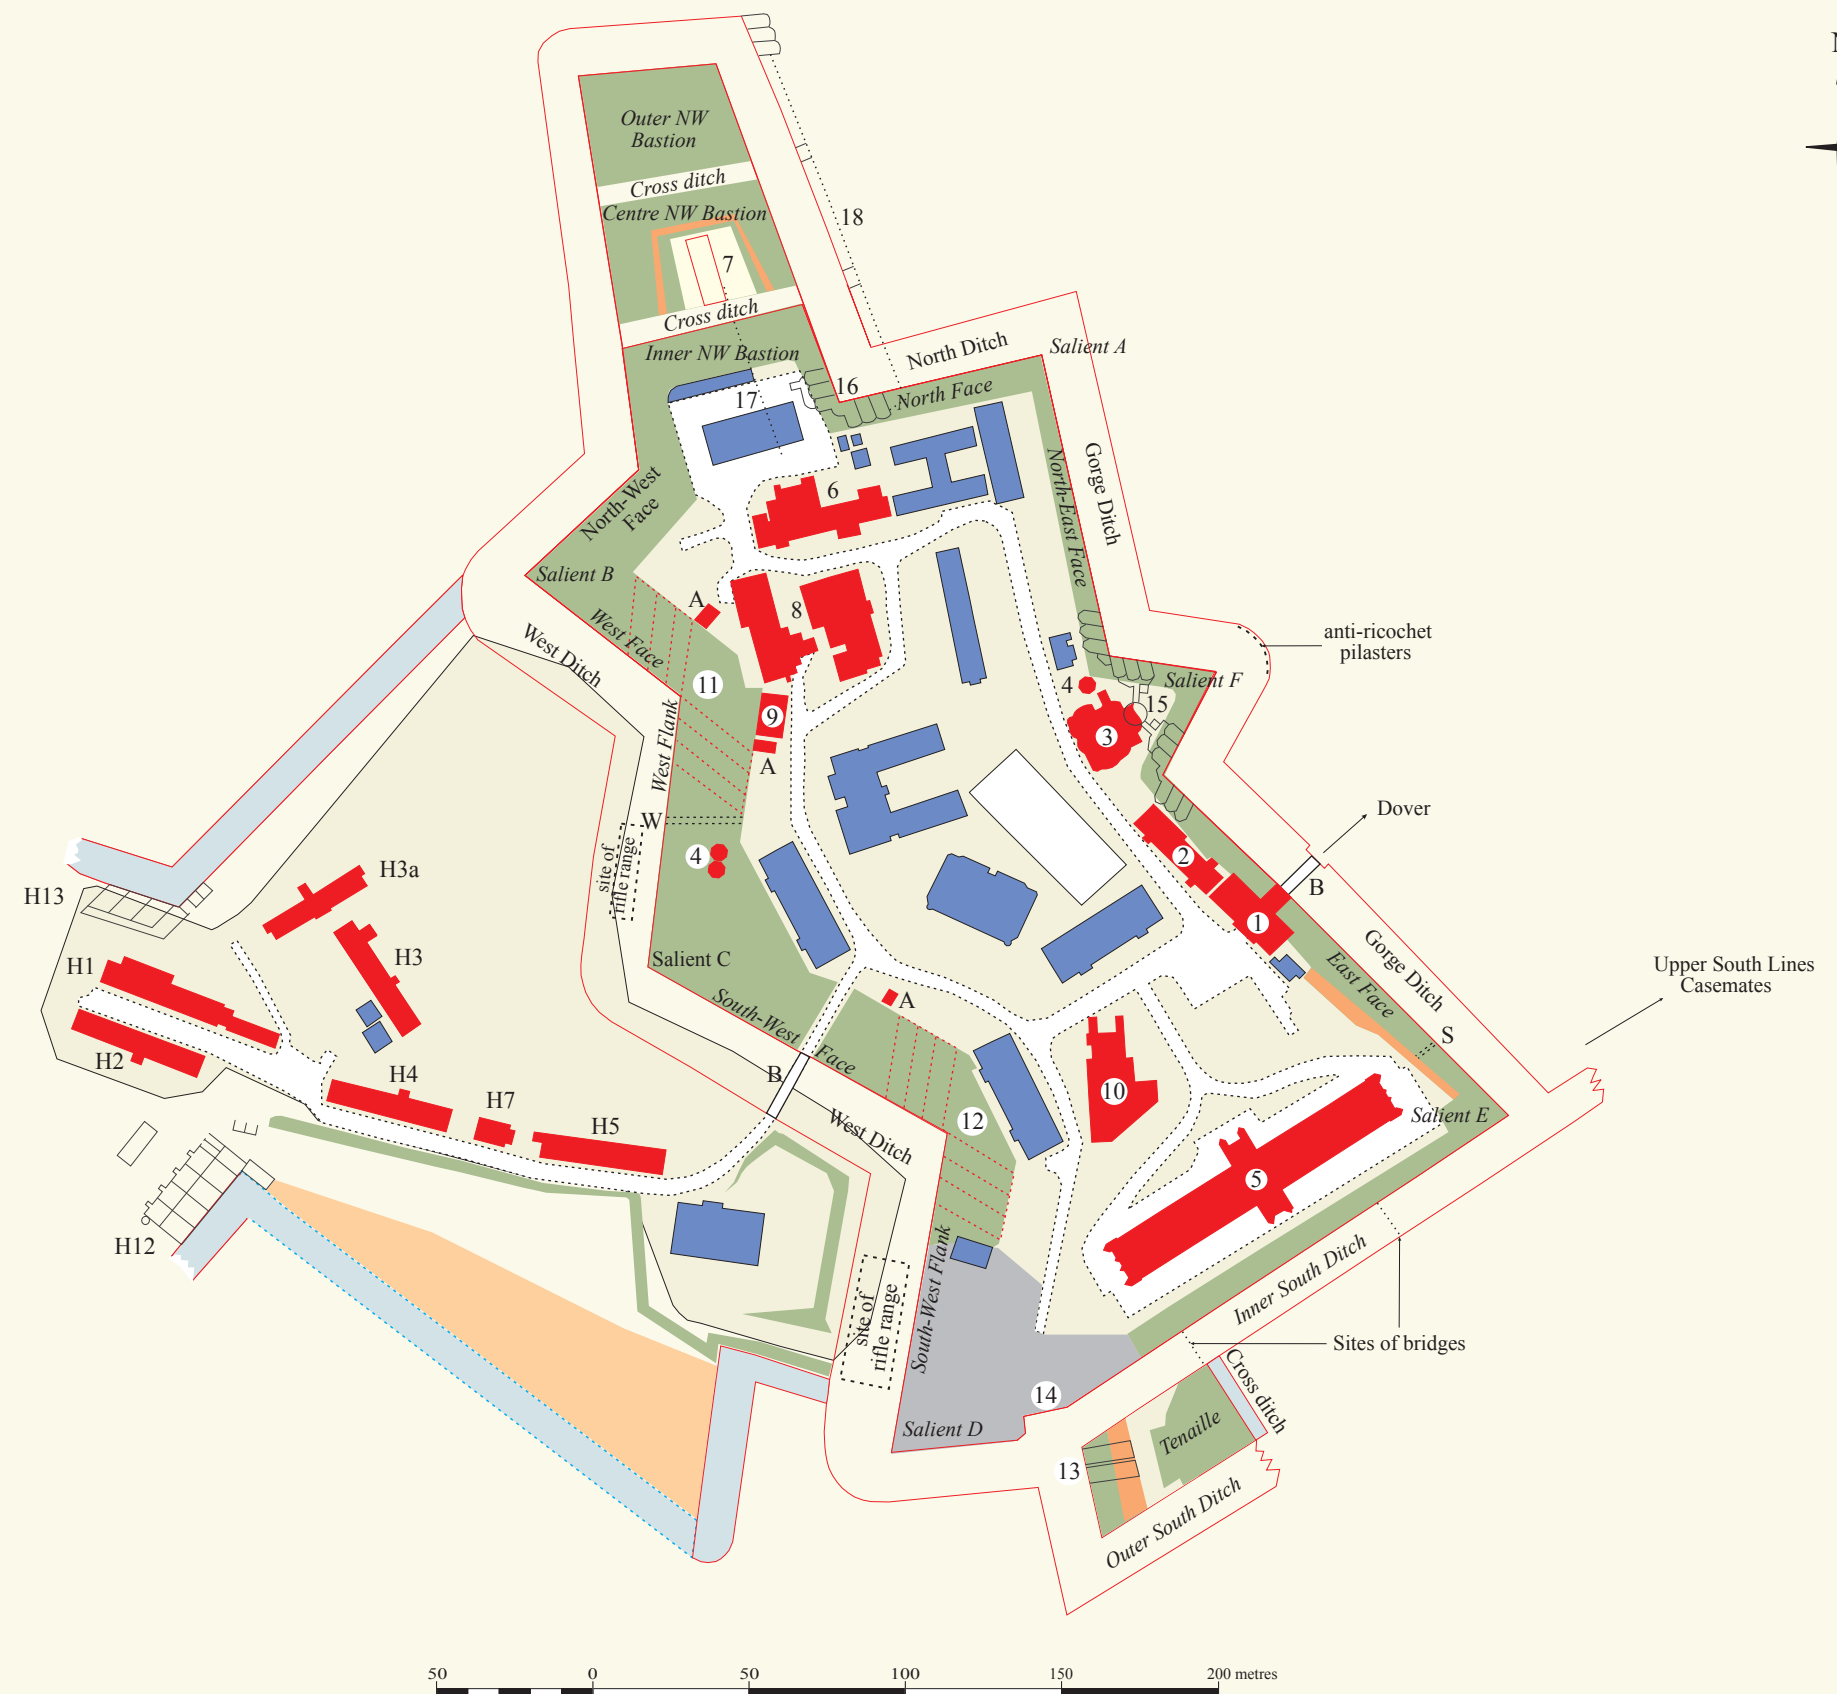
Figure 15 Plan showing the Citadel c1998 (text in *italics* indicates the nomenclature of the fortress used from the later 19th century onwards)

The West Ditch (Fig 15)

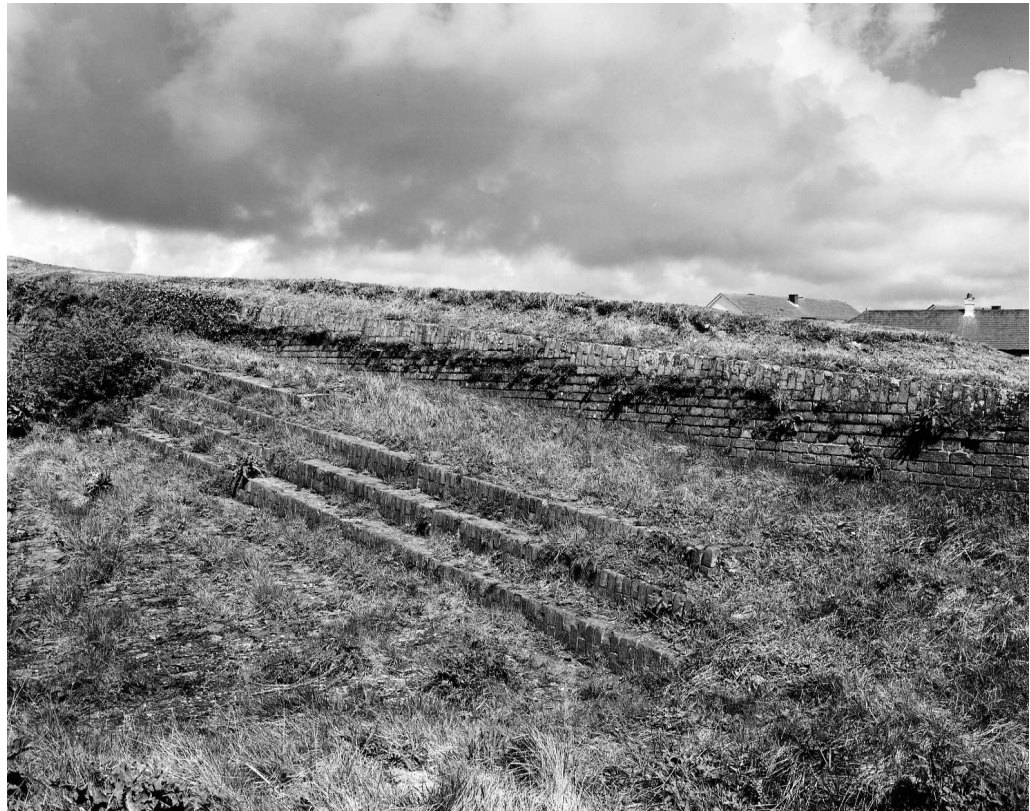
Figure 17
*Overgrown infantry
banquette and steps on
the East Face, or south
end of the gorge
rampart (NMR:
BB032736 © Crown
copyright 1998)*

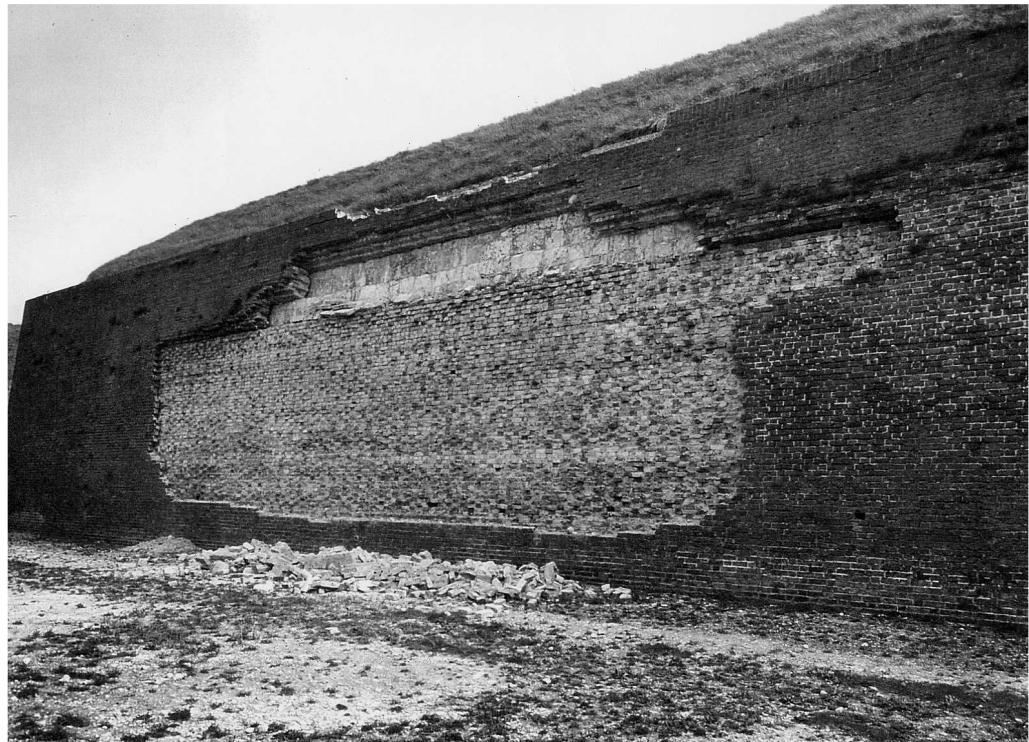
Figure 18
North end of the western scarp revetment of the NW Bastion, in 1959, showing defective brickwork cut out prior to repair. Note the heightening marked by a junction between brickwork and chalk ashlar, probably representing the Napoleonic and 1860s construction phases respectively (A6207/4 © Dover Museum)

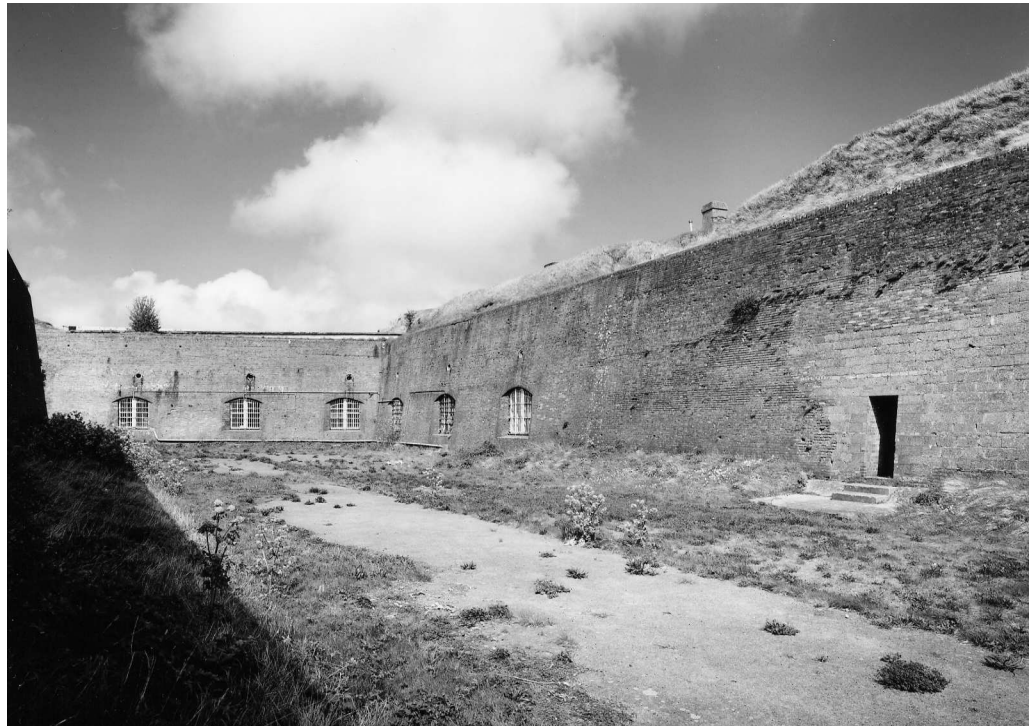
Figure 19
The West Ditch, looking north, showing the West Postern (at right) and the windows of the casemates of the West Face and West Flank (NMR: BB032743 © Crown copyright 1998)

North of Salient C, a concrete floor in the ditch is from another miniature rifle range. The scarp revetment incorporates the West Postern, a small square-headed doorway constructed in a concrete repair to the revetment and approached up three steps defined by low flanking walls (Fig 19). Inside the doorway, a small section of an earlier semi-circular brick vault is visible, from a gallery that led under the rampart to the interior of the fort. Both entrance and gallery were probably inserted in the 1850s/60s and they are depicted on the 1871 Citadel plan, although the present form is modern (PRO: WO/78/2755/12). Originally, it was a sally port to the ditch and a stairway ascending the counterscarp into the Western Outworks; although the stair has gone, the scar of its two relieving arches remain. In the 20th century it provided a route to the rifle ranges.

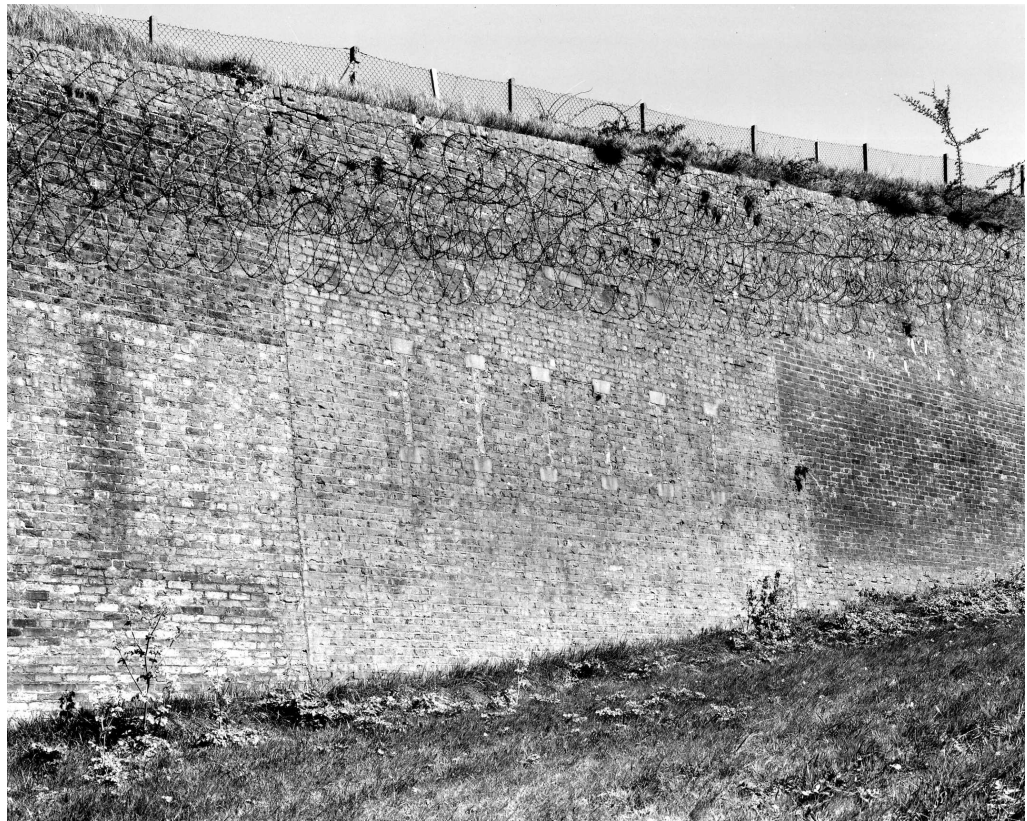
Figure 20
*Inserted walling in the
counterscarp revetment
of the NW Bastion with,
just visible, blocked
loopholes (NMR:
BB032730 © Crown
copyright 1998)*

The revetments have large areas of patched repairs, most by HMPS. On the east, the counterscarp has two sections inserted into the Napoleonic brickwork, with very clear

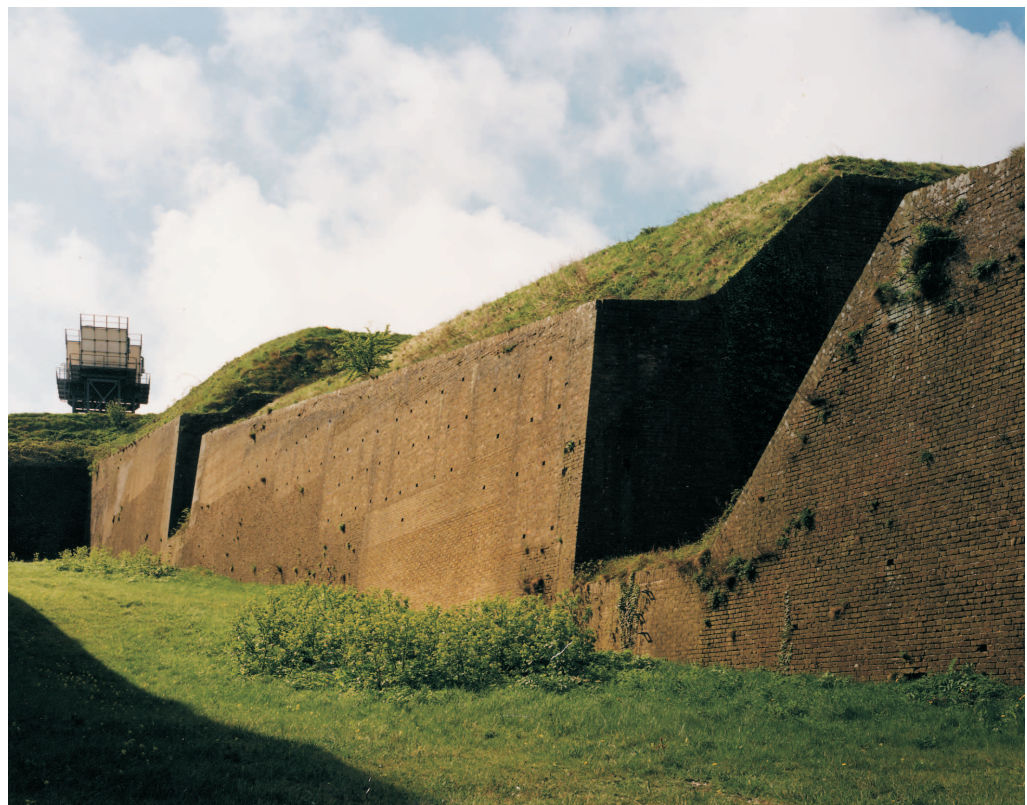
Figure 21
*The eastern scarp
revetment of the NW
Bastion, showing the
cross ditches and clear
patching of the
brickwork (NMR:
BB03729 © Crown
copyright 1998)*

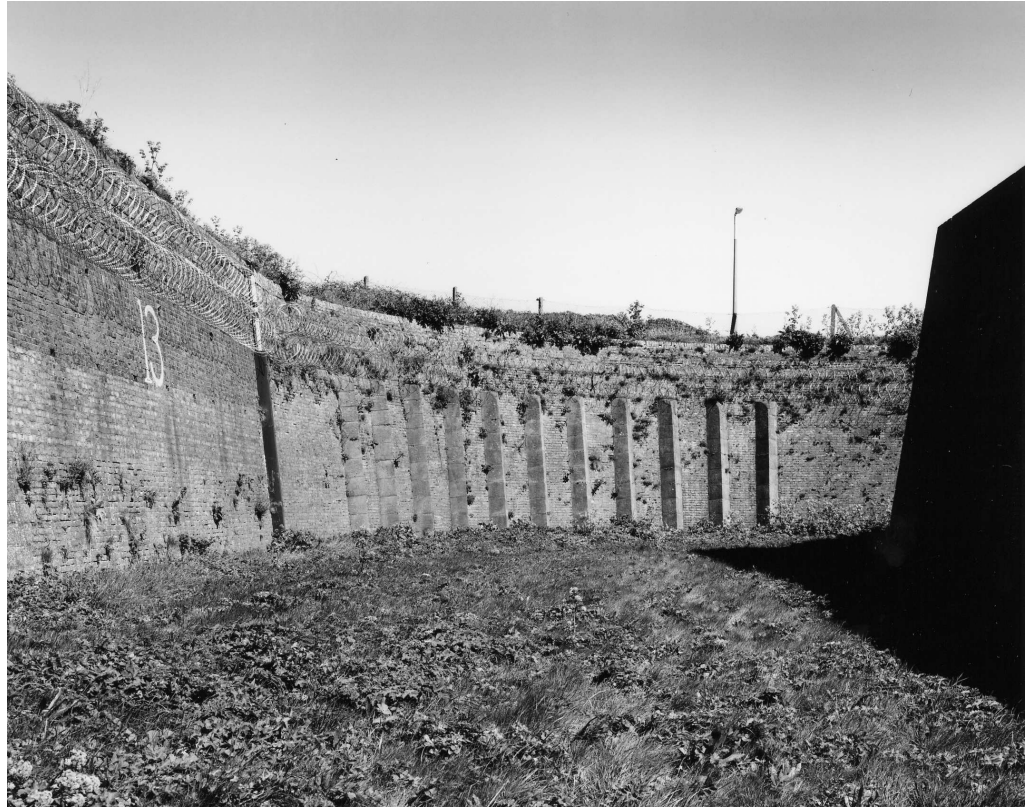
Figure 22
*Anti-ricochet pilasters
against the
counterscarp of the
Gorge Ditch, from the
west (NMR: BB032731
© Crown copyright
1998)*

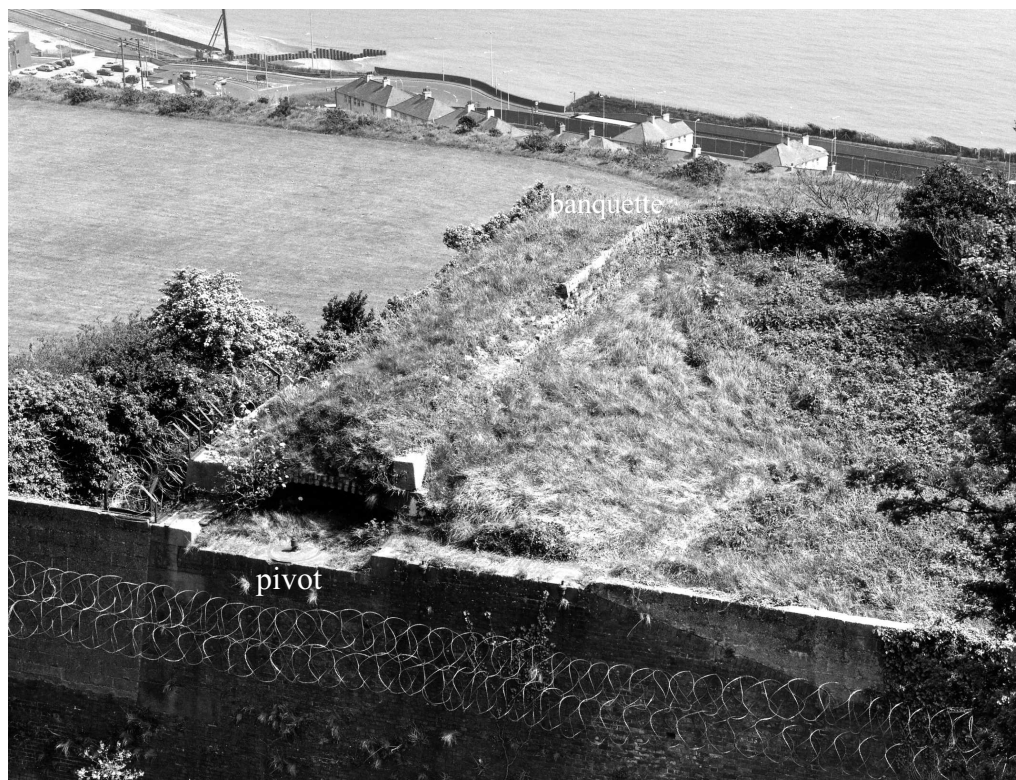
Figure 24
*Part of the
demi-bastion at the
west end of the tenaille.
Note the infantry
banquette (centre) and
pivot for a swing bridge
(lower left) (NMR:
BB043986 © Crown
copyright 1998)*

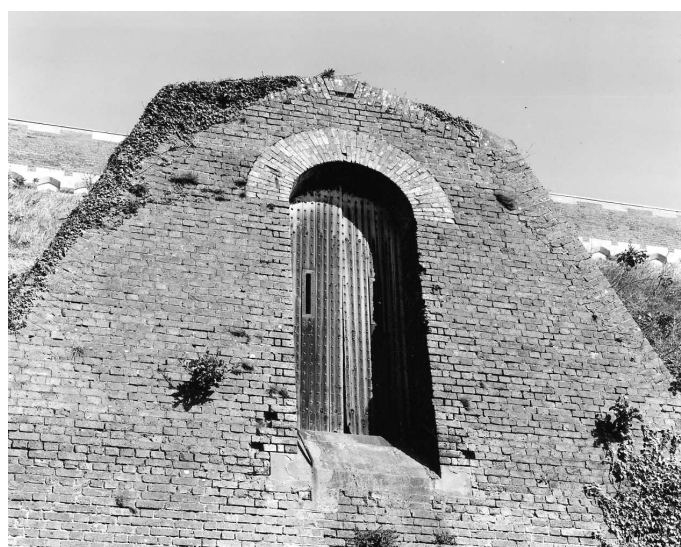
revetment. The gate gave directly onto a bridge across the inner ditch to the longer part of the *tenaille*. Although the bridge has gone, the gate can still be seen, built into a canted elevation, with recessed double inward-opening reinforced doors, each with a vertical slit for observation and small arms fire, the whole capped by a round arched head of cream rubbed brick (Fig 25). There is a stone sill, chamfered down to the exterior at an angle of

Figure 25
*Reinforced doors in the
scarp revetment of the
inner South Ditch,
formerly leading onto a
bridge to the tenaille
(NMR: BB032740 ©
Crown copyright 1998)*

around 60°, suggesting that the bridge may at one time have incorporated a lifting section. The sill and brickwork below it are patched, probably following removal of the bridge structure, while a metal grip handle set in concrete is of relatively recent origin. Opposite the door in the counterscarp revetment, two small patches in the

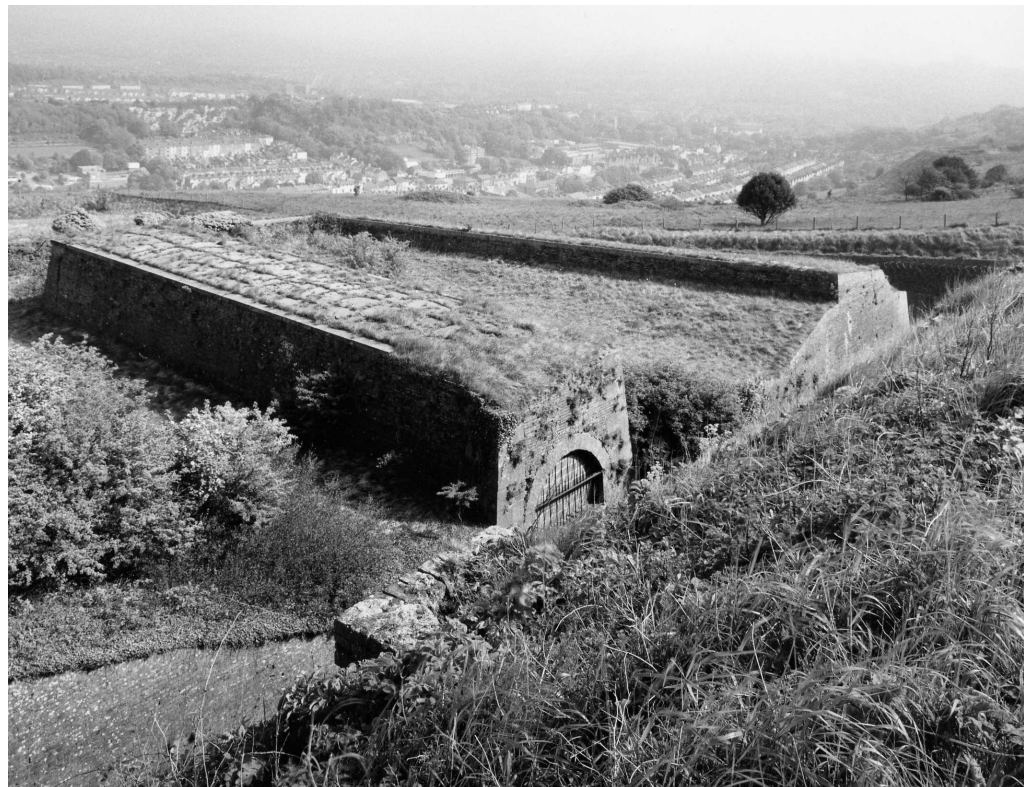
Figure 27
The long rectangular Guard Room on the Centre North-West Bastion, with the infantry banquette beyond, from the south-west. The only window to the Guard Room is just visible (lower centre) (NMR: AA043948 © Crown copyright 1998)

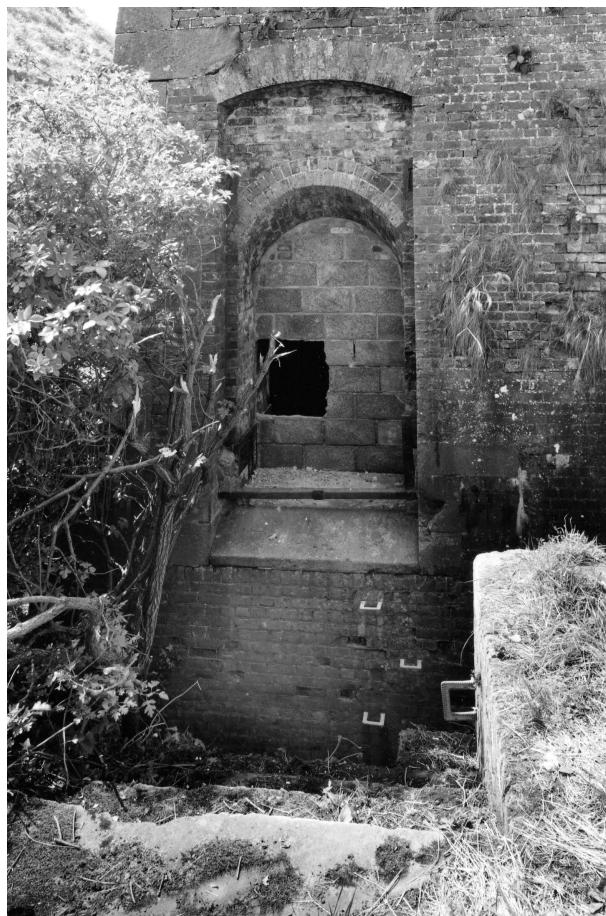
Figure 28
*Centre North-West
Bastion: the
drawbridge entrance to
the Guard Room, from
the east (NMR: ©
Crown copyright 1998)*

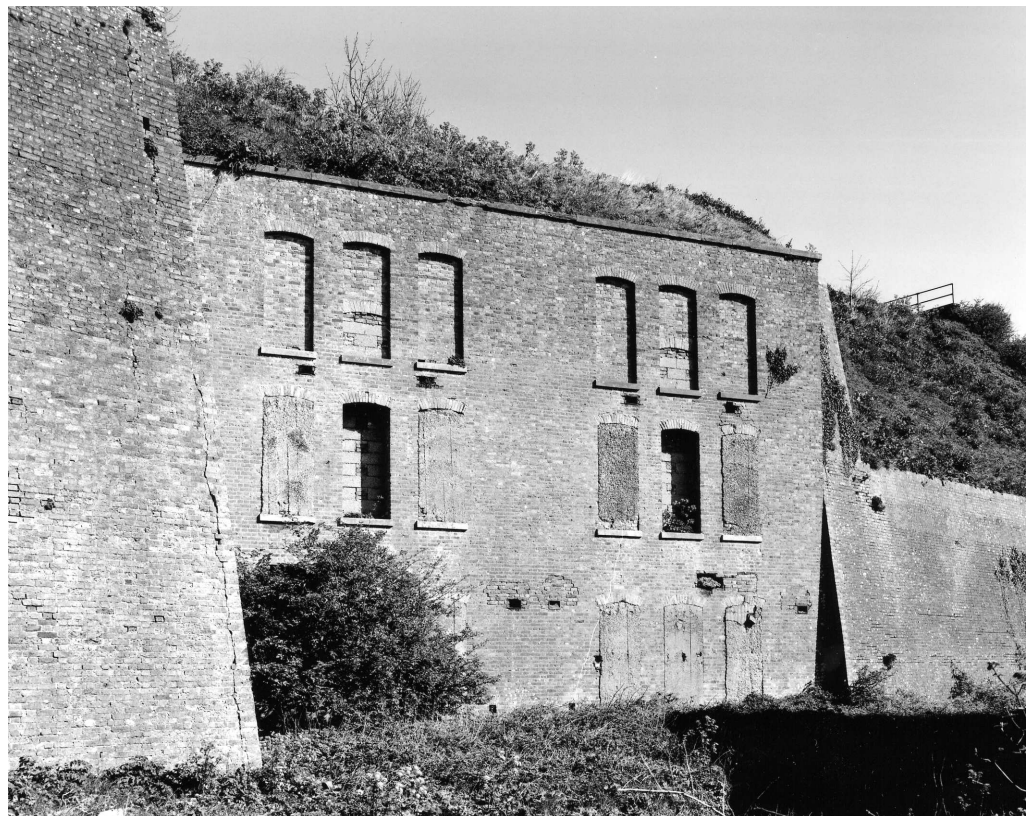
Figure 30
*The Long Casemates;
south elevation forming
the scarp revetment of
the inner South Ditch
(NMR: 032741 ©
Crown copyright 1998)*

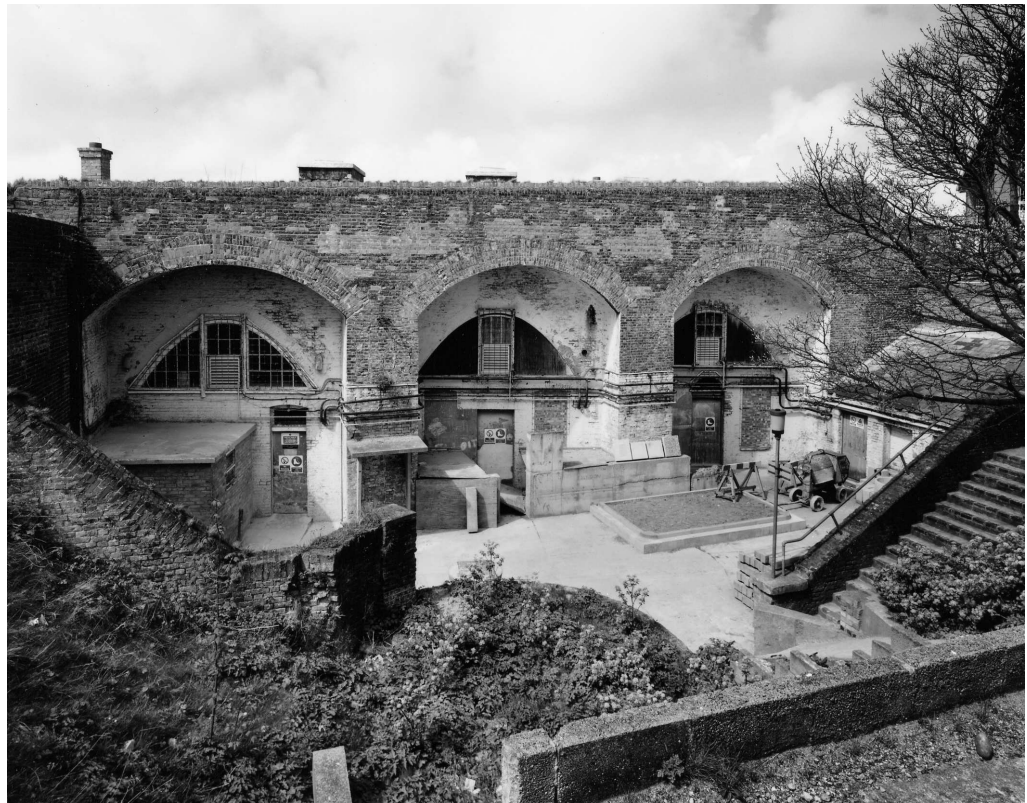
Figure 33
The rear elevation of the West Face Casemates. The central casemate retains much of its original appearance with central fan-lit entrance and flanking windows. Above the entrance another window rises to the crown of the parabolic vault (NMR: AA043936 © Crown copyright 1998)

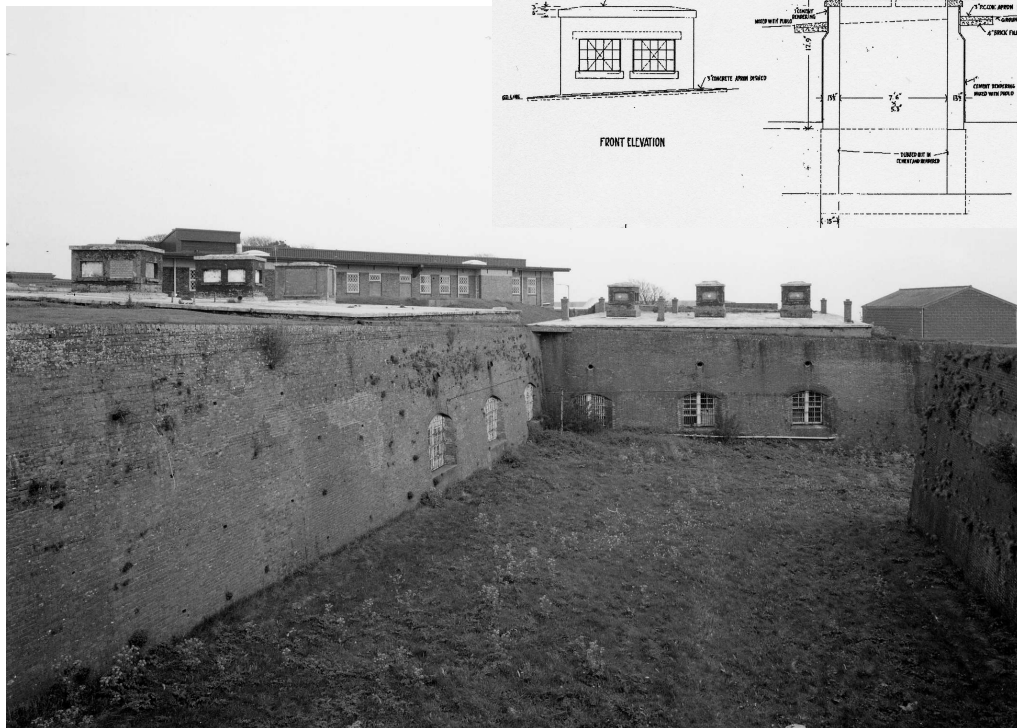
The South-West Face Casemates and the South-West Flank casemates, from the NW, showing the windows at ditch level (inserted into the former embrasures) and the lantern lights placed on the roof around 1913. The drawing shows the lanterns as proposed in 1913 (photo NMR: AA043990 © Crown copyright 1998, drawing 402652 © HMPS)

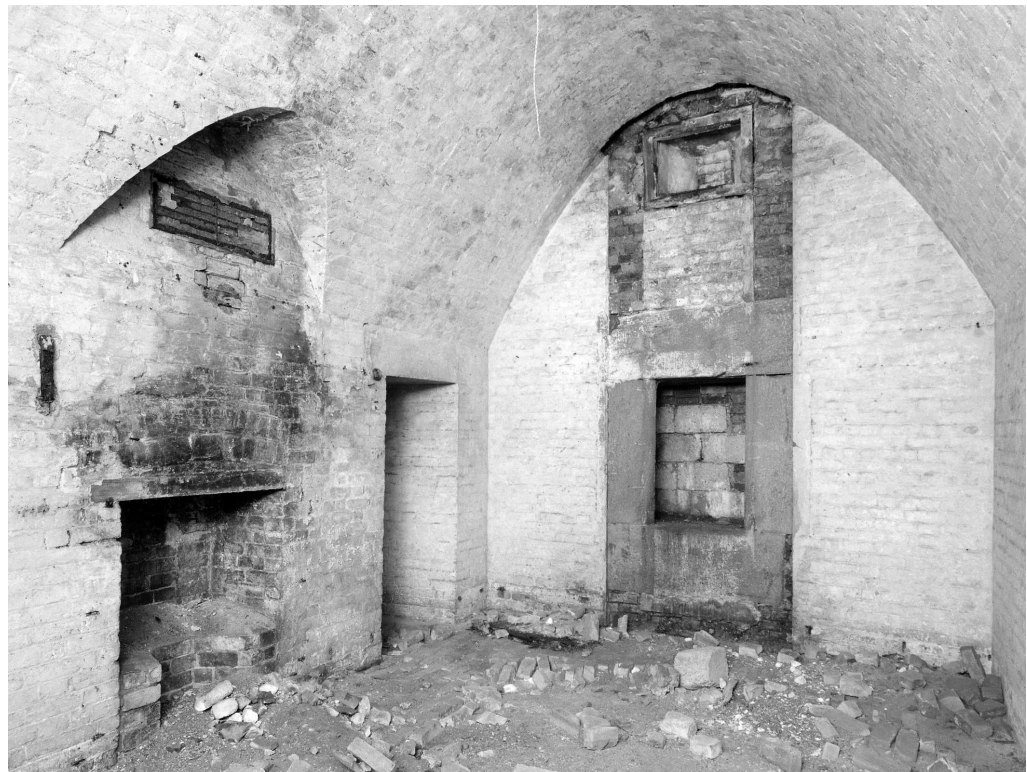
Figure 38
The Gorge Casemates; detail of cast iron fire surround (NMR: AA044009 © Crown copyright 1998)

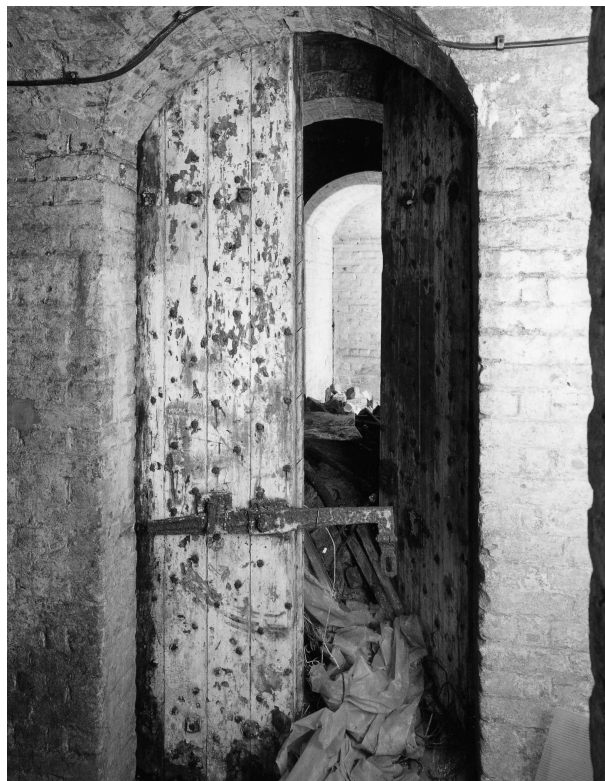
into the casemates at the various points of access. Surviving doors are pintle-hung and comprise an iron plate sandwiched between diagonal boarding on the outer face and vertical boarding on the casemate face, the components bonded together with iron studs standing proud of the boarding (Fig 39). A large iron pivoted locking-bar is provided on the casemate side, enabling troops to hold off an attacker who had gained the interior of the Citadel. In reality, the position of such defenders was hopeless unless a relief force was available, though re-taking the

Figure 39
*Gorge Casemates;
detail of reinforced
door, showing iron
locking bar (NMR:
AA043935 © Crown
copyright 1998)*
