THE WESTERN HEIGHTS DOVER, KENT

Report No 2: The Citadel

SURVEY REPORT

LAND-FRONT FORTRESS AND BARRACKS 1779-1950

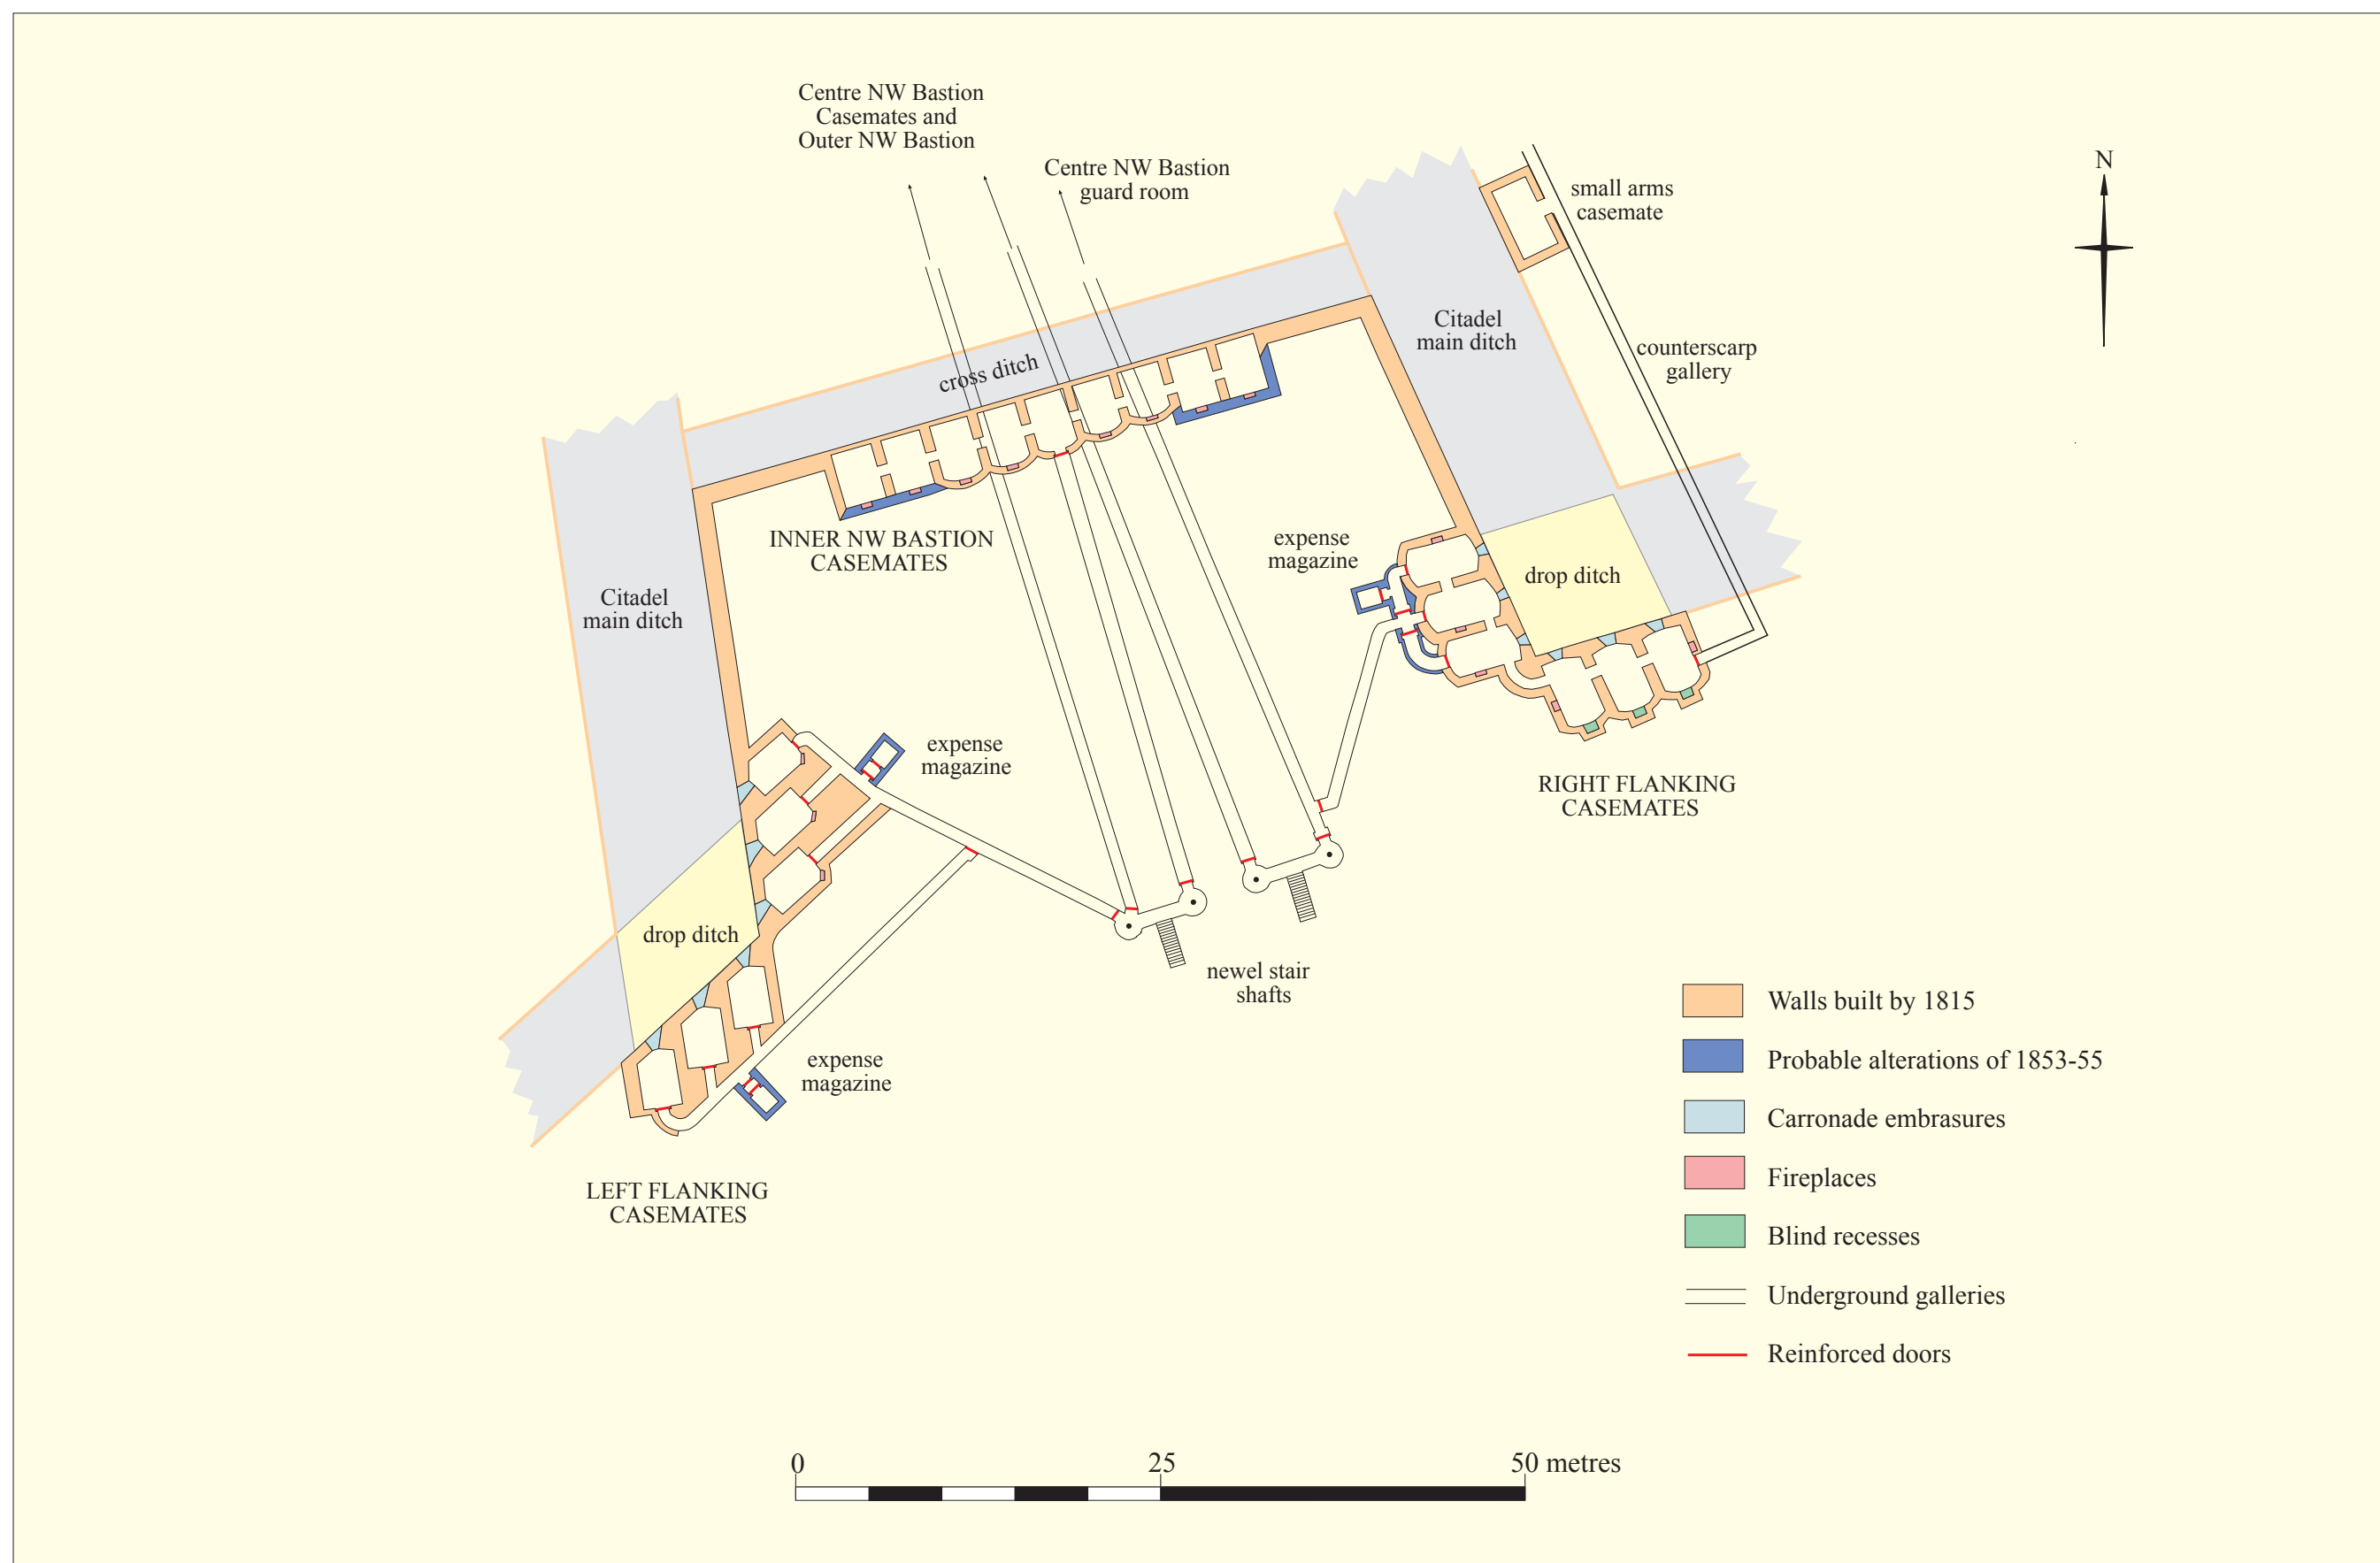
Figure 40 Plan showing the Inner NW Bastion Casemates, Right Flanking Casemates and Left Flanking Casemates. Note that the fourth (eastern) expense magazine and gallery connecting the casemates to it, is illegible on the original plan (after HMPS 402513 and 402594)

In 1877 the two expense magazines were still in commission, each with a capacity of 36 barrels of gunpowder, implying that carronades were in position (PRO: WO/78/2755/1-2). However, by 1887, the guns had been withdrawn and were not replaced (PRO: WO/33/2775). In 1911, the inner sets of each group were in use as Company Stores; the rest were disused as, in all probability, they had been since the 1880s (HMPS: 402581). This is reflected in the condition of the outer sets where there is no evidence for adaptation to a new rôle, while, in contrast, those nearest the stair have the remains of suspended wooden floors and remains of, or scars from, shelf brackets. They also have hearthstones, flue-pipe openings, mountings for stoves, and, in some cases, one or both jambs of the embrasure removed to accommodate a window. This evidence suggests use as barracks, presumably prior to 1897 when they do not appear on the Citadel accommodation plan. This can only have been temporary as they were not designed for permanent occupation (PRO: WO/78/2426/6).

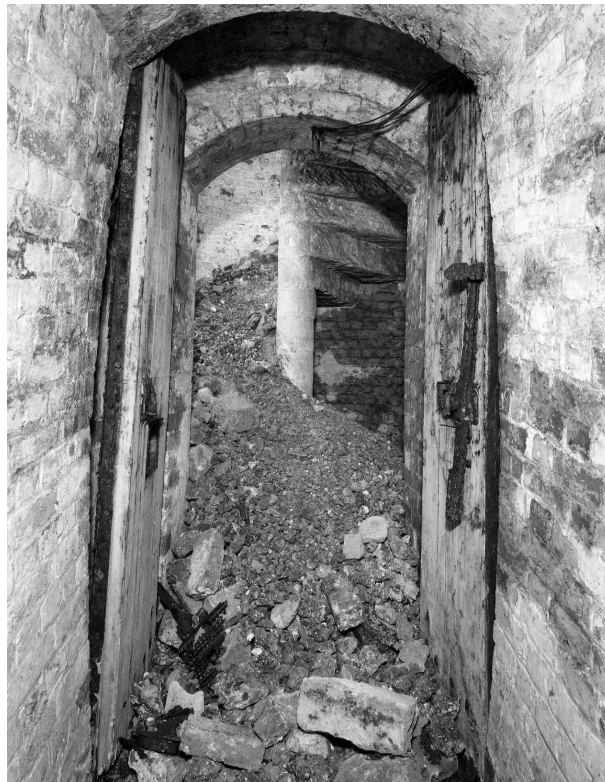
Although the shafts are sealed, HMPS provided temporary access to the easternmost shaft. It is 2.34m (7ft 8in) in diameter with a central stone newel (Fig 41). The galleries leading from it are lined with brick in English bond, usually whitewashed, with paved brick or plain chalk floors. There are groined intersections to the segmental brick vaults and where stairs are necessary, they are formed in gritstone. Between each casemate or group of casemates there is a set of double-leaf doors, opening into tie-back recesses, that were intended to delay the progress of an enemy in possession of part of the bastion. Where they survive, as at the entrance to the gallery from the Counterscarp Casemates, they are strongly built, counter-boarded, with the casemate face armoured with 3mm iron plate. Each leaf incorporates a small loophole and each pair could be secured using a heavy, centrally pivoting iron strap. At intervals of seven to eight metres there are splayed lamp recesses in the gallery walls. These always have stone lintels and, in the

Figure 41
*Inner NW Bastion; base
of a newel stair shaft
linking to a gallery
leading to Centre and
Outer NW Bastions
(NMR: AA043964 ©
Crown copyright 1998)*

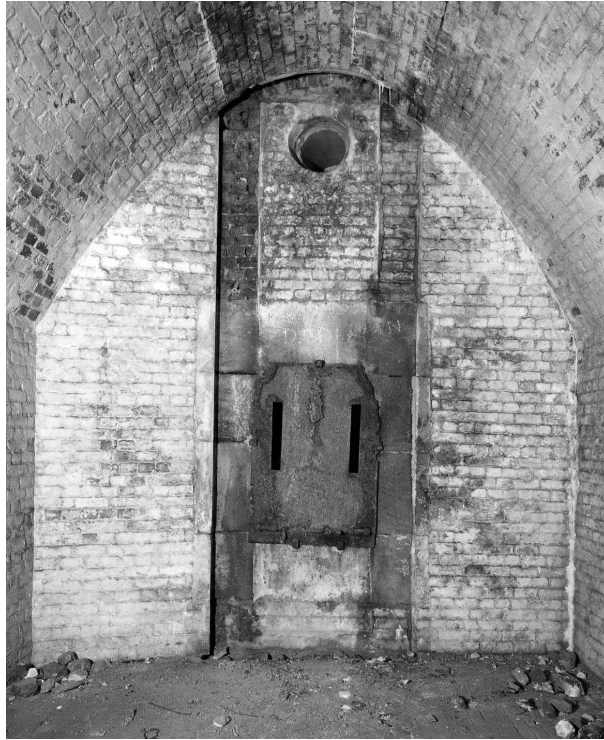
Figure 42
*Inner NW Bastion; a
gunroom in the Right
Flanking Casemates.
Detail of the ditch wall
showing the scars from
the original sliding
shutter and its
replacement, a small
fixed steel shutter
perforated with loops
for small arms fire
(NMR: AA043967 ©
Crown copyright 1998)*

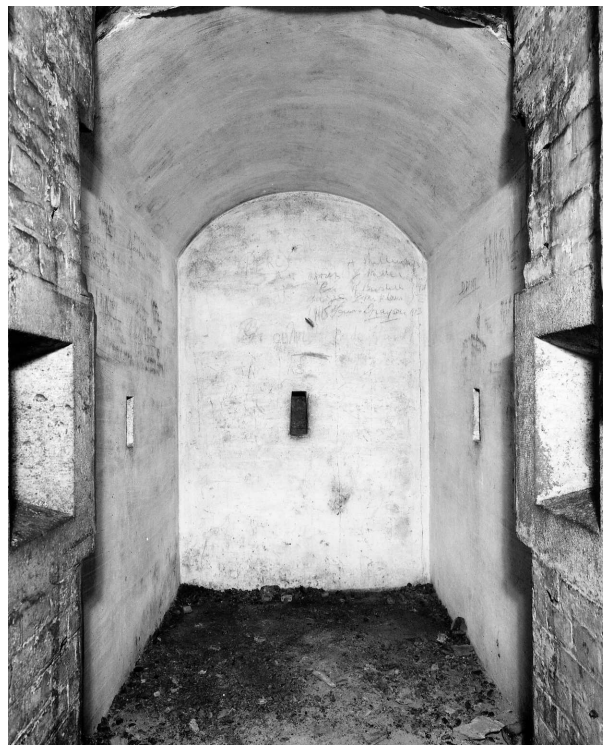
Figure 44
*Inner NW Bastion;
Right Flanking
Casemates. Interior of
an expense magazine,
showing stone
ventilators flanking the
entrance and
ventilation slots in the
walls (NMR: AA043968
© Crown copyright
1998)*

removed). These ventilated the magazine via a cavity in the double brick skin and also provided ventilation under the floor; the apertures inside the magazine are plain (Fig 44). The door was hung in the rebate on the inside face of the magazine. The magazine was rendered internally and had a suspended timber floor. The eastern magazine has a sign reading '25 Expense Magazine' next to the entrance.

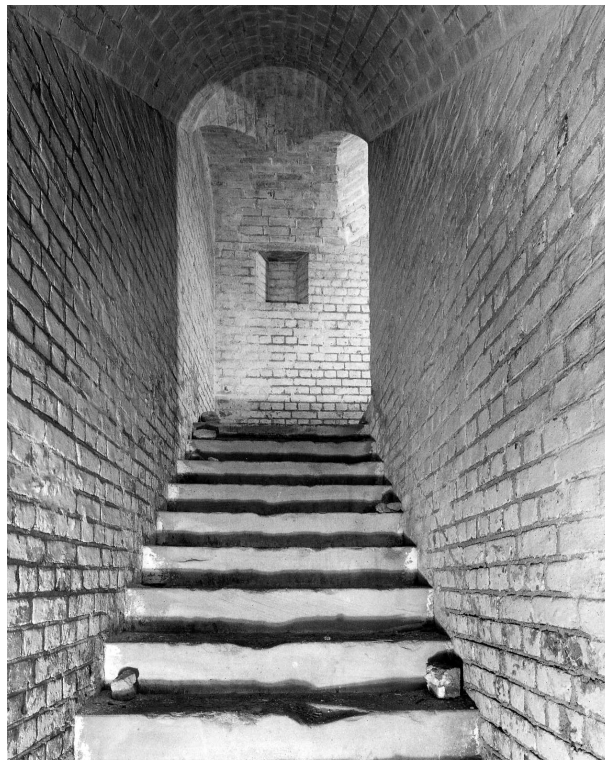
Figure 45
*South end of the
counterscarp gallery,
showing steps up
towards the Right
Flanking Casemates in
the Inner NW Bastion.
Note the small lamp
recess in the wall of the
quarter landing (NMR:
AA043977 © Crown
copyright 1998)*

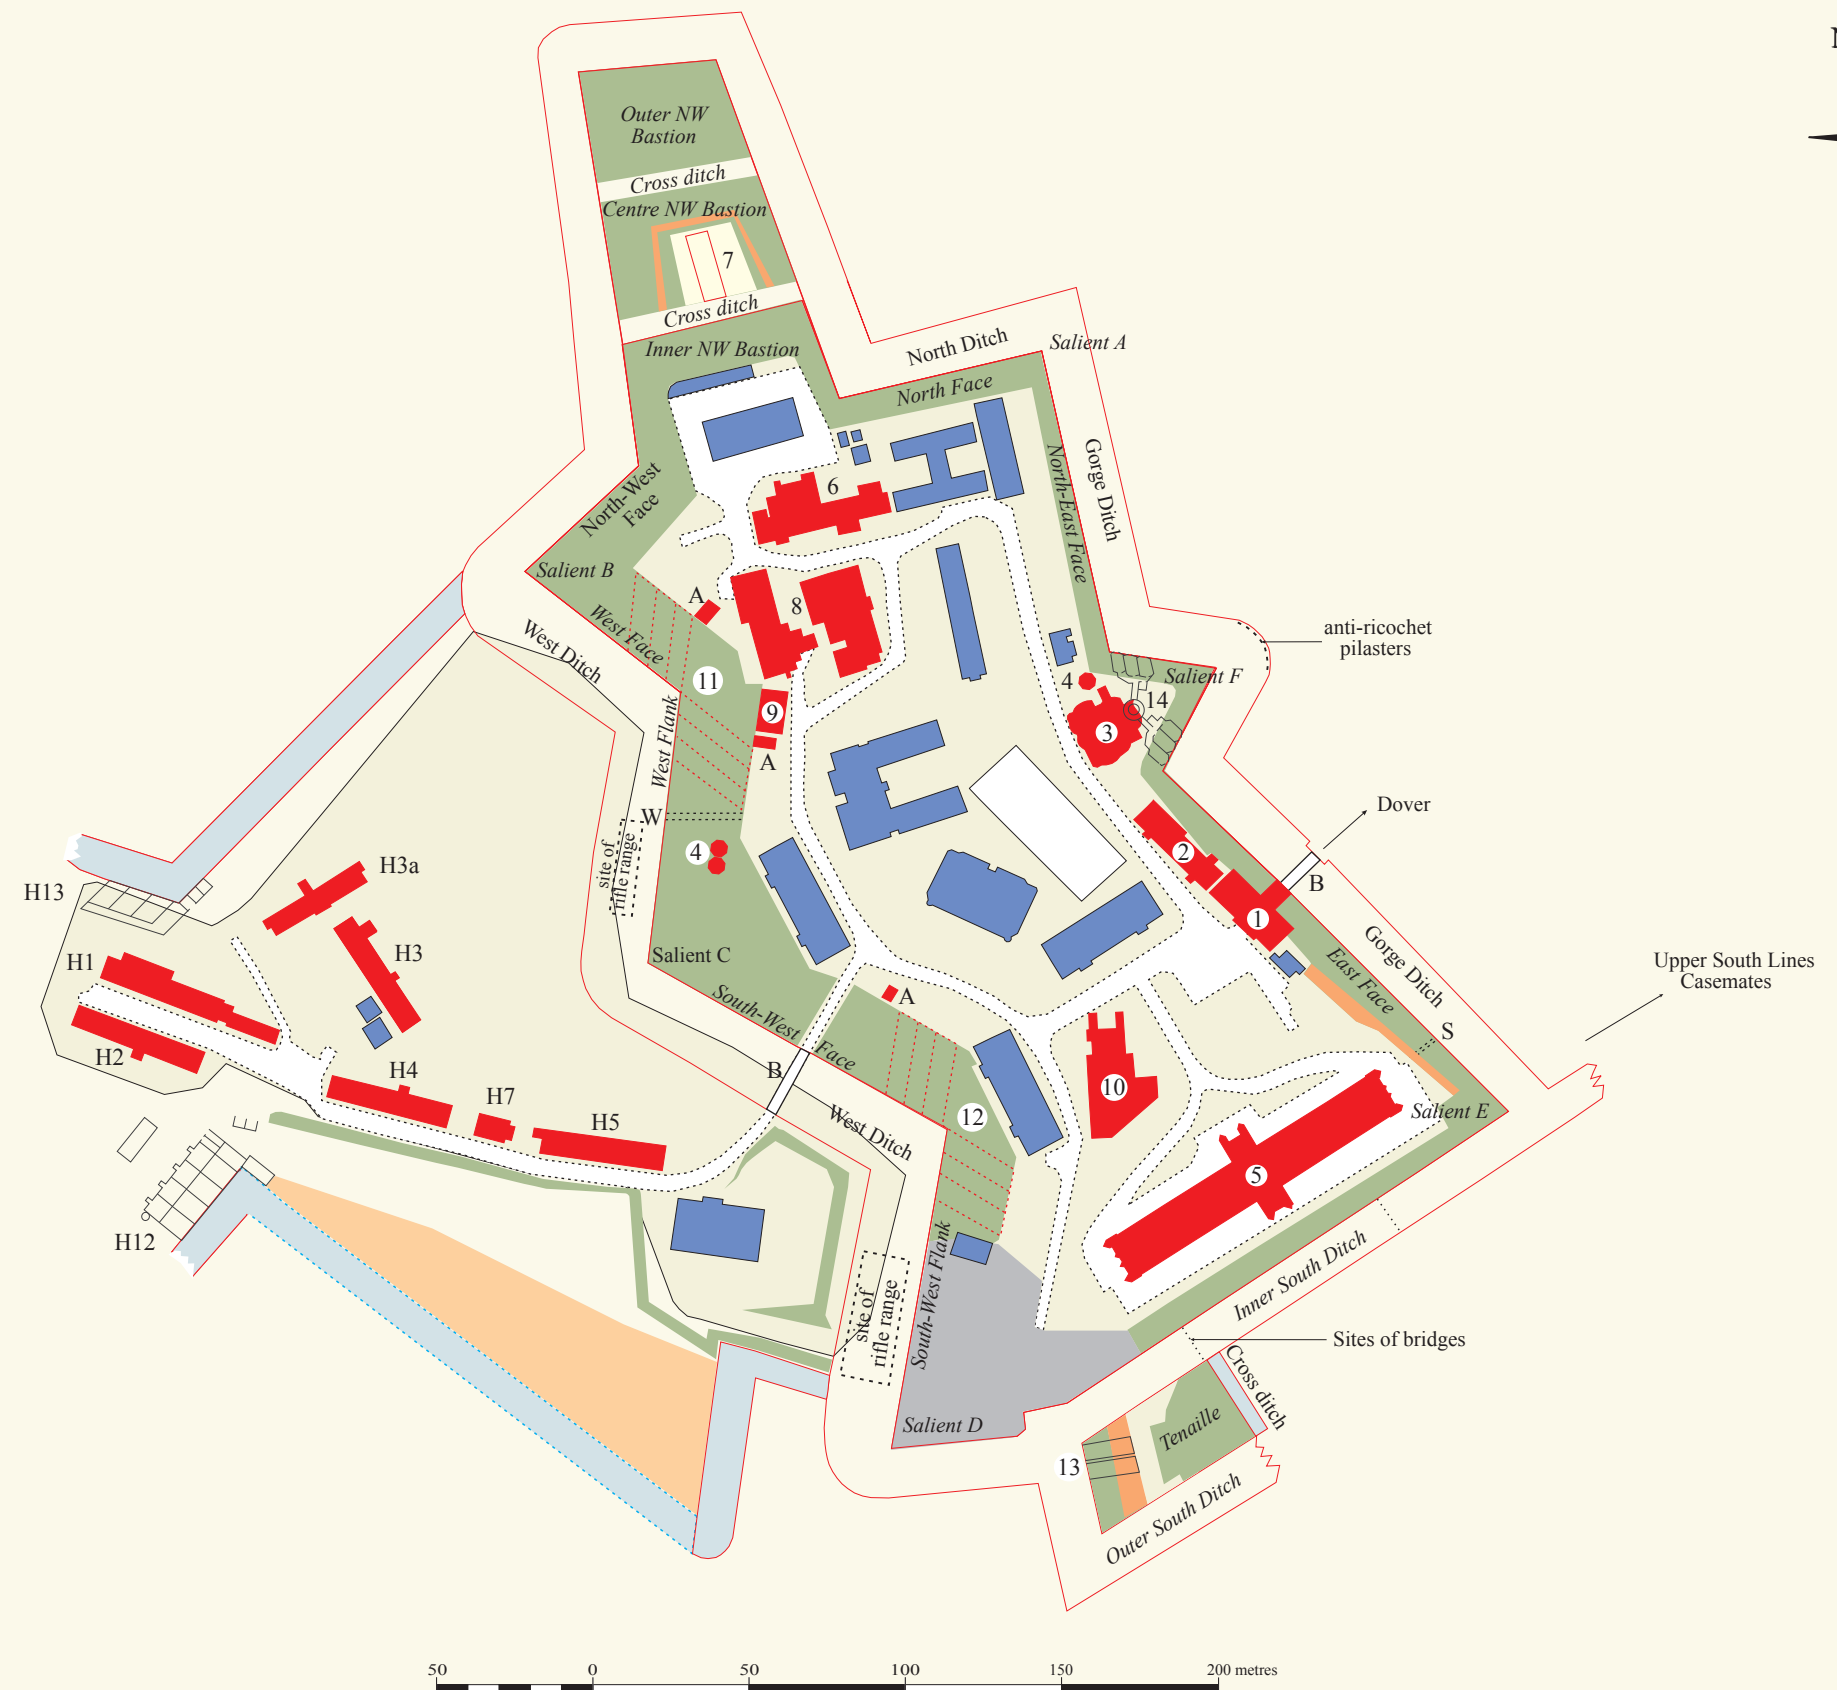
Figure 49 Plan showing the Citadel c1998, with all remaining buildings (text in *italics* indicates the nomenclature of the fortress used from the later 19th century onwards)

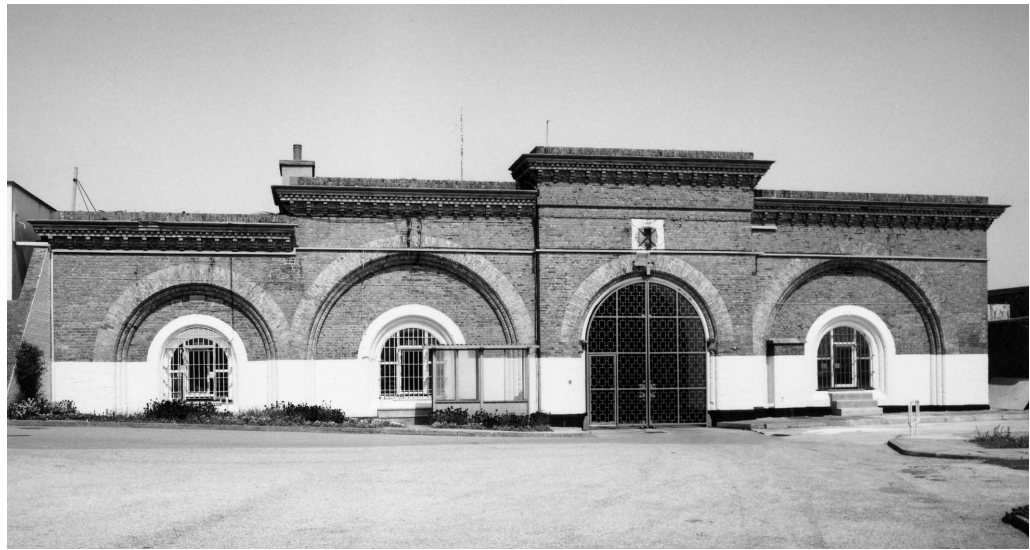
Figure 51
*The Citadel; Main
Entrance and Guard
Room casemates,
viewed from the Parade
Ground (NMR:
AA043941 © Crown
copyright 1998)*

ditch on a bridge with a lifting span that closed against an outer gateway. This outer opening was protected by a pair of strong doors, which gave onto a vaulted tunnel through the rampart. The tunnel leads to an inner gateway with a second pair of doors. A gatehouse rose over the outer section of the tunnel, its east elevation carried up from the ditch scarp revetment, while from the inner, wider section of the tunnel, doorways in the north-west and south-east walls led into flanking casemates which together formed the Guard Room. These were built in the body of the rampart but presented an elaborate south-west elevation, incorporating the inner gateway, facing onto the Parade Ground (Fig 51).

The building has an irregular four-bay plan, of which a single bay forms the tunnel through the rampart to the outer gateway. The four-bay south-west elevation was originally flanked by westward projecting revetment walls, of which the northern example survives (Fig 51). The three southern bays form a symmetrical grouping, within which the narrower central bay, through which the tunnel passes, projects slightly and rises above the other two. The north-western bay is set apart by its lower eaves level, and does not extend as far back into the rampart. All four bays are articulated by large Gault brick semicircular arches of three chamfered orders. With the exception of the tall bay containing the tunnel these incorporate large semicircular-headed windows. In the bays flanking the tunnel these had two round-headed lights each, beneath an overall round head, in a style reminiscent of plate tracery, as on the Guard Room at North Entrance (Brown and Williams 2001). In the lower north-western bay the window took the form of a lunette; the sill has been dropped subsequently to match the others. All the fenestration has been renewed with modern casements. The whole elevation was crowned by an

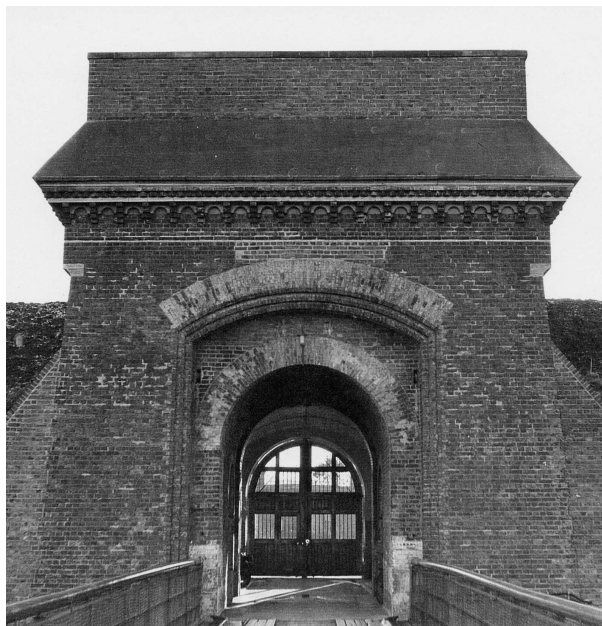
Figure 52
The Citadel; external elevation of the Main Entrance, from a photo taken in 1959 (© Dover Museum, ref A.5513/48)

The lifting bridge has been replaced by a fixed span since 1947, but some evidence survives for both its form and for the lifting mechanism. The record drawing shows that the bridge was carried by two pairs of columns, probably of cast iron, the masonry bases for which remain in the ditch bottom (HMPS: 402550). It also shows cross-bracing, presumably of wrought iron, between each pair of columns. The timber deck had iron balustrades. The south-western section, approximately one-quarter of the total span, could be raised by ropes or chains to close against the entrance in a rebate in the elevation. These and other details resemble those for the bridge at the South Entrance to the Western Heights, for which more detailed drawings, dated 1876, survive (Brown and Williams 2001, 35; NMR: WD/2316).

Large rectangular sandstone blocks set on either side of the roadway at the outer gateway appear to be mounting blocks for the bridge pivot. Rectangular iron slots placed on either side of the arched entrance contain pulley wheels for the lifting ropes or chains to pass over. Similar slots are found in the north-east faces of two small vaulted chambers opening off either side of the tunnel. These chambers, which are rebated for former

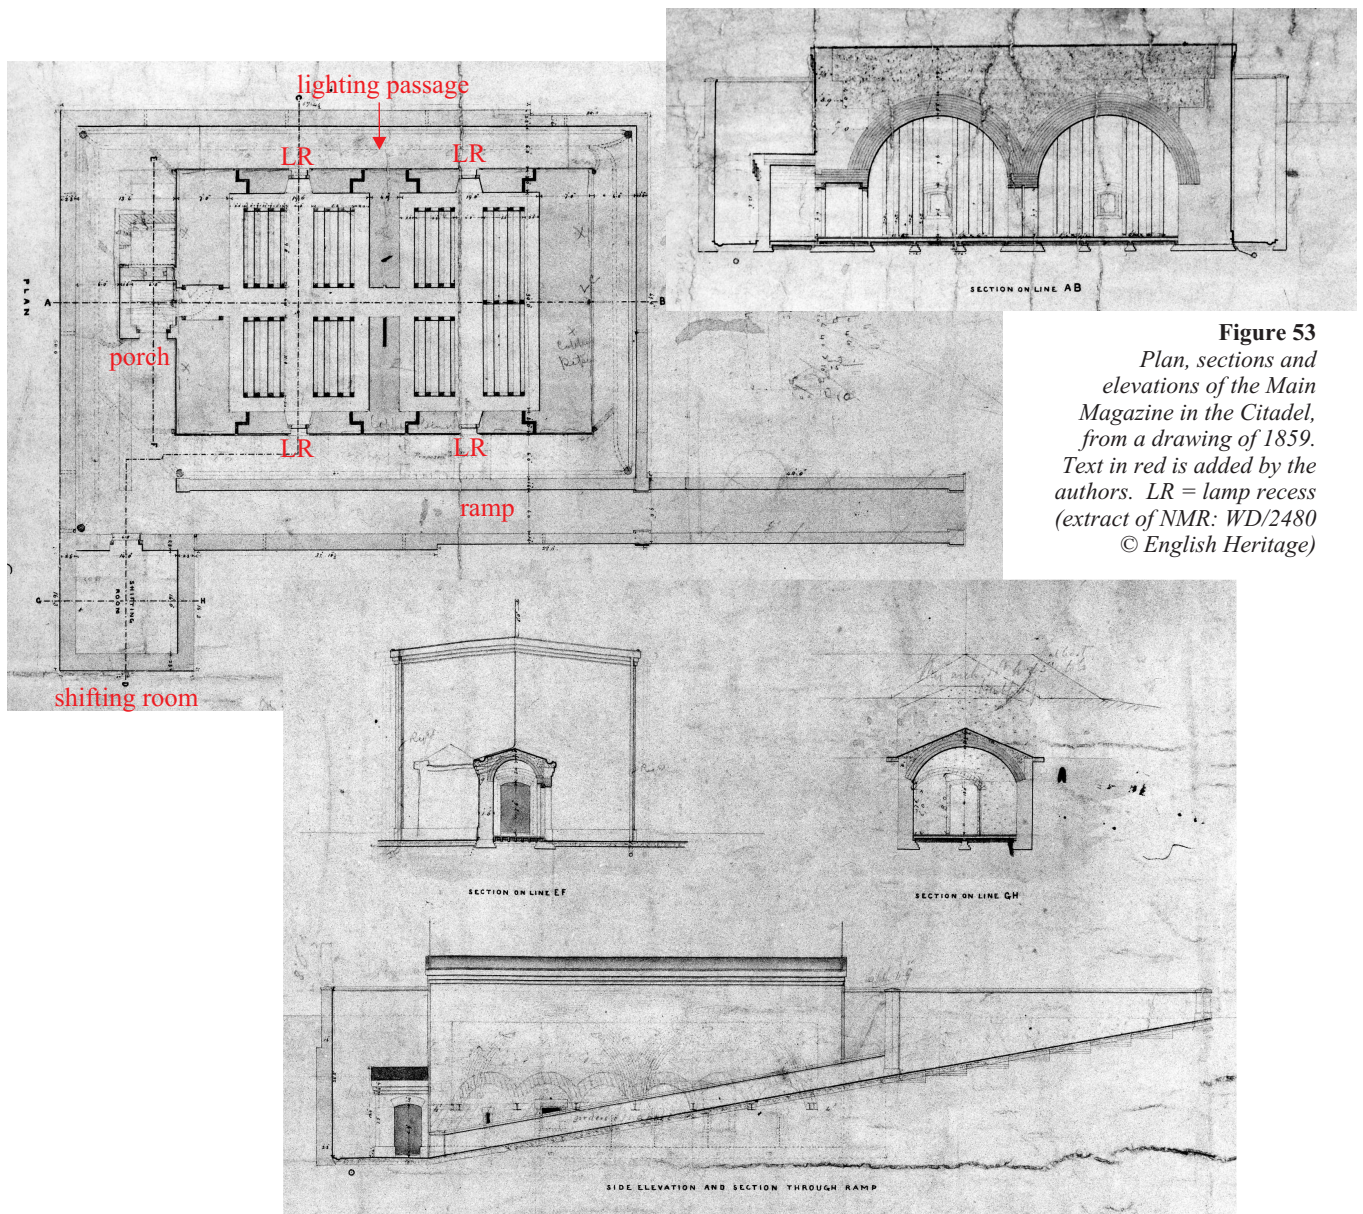
Figure 53
Plan, sections and elevations of the Main Magazine in the Citadel, from a drawing of 1859. Text in red is added by the authors. LR = lamp recess (extract of NMR: WD/2480 © English Heritage)

The magazine was partially damaged and infilled as part of works by HMPS, although it may be reasonably well preserved underground.

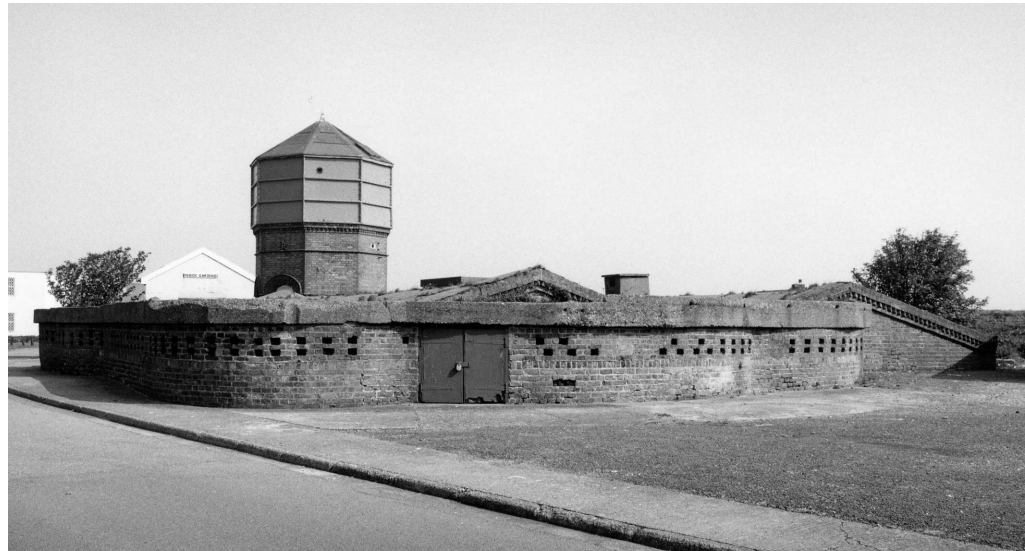
Figure 55

The 1860s Well and Pump House, from the south. The gables of the sunken Engine Room (centre) and Boiler Houses (right) are just visible. The flat concrete roof over the lobed walls of the light wells was installed sometime between 1930 and 1945. The water tank dates to 1891 (NMR: AA043943 © Crown copyright 1998)

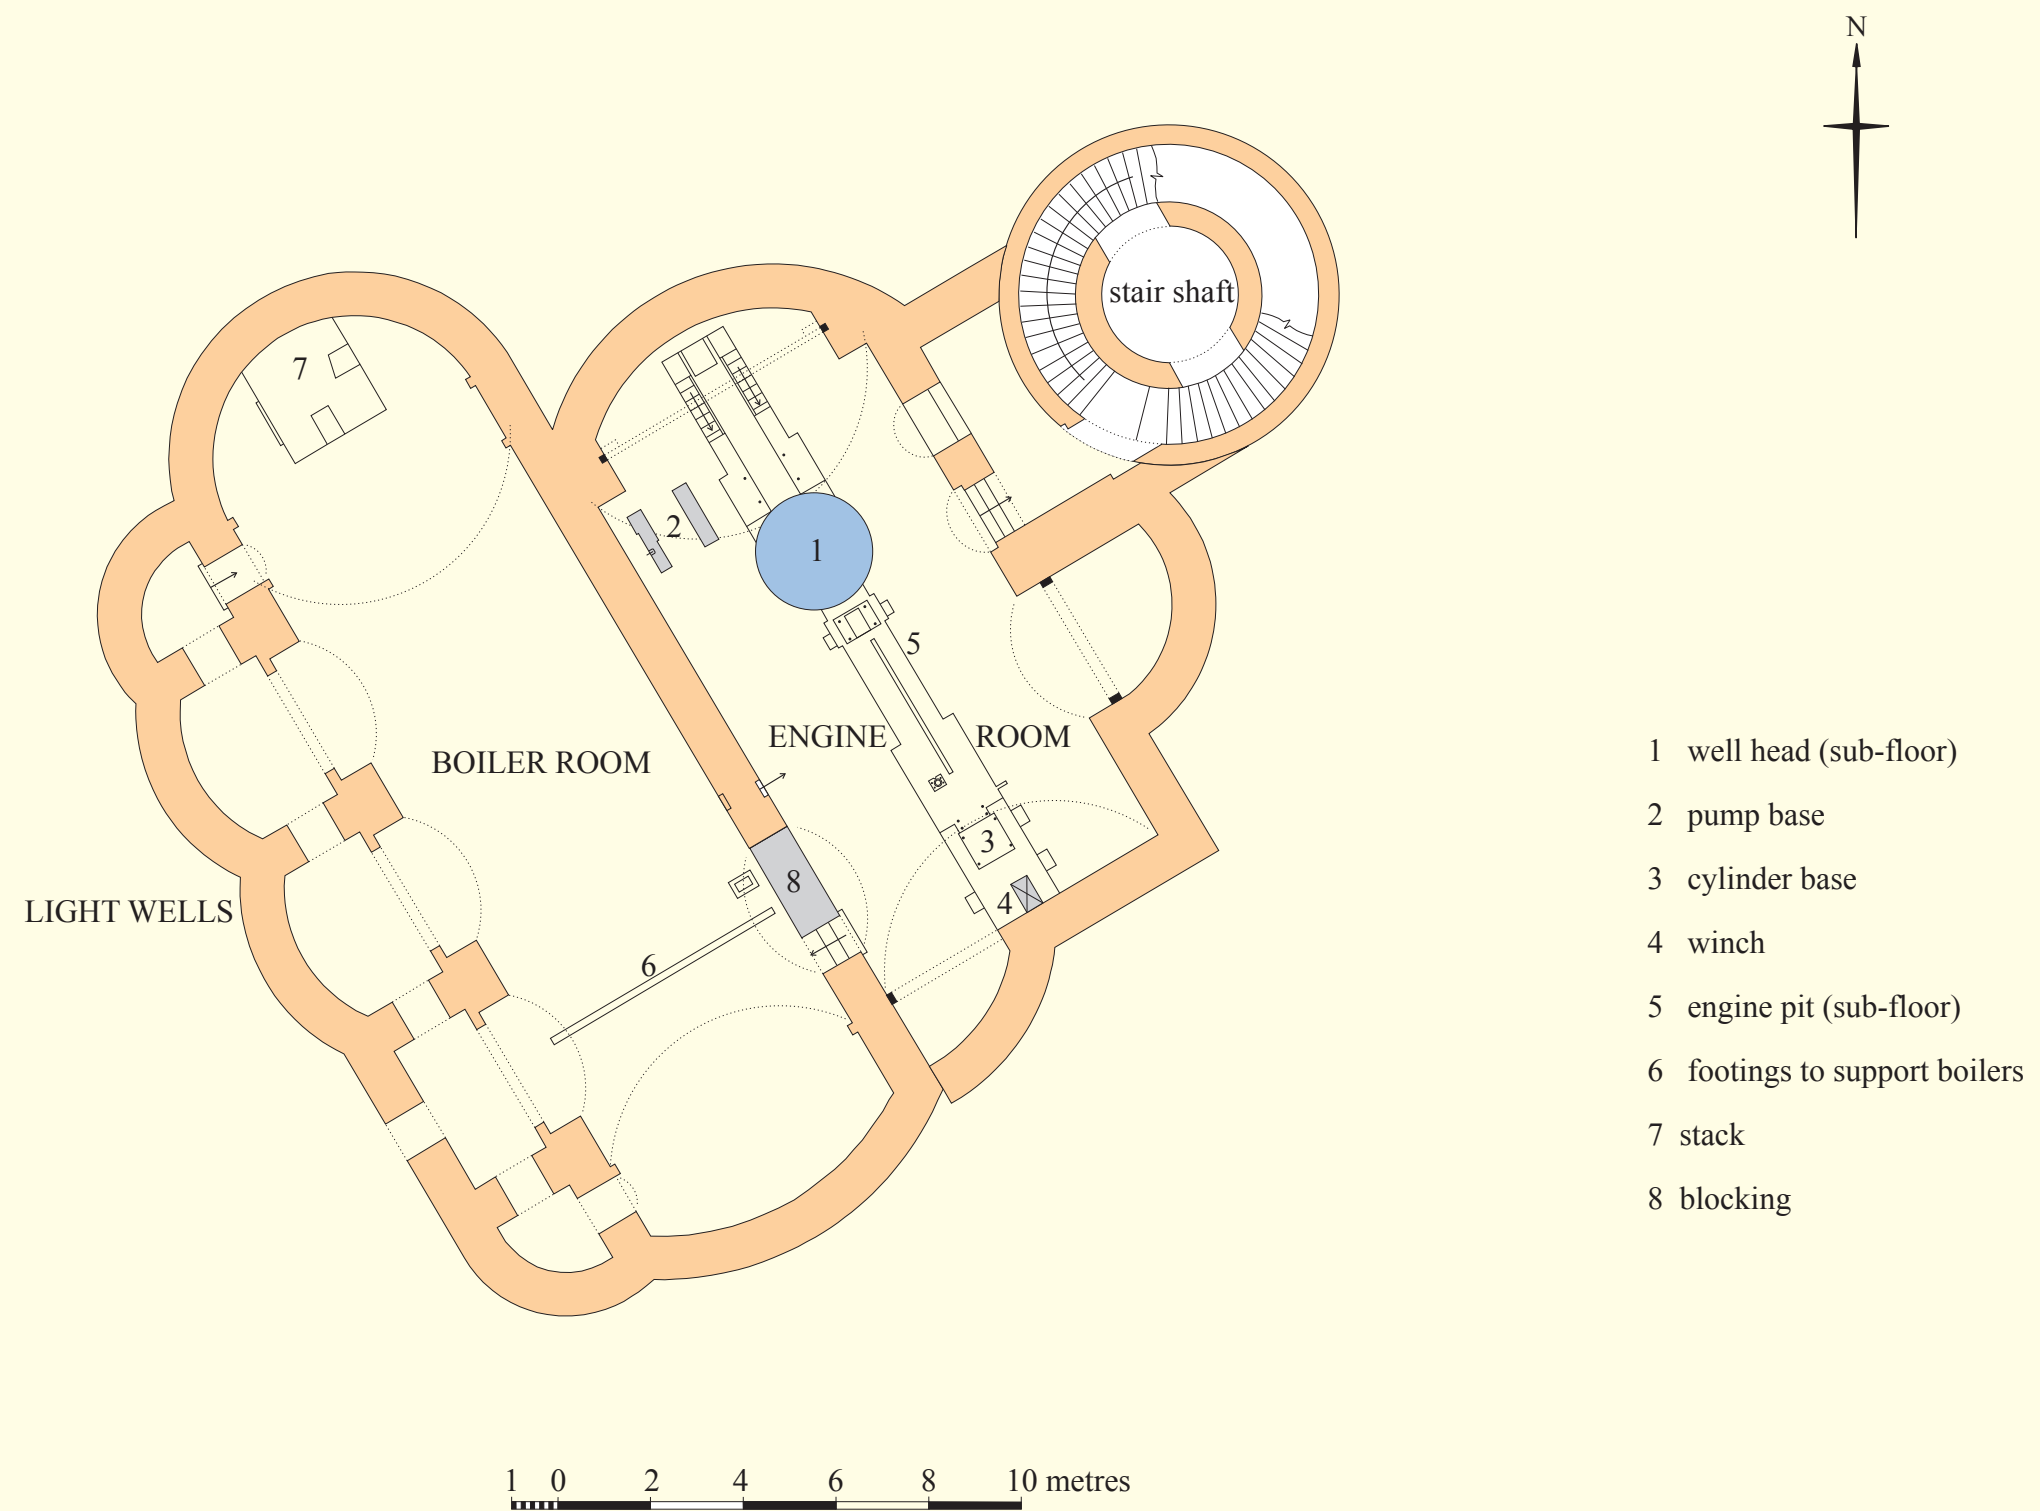
Figure 56 Plan showing the 1860s Well and Pump House

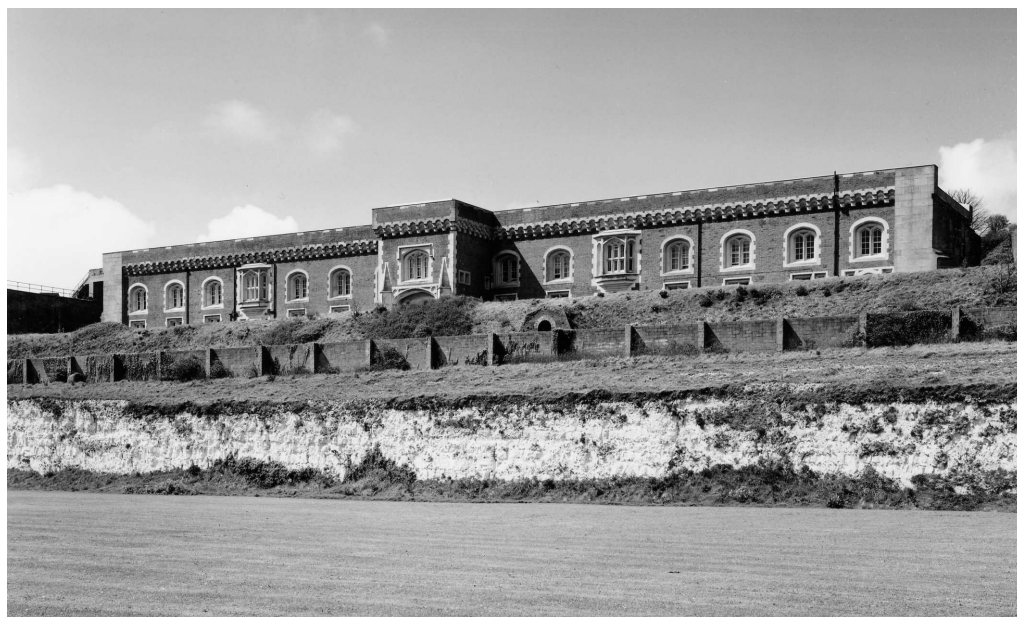
Figure 60
The Officers' Quarters,
south elevation (NMR:
BB032722 © Crown
copyright 1998)

brick as its principal facing material. The brickwork is laid in English bond, with limestone dressings (mostly concealed by stucco repairs), including door and window surrounds, the moulded top course of the plinth, and the corbelled eaves, from which the stone-coped brick parapet rises. The heavily fortified and buttressed ends of the building, however, which are comparable in detailing to the contemporary *caponiers* at Drop Redoubt and Detached Bastion, have more durable gritstone masonry and are divided into three by pointed buttresses incorporating shouldered set-backs (Brown *et al* 2001, Pattison 2001). Similar pointed buttresses flank the entrances in the north and south porches, which have flush stone quoins to the corners.

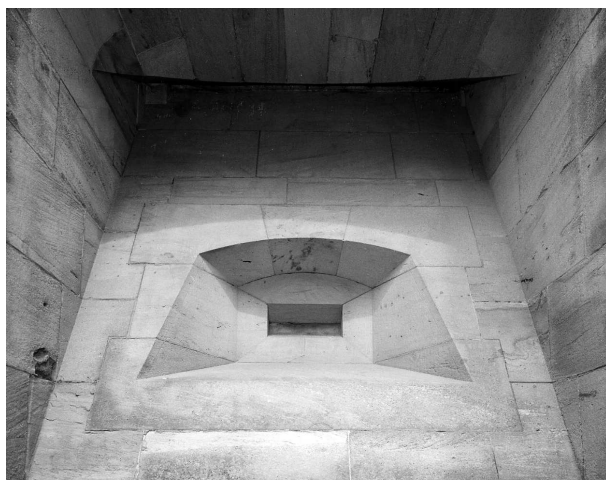
Figure 61
The Officers' Quarters;
detail of loophole in the
W end wall (NMR:
AA043956 © Crown
copyright 1998)

loops. To the west there is a single loop in each recess (Fig 61), but to the east, opposite where two galleries emerge from under the gorge rampart, the armament is increased to two paired loops flanking a singleton. At the top of the batter a narrow slot, now blocked with timber, functioned as a 'murder hole', allowing fire to be directed downwards into

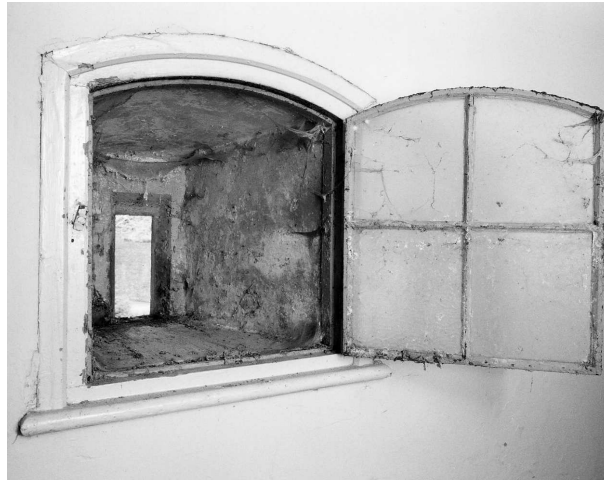
Figure 62
The Officers' Quarters;
metal framed internal
casement over a gun
loop (NMR:
AA043960 © Crown
copyright 1998)

the dead ground close to the wall. At both ends on the first floor, widely splayed segmental-headed loops flank a central four-centred arched window. The first-floor loops at the west end are high enough to sweep the *terreplein*; those to the east are less well positioned. Internally, at least one of the loops (first floor, north porch) retains a metal-framed casement, which may reflect the original provision throughout the building (Fig 62).

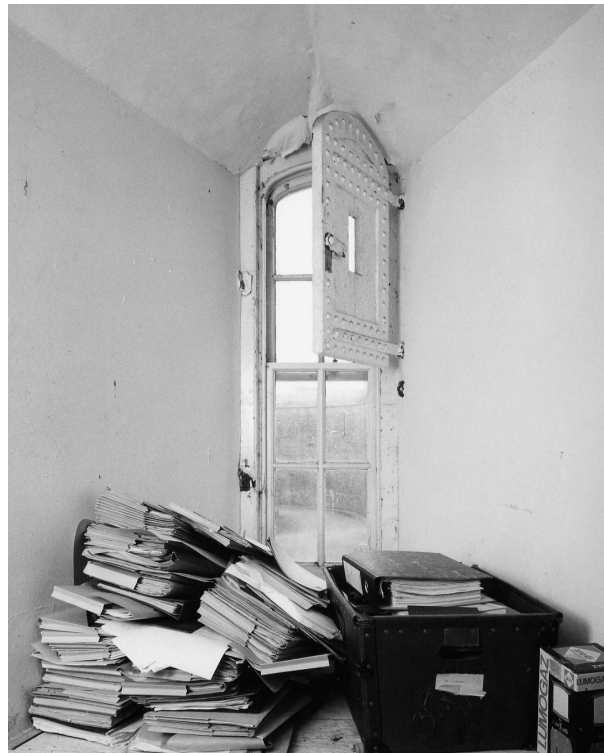
Figure 63
The Officers' Quarters;
armoured shutter to a
first-floor window on
the west side of the
north porch (NMR:
AA043959 © Crown
copyright 1998)

armoured exterior face and were square-headed, beneath a similarly armoured, but fixed, *tympanum*. The Entrance Halls were also provided with iron-reinforced window shutters, one of which survives on the first floor of the north porch (Fig 63; HMPS: 402531).

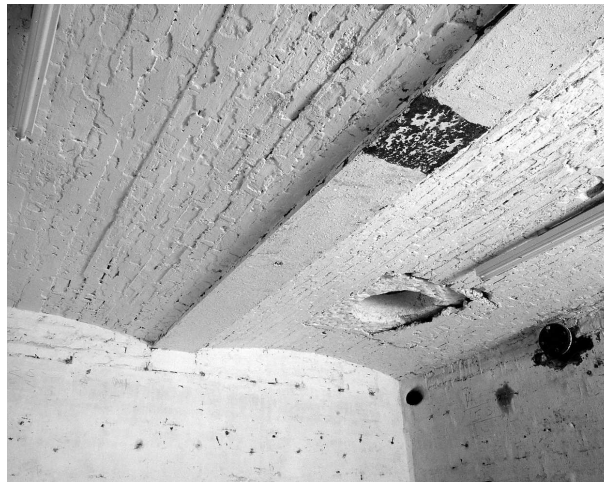
section rest on the lower flanges of the joists and on these concrete is laid (Fig 64). The laths were underdrawn with plaster. This represents a somewhat inferior variant of the method patented by Henry Hawes Fox in 1844 and developed and marketed by James Barrett. The method described here is inferior in that the beam soffits (though not the joist soffits) are left exposed and

Figure 64
*The Officers' Quarters;
ceiling of one of the
basement rooms,
showing fireproof
construction and
circular inspection
aperture (the room
housed a water tank)
(NMR: AA043963 ©
Crown copyright 1998)*

therefore vulnerable to fire, whereas Fox's system stipulated the complete encasing of the iron in plaster. The system was more widely adopted following the expiry of Fox's patent in 1859, and the Officers' Quarters must represent one of the earliest such uses (Hurst 1996).

vault, either one or two per vault (Fig 64). On the ground floor these are positioned so as to allow their use with minimum disruption, all but two being placed within service rooms, store-rooms or circulation areas. They may have served as inspection hatches, but could perhaps also have been used to draw water from the tanks under siege conditions. Water was supplied from the Pump House (HMPS: 402604).

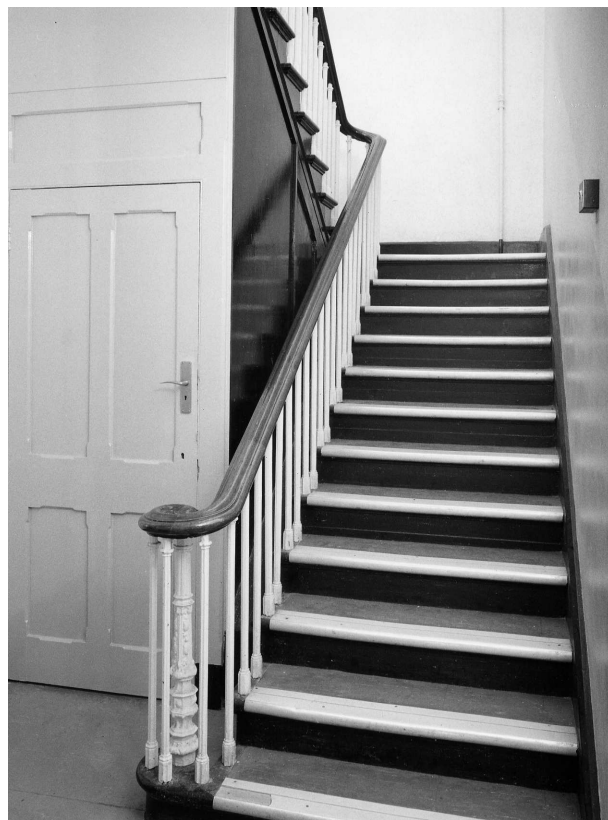
Figure 67
*Officers' Quarters;
stair on ground floor of
COs Quarters, from the
NE (NMR: AA043958
© Crown copyright
1998)*

The stair is poorly lit at ground level, deriving most of its illumination from fanlights above two doorways off the stair-head, and from an axial Passage extending from the stair-head to the east wall. The compartment is not a generous one, and an arched recess in the west wall is required to give sufficient space for the half-landing. The stair is of dog-leg form, with fluted cast-iron column balusters and a more elaborate cast-iron newel at the curtail step (Fig 67). The simply moulded hardwood handrail is wreathed at the turn and scrolled at the curtail. The present basement stair is modern.

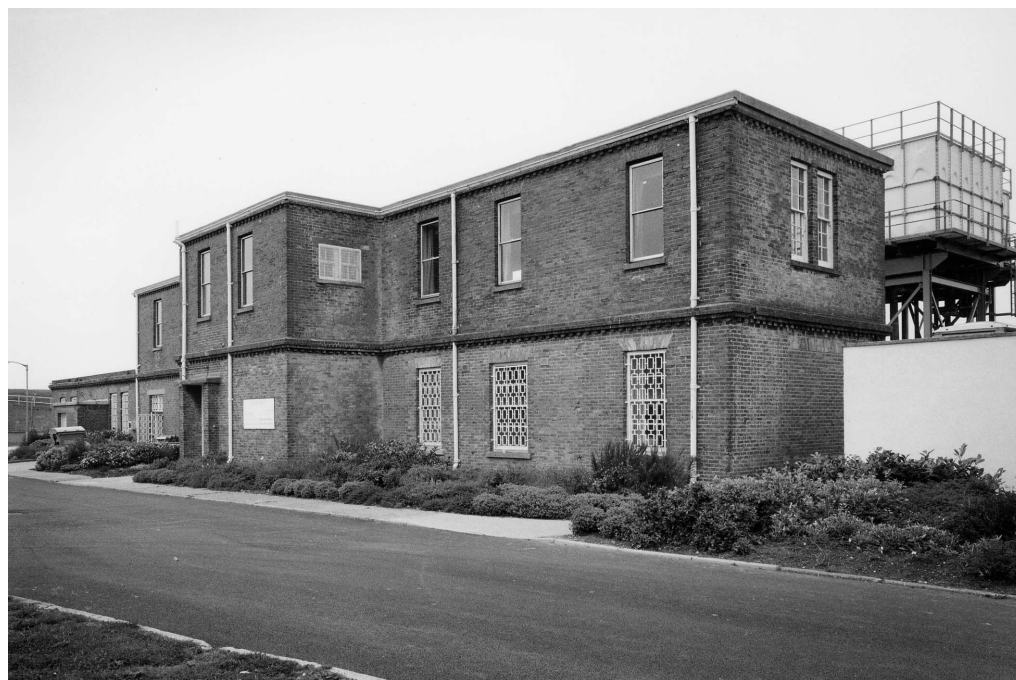
Figure 68
*The former Canteen
and Regimental Institute
building in the Citadel,
from the east (NMR:
AA043938 © Crown
copyright 1998)*

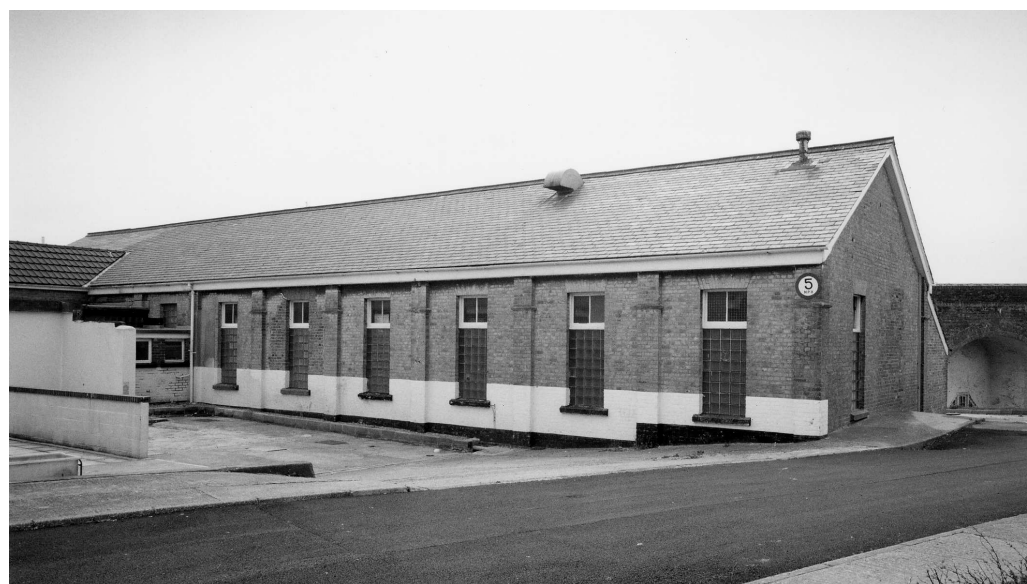
Figure 69
The 1927 Dining Room,
from the NE (NMR:
AA043940 © Crown
copyright 1998)

The new Dining Room, now converted to a Gymnasium, is a single-storeyed building, gabled north-south (Fig 69). It has eleven bays of pier-and-panel construction in yellowish brick, laid in English bond on a chamfered plinth, with pale brick flat arches to the original openings and concrete sills to the windows. The piers incorporate moulded brick impost. The roof is carried on steel trusses and covered with Welsh slate.

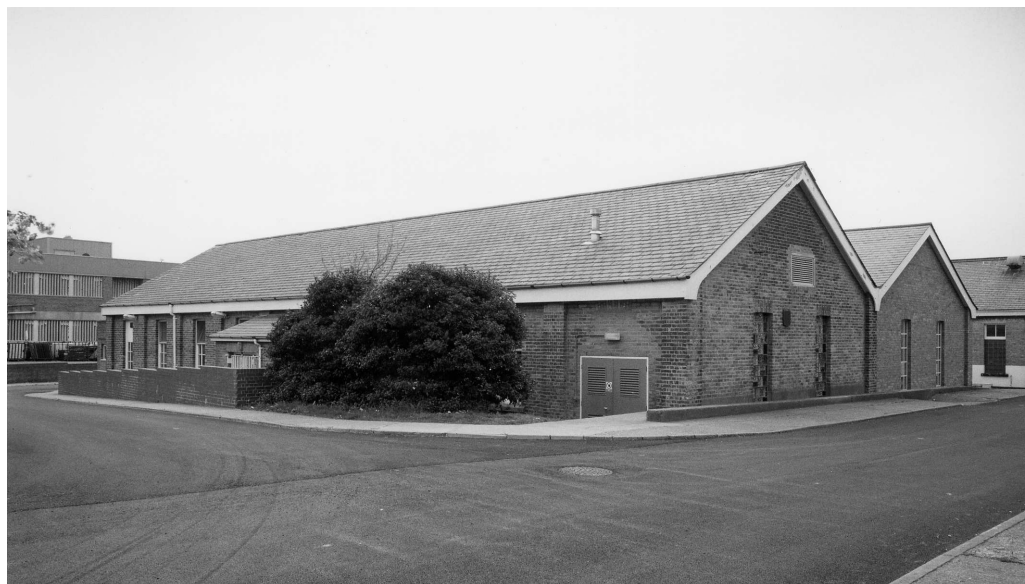
Figure 70
*The 1932 Dining Room,
from the NE (NMR:
AA043939 © Crown
copyright 1998)*

The new Dining Room formed, when viewed from the south, a balancing wing to the old. It was slightly broader, but just nine bays in length. Broadly similar in style, it is plainer in detailing, lacking a plinth and moulded imposts, and having arches turned in the same brick as is used for the walling (Fig 70). The trusses bear on padstones, visible externally
