THE WESTERN HEIGHTS DOVER, KENT

Report No 2: The Citadel

SURVEY REPORT

LAND-FRONT FORTRESS AND BARRACKS 1779-1950

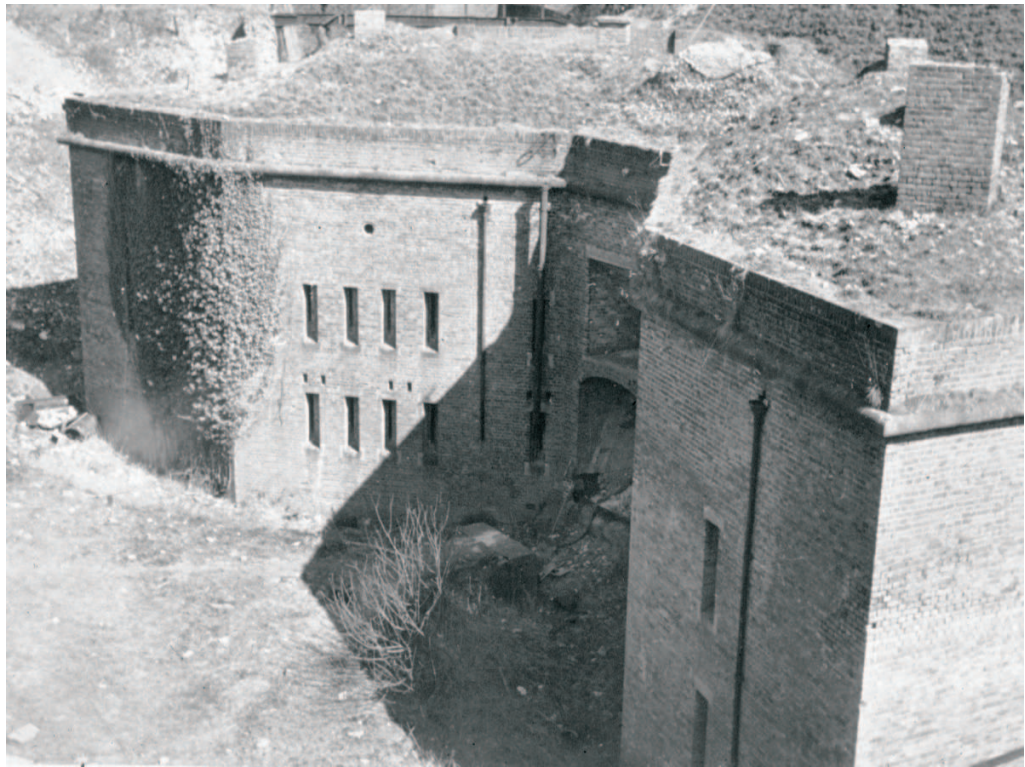
Figure 72
*The Double Caponier of
the Western Outworks,
from the SW c1959 (©
Dover Museum, ref
D07891)*

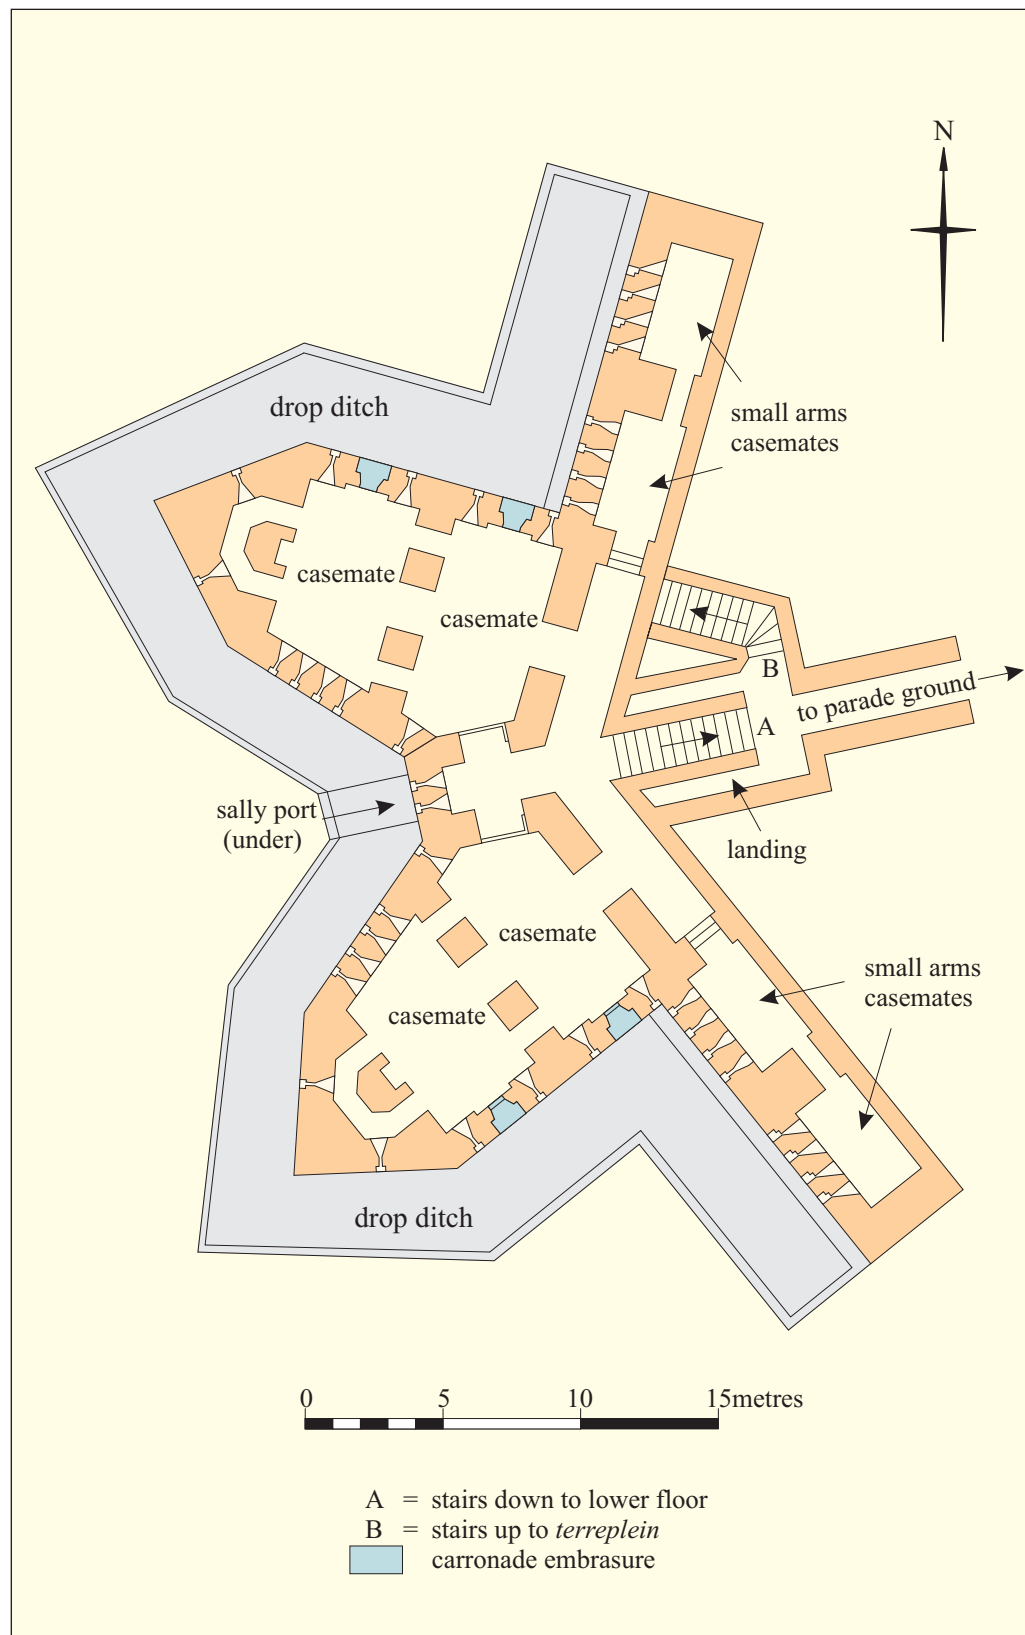
Figure 73
*Plan of the upper floor
of the double caponier
in the Western
Outworks (after HMPS
402478; 402484)*

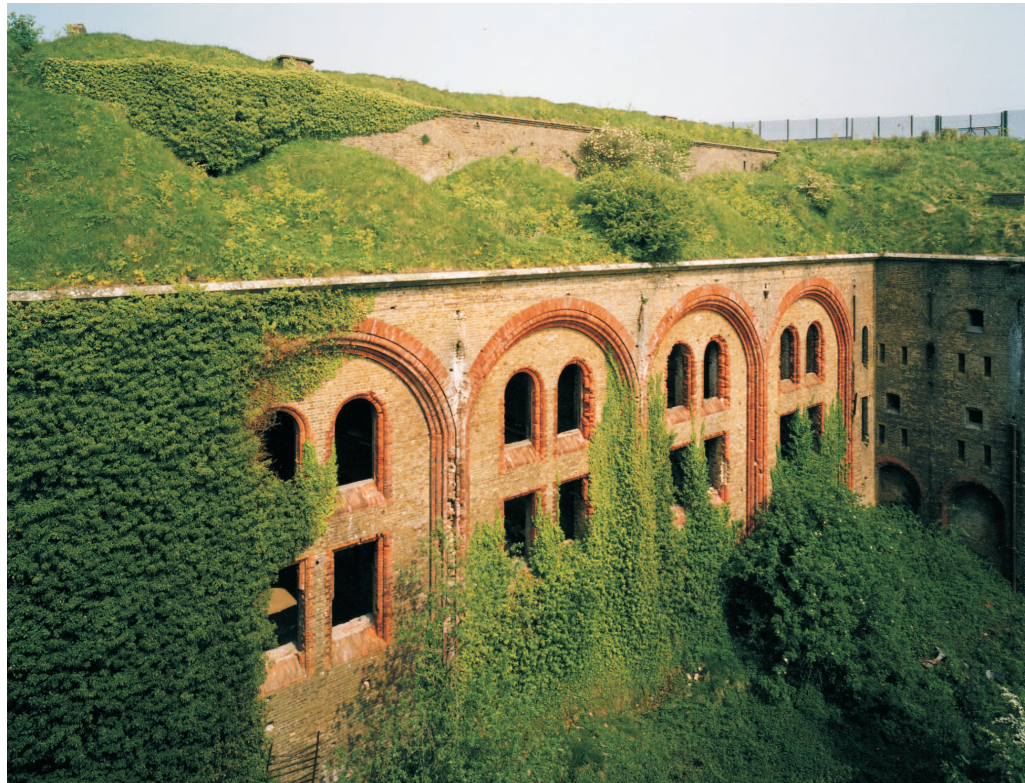
Figure 74
The South Flank Casemates of the Western Outwork, from the south. Above the capping course of the main elevation, earthworks protect a series of casemated gun positions, the front wall of which is just visible (NMR: BB032747 © Crown copyright 1998)

These casemates are positioned in the re-entrant where the South Flank (here facing south-east) meets the South Ditch. They are constructed against the rock-cut scarp face of the ditch, forming its revetment, in two ranges arranged at right-angles to one another (Fig 74). The larger of the two ranges, oriented roughly north-east to south-west, provided casemated barrack rooms on two basement levels, the lower of which has a floor level more than a storey's height above the bottom of the ditch. Above the rear half of the barrack rooms are a series of casemated gunrooms which accommodated carronade positions. These were served by a magazine on the opposite side of a sunken courtyard in the gorge. An undated but possibly original record drawing refers to them as '*Haxo*

Embrasures in the south-east front of the casemates look down the South Ditch and its *glacis*. Substantial profiled earthworks protect the embrasures and the surrounding face wall (Fig 74). To the rear the casemates open onto a paved sunken courtyard forming the gorge, on the opposite side of which there is a magazine serving the gun positions. This arrangement protects the gun crews from reverse and enfilade fire coming from the west and south-west respectively. The sunken courtyard also served as an assembly area for troops ascending from the barracks below, while rapid access to the remainder of the Western Outworks was facilitated by placing a broad stair at the rear of the area directly in line with the stair rising from the barracks. Soldiers latrines occupied two bomb proof casemates set in the revetment at the eastern end of the area.

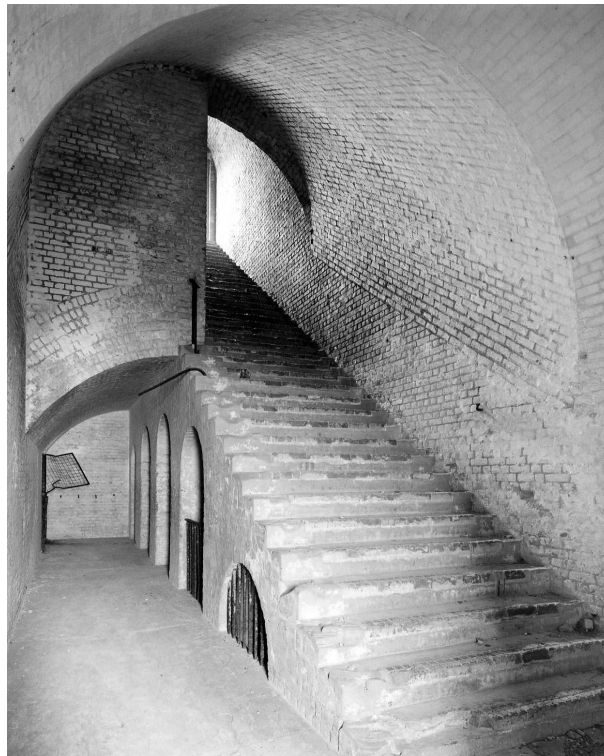
Figure 76
*Stairway between levels
in the South Flank
Casemates, looking NW
(NMR: AA043996 ©
Crown copyright 1998)*

small lockable room in the north corner of the bay, labelled ‘Lobby’ on the 1897 plan (HMPS: 402514). A second straight flight descends to the lower basement level, where there was a similar arrangement (Fig 76).

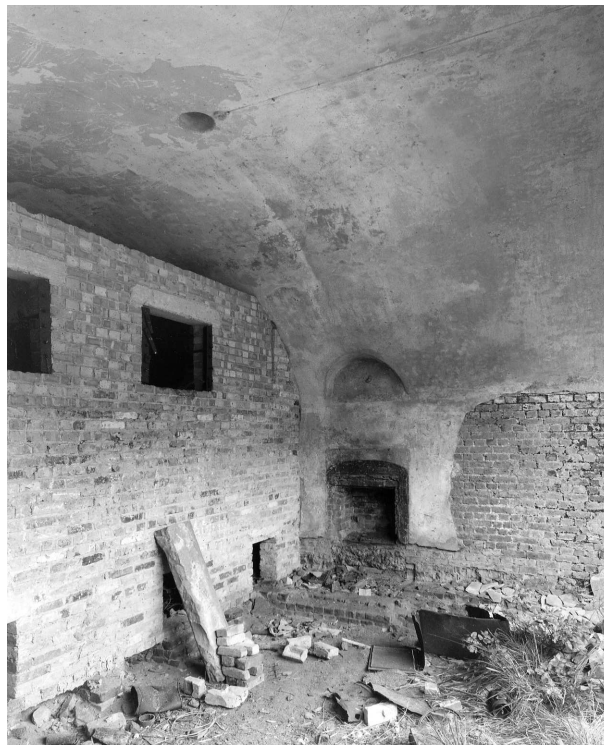
Figure 80
Interior of a Haxo casemate in the South Flank Casemates, showing the original vault with circular smoke vent, fireplace, and the inserted wall (at left) partitioning off the front of the casemate (NMR: AA043998 © Crown copyright 1998)

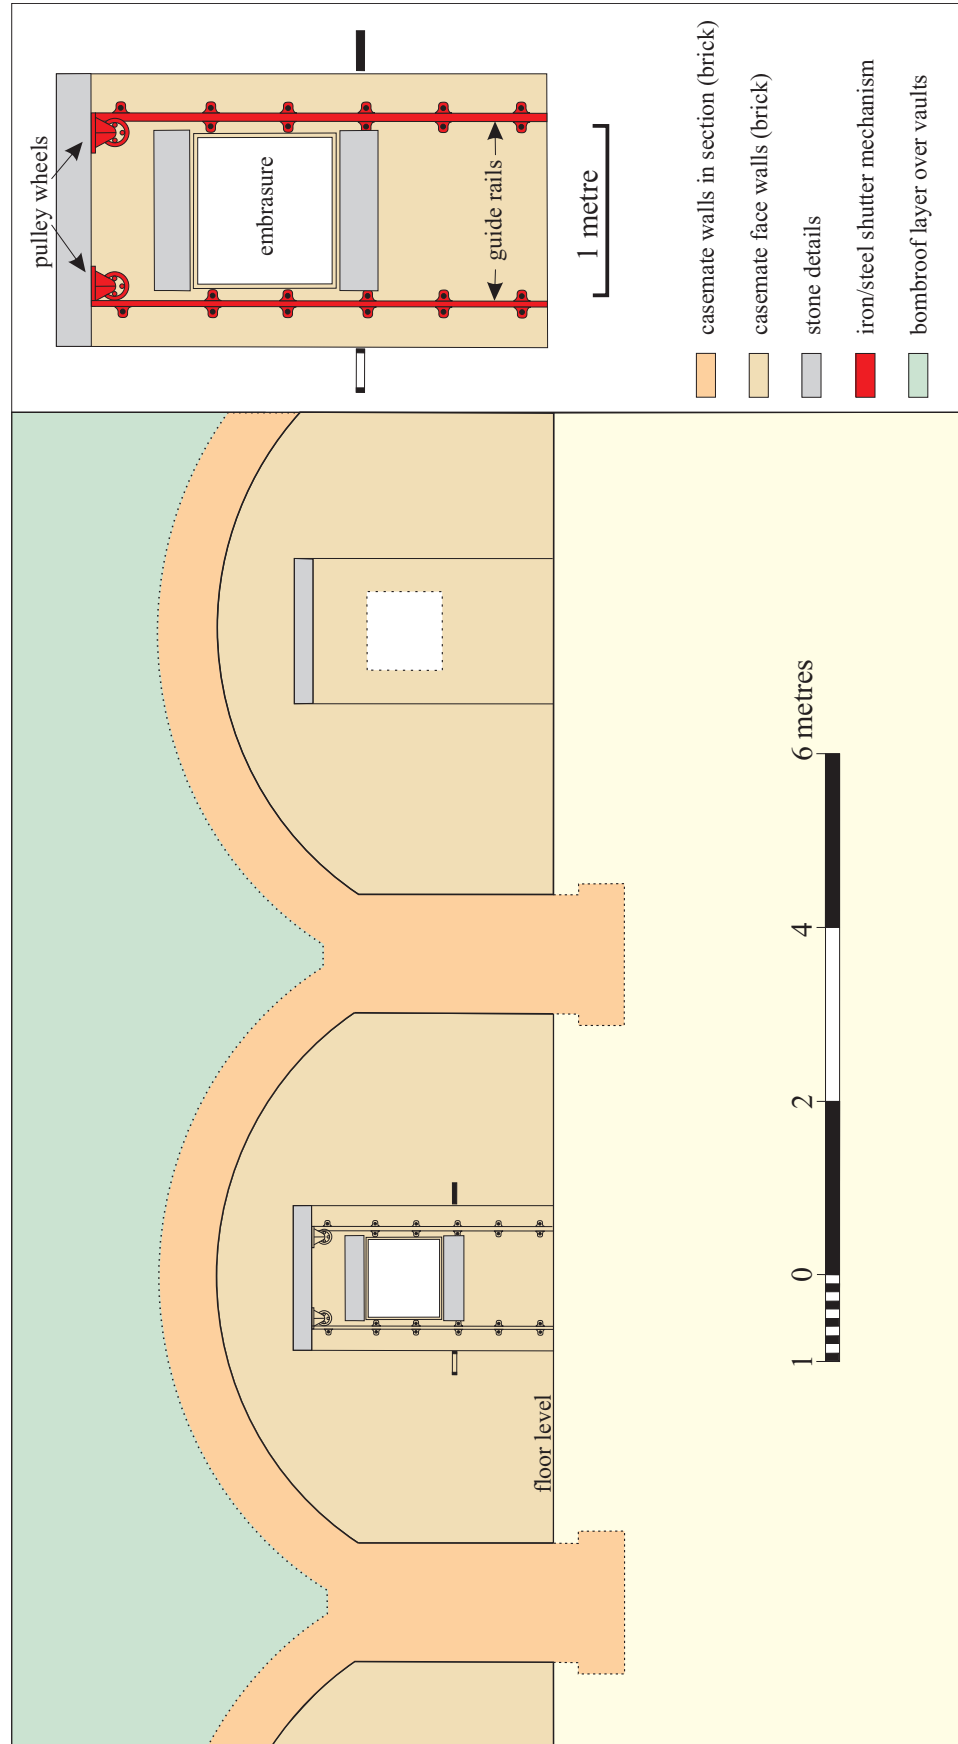
Figure 81
South Flank Casemates: elevation of the face wall of No 3 Haxo casemate, showing the wrought iron shutter over the carronade embrasure, with detail

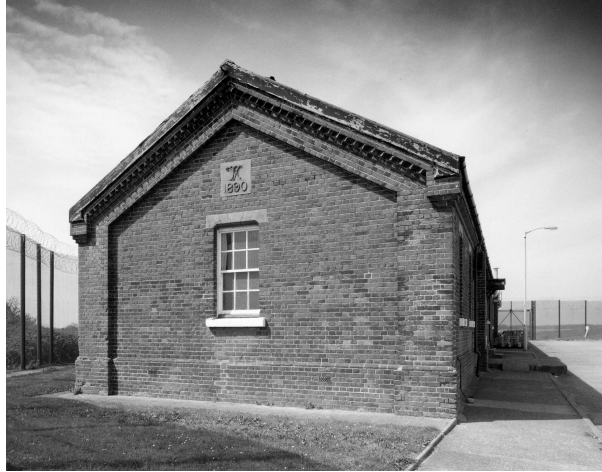
Figure 84
*Barrack Hut No 1, in
the Western Outworks,
showing the royal
cipher on the east gable*
(NMR: AA043992 ©
Crown copyright 1998)

These were all thirteen-bay barrack huts and five of them survive, nos 1-5, all bearing a terra-cotta plaque on one gable, with the cipher of Queen Victoria and the date 1890 (Figs 84-5). A modern store and boiler house occupies the site of no 6, which was demolished after 1947. All but no 3 were located beside the road. A further hut, no 3a, was built to a different plan in 1928-9 and is

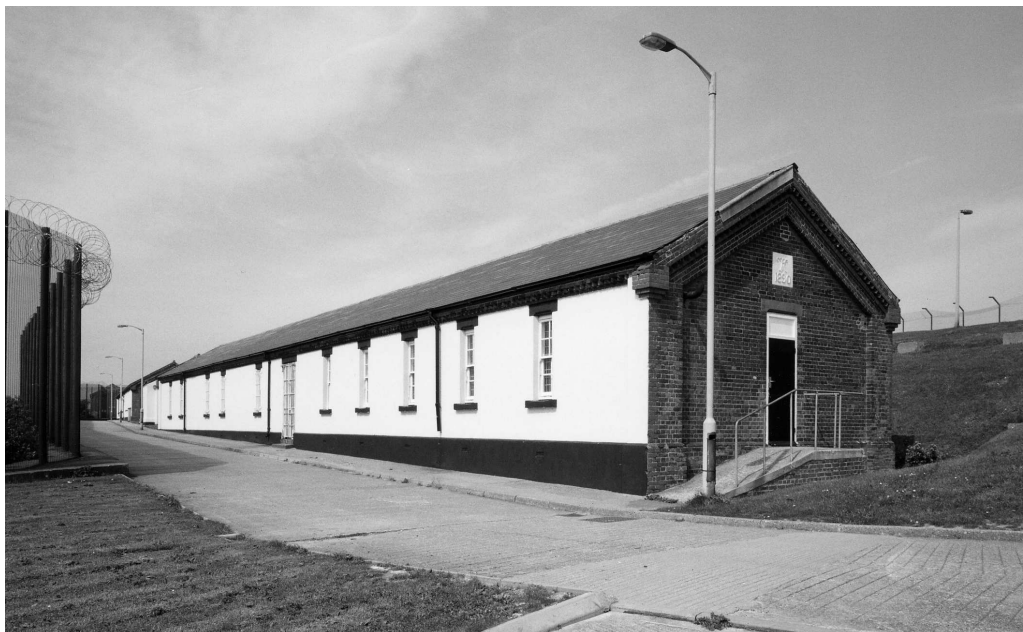
Figure 85
*Barrack Hut No 5, in
the Western Outworks,
from the SE (NMR:
AA043991 © Crown
copyright 1998)*
